Failure Analysis of a Total Damage by Hail Impact of an External Thermal Insulation Composite Systems

Keywords: *ETICS, Hail Damage, Impact, Ageing, Testing.*

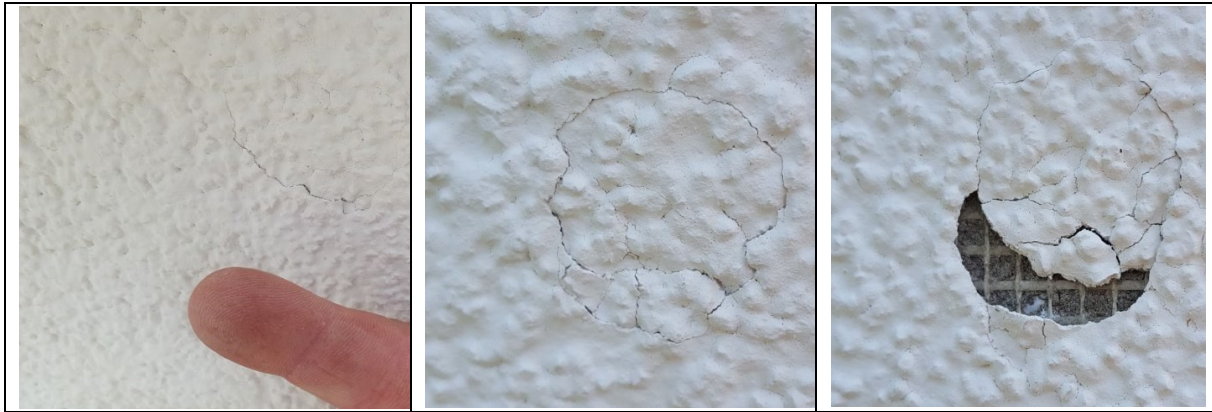
Figure 1. Representations of the damage classes: crack (left), full circle fracture (center) and breakout (right).

The damage to the façade by the natural hail event of August 1st 2017 could be reproduced by bombardments with ice balls of 30 mm and a kinetic energy of at least 2.5 J. An effect of ageing is weakly recognizable, both for full circle fractures and for breakouts: Both threshold values decrease with age, but only by approx. 15%. However, the tests in the laboratory did not show a thickness effect. Such an effect might be present in mineral rendering, in the aged condition, but not when it is new.

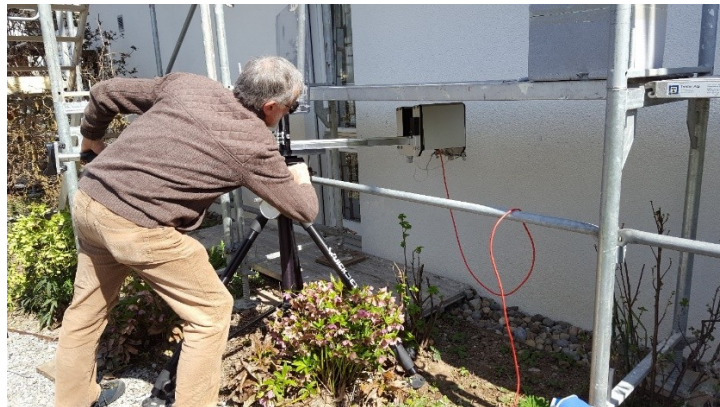
Figure 2. On-site determination of the hail resistance with an ice ball launcher
