Dynamic experiment of integrated ceiling system used in large span office buildings

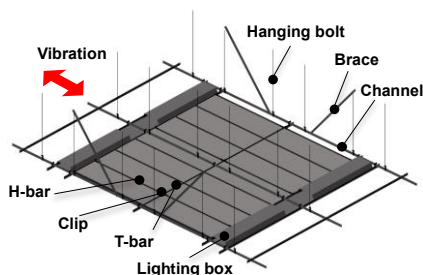
Fig.1 shows the integrated ceiling system components. The ceiling boards are connected with the H-bars on the T-bar flange (fig.2-a). The T-bar and H-bar are jointed by the vulnerable clip. Therefore, the ceiling boards easily fall by the rotation of the T-bar (fig.2-b). However, the T-bar is easily deformed by the inertial force of the ceiling board.

Fig.1 Overview of integrated ceiling system

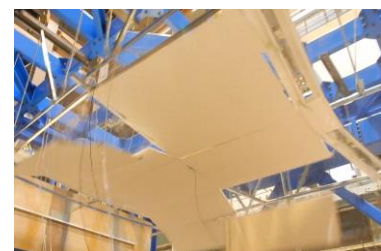
In this experiment, we constructed the five test ceilings to study the effect of the number of clip and the rigidity of the lighting boxes on the ceiling collapse. In the test ceiling desinged by the general standard, the ceiling boards fell at only about 50gal. However, in the test ceiling with the increased clips and reinforced the lighting boxes, the ceiling boards fell at about 500gal(fig.3). From these experiments, we revealed the response characteristics of the integrated ceiling system with braces to the ground motions. Moreover, we devised a method to construct an seismic resisting the integrated ceiling system.

Fig.3 Ceiling collapse
