## COMPUTER MODELLING AND SEISMIC PERFORMANCE ASSESSMENT OF A BYZANTINE BASILICA

**Keywords:** Unreinforced masonry building, Seismic assessment, Historic structure.

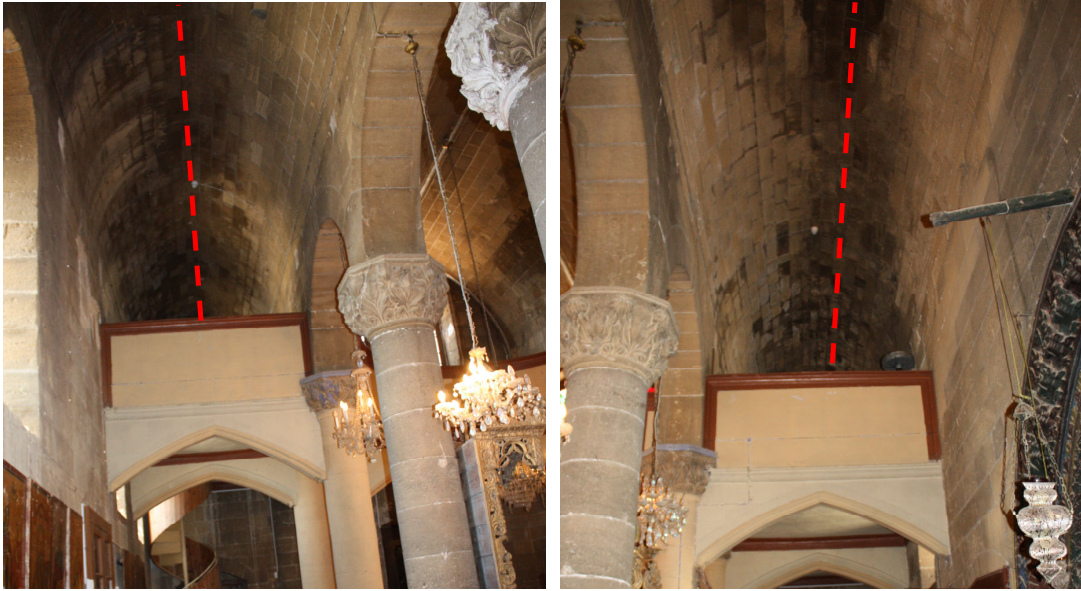
The malfunctioning drainage system of St. Mamas Church was already mentioned above. As presence of water accelerates deterioration of masonry and hence weakens it, variations in moisture content were documented by employing the infrared thermography technique. Results obtained indicate positive temperature gradients along the height of internal column elements suggesting moisture intake from the foundation of the structure through capillary action. However the lowest of all temperature measurements taken corresponded to the two side aisle vaults (Figure 2). On these vaults, severe discoloration was observed; the measure-

ments obtained are the proof that these discolorations are not just stains but due to high moisture content of the masonry at these locations.

Figure 2: Pictures depicting two aisle vaults along which the lowest temperatures within the structure were detected.

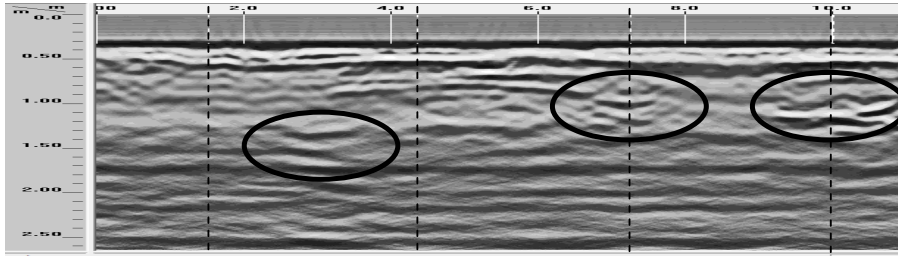
The main objective of carrying out the ground penetrating radar surveys on the structure floor was to investigate the foundation type of the structure as well as existence of any possible underground structures. For this purpose a ground penetrating radar unit with a 400 MHz antenna was used that is capable of providing moderate resolution up to 5m depth. The structure floor was surveyed regularly in both North-South and West-East directions. Results indicate that the foundation system is pad foundation type with no interconnecting ground beams. Also numerous archeological remains were detected throughout the plan area of the structure. These were found to exist at two main depth levels: (i) 0.75-1.25m and (ii) below 1.5m, probably corresponding to the early Christian and Byzantine church remains mentioned above (Figure 3). Existence of such remains/cavities may give rise to settlement problems; hence the observed difference in behavior of axes 2 and 3 columns can also be attributed to differential settlement caused by these detected remains/cavities. However it should be underlined that remains detected are not localized along axis 2 only but rather distributed throughout the whole floor area.

Figure 3: Ground penetrating radar survey result along axis 2. Horizontal axis represents distance along axis 2, vertical axis represents depth. Dotted black lines represent locations of columns B2, C2, D2, E2 from left to right respectively. Black ellipses close identified remains along axis 2.

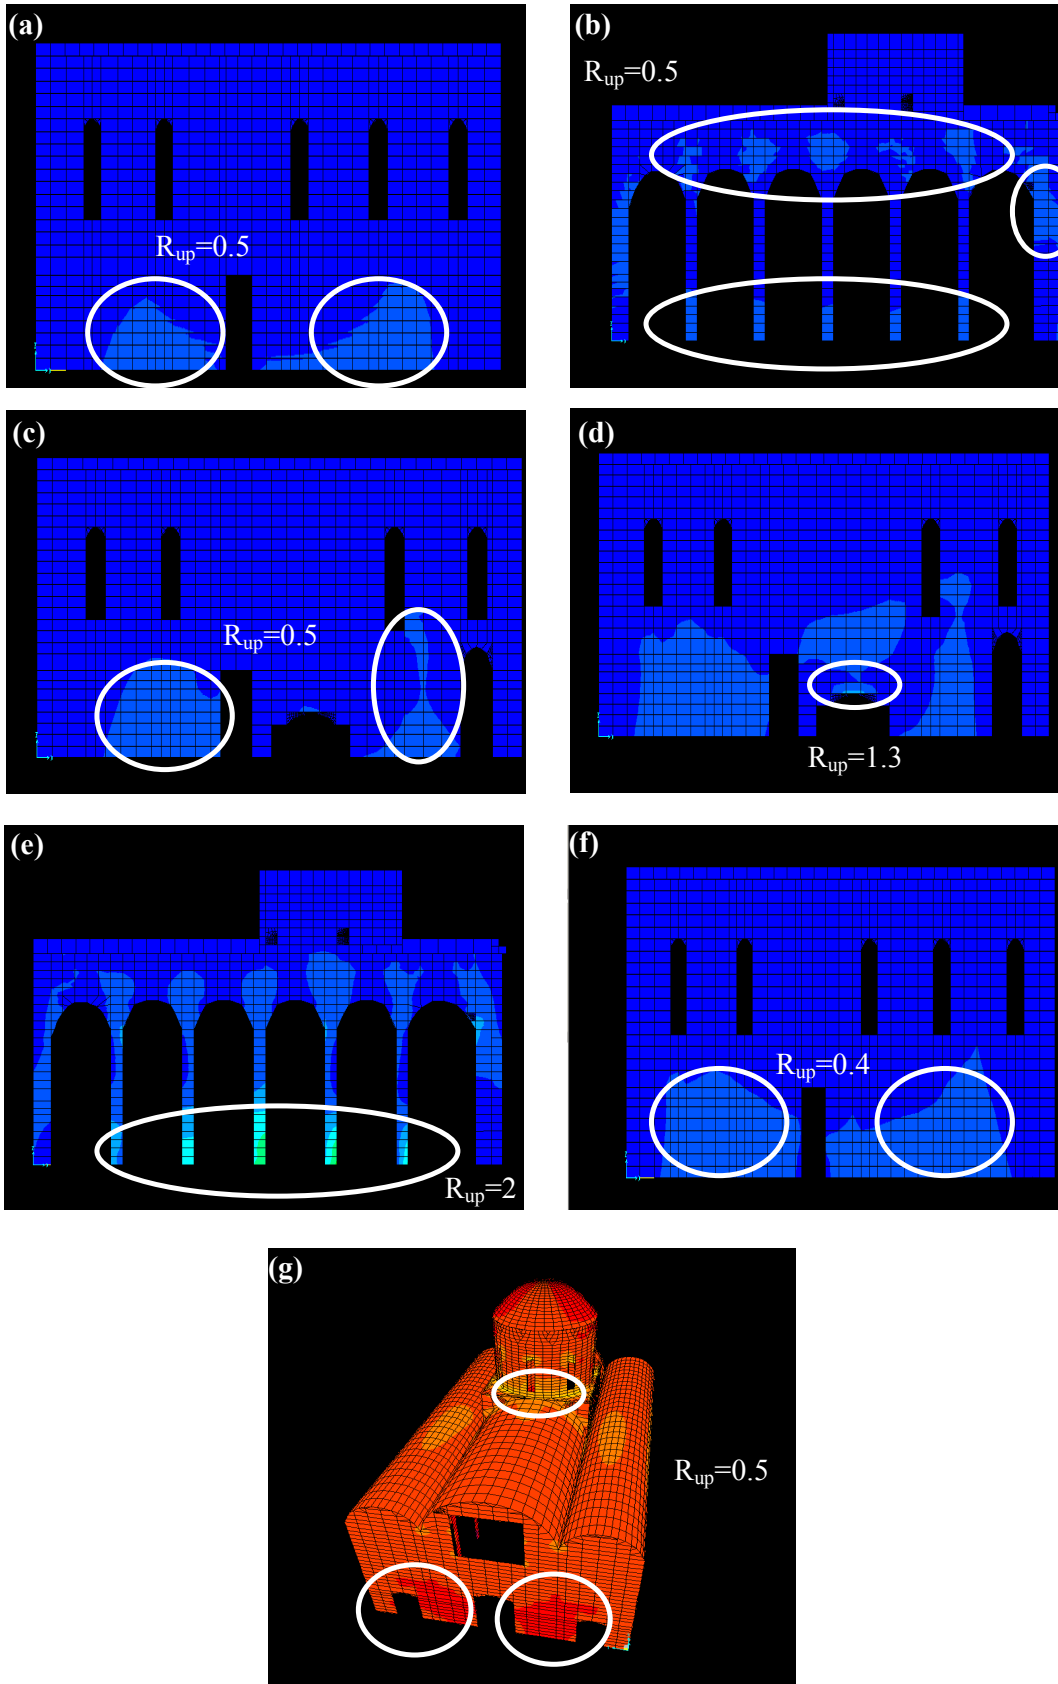
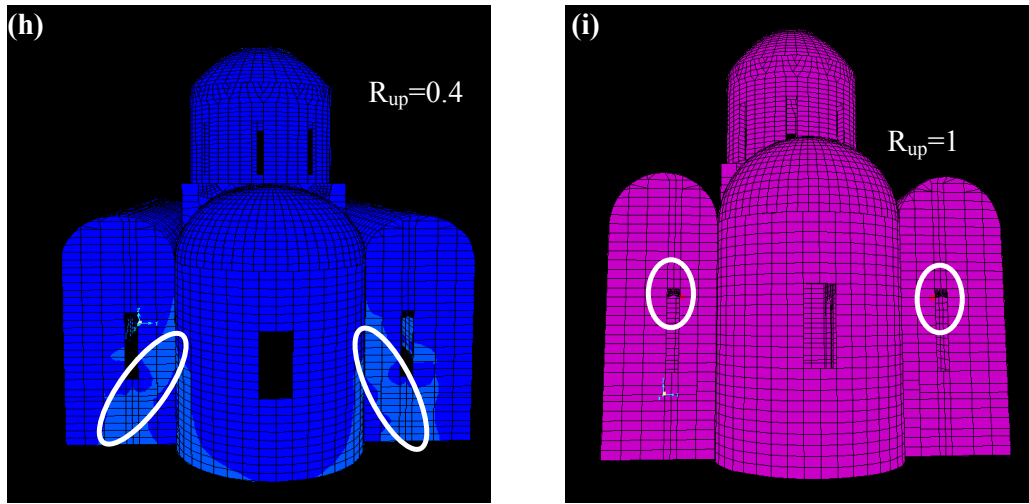
In Figure 6, distribution of stresses is shown for peripheral walls, internal colonnades, and the roof structure. Under the average strength values given in section 2 of this manuscript, the structure is not expected to sustain any damage due to seismic loading. However as the non-destructive testing results illustrate, mechanical properties of the masonry vary considerably throughout the structure. If the lower limit strength values are considered rather than the average values obtained, several structural elements appear to be critical throughout the structure. The lower limit strength values that were employed in this study were 3MPa for compressive strength and 0.3 MPa for tensile strength. For columns D2, E2 and F2, 20% lower strength values were used to reflect non-destructive test results. The critical elements identified are the internal columns carrying the drum and the dome of the structure (D2, E2, F2, F3, E3, and F3 of Figure 1a), vicinity of openings (doors, windows, sarcophagus of St. Mamas) on the pe-

ripheral walls, base of peripheral walls and the drum-lower roof intersections of the roof structure. Based on the aforementioned lower limit strength values, masonry over limit factors (ratio of observed stress level to assumed lower bound strength value) were also computed for these critical regions. These masonry over limit factors ( $R_{up}$ ) are all indicated on Figure 6 as well.

Figure 6: Stress distributions under (a)-(c) combination 3  $G+0.9E_x+0.3E_y$  and (d)-(i) combination 4  $G+0.9E_y+0.3E_x$ . As the structure is weaker in the transverse direction, the combination 4 yielded more critical results. Most critical regions are marked with the white ellipses, for these regions masonry over limit factors ( $R_{up}$ , ratio of observed stress to assumed lower bound strength level) are given as well.
