SEISMIC REHABILITATION OF TRADITIONAL UN-REINFORCED MASONRY BUILDINGS IN IRAN

Keywords: Seismic rehabilitation, ASCE 41-06 standard, Un-reinforced masonry building, Steel I-beam jack arch slab, Iran.

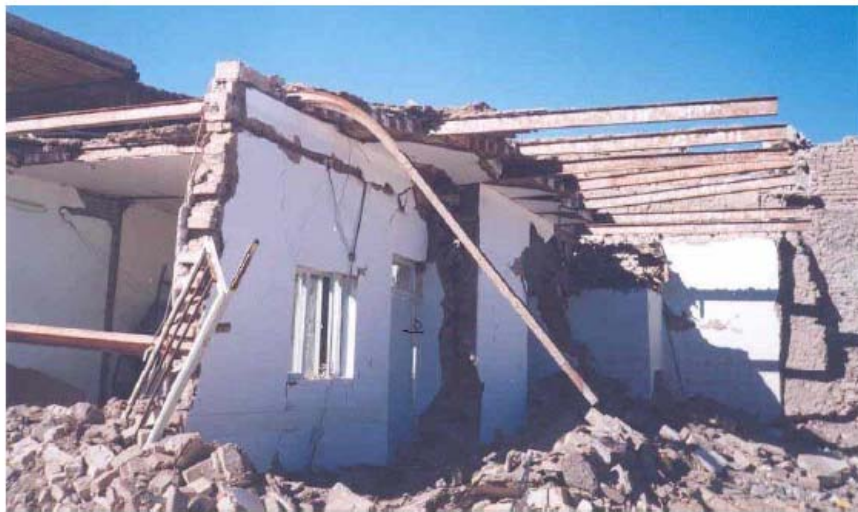
Figure 2. Damage to a traditional jack arch slab during Bam earthquake, 2003 [4].

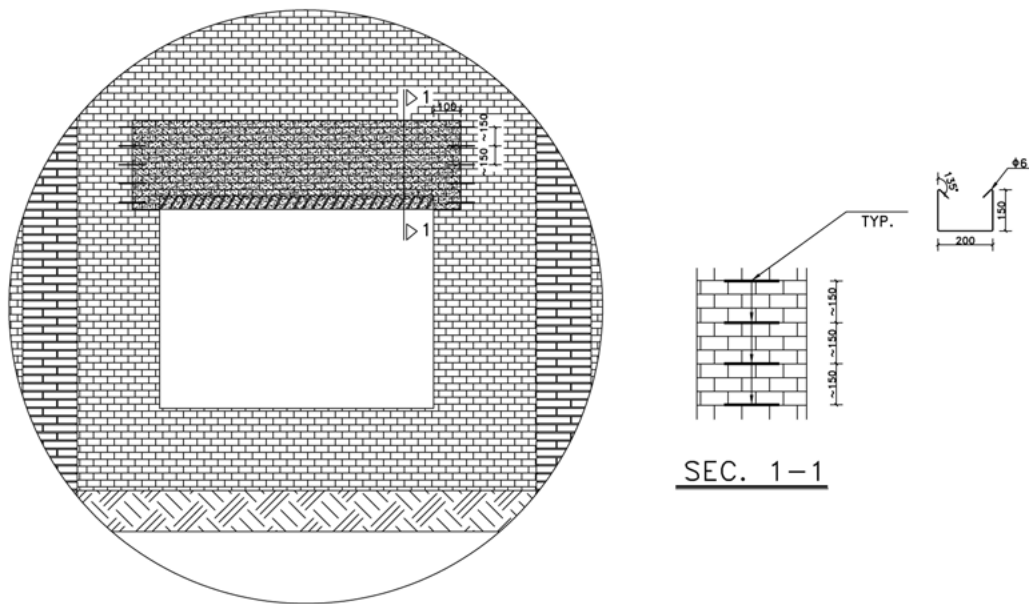
Figure 3. Decreasing of the opening dimensions.

The openings height or width in the masonry walls has been changed in order to reduce the opening dimensions as well as increasing the coupling beams dimensions. The new part of the masonry wall, as seen in Figure 3, should be connected to the existing part of the masonry wall by enough number of U shape rebars to be able to transfer the shear forces.

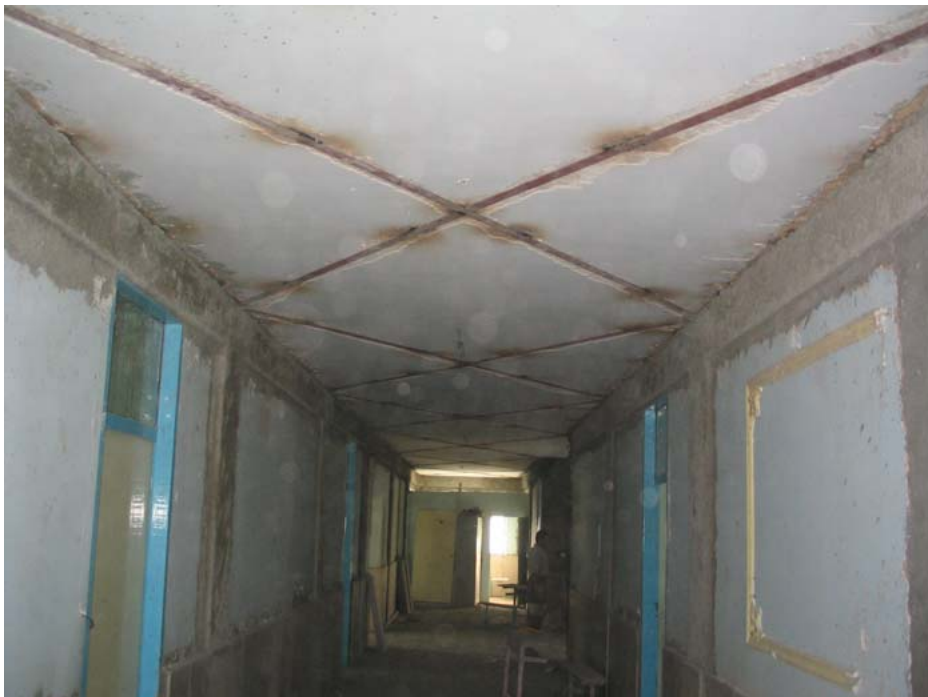
Figure 4. Adding $50 \times 5\text{mm}$ steel plates in order to integrate the traditional jack arch slab joists.

The traditional jack arch floor slab, as described in Section 3, can not act as an integrate slab. Hence, $50 \times 5\text{mm}$ flat bar was welded to the bottom flange of all steel I beams of the floor as shown in Figure 4. The added bar was welded, at the end, to the steel angle which is in the wall and floor intersection. The last steel I beam joist, which usually has the brick floor in only one side, should be connected to the adjacent I beam steel joist by steel flat bars at each 2 m.

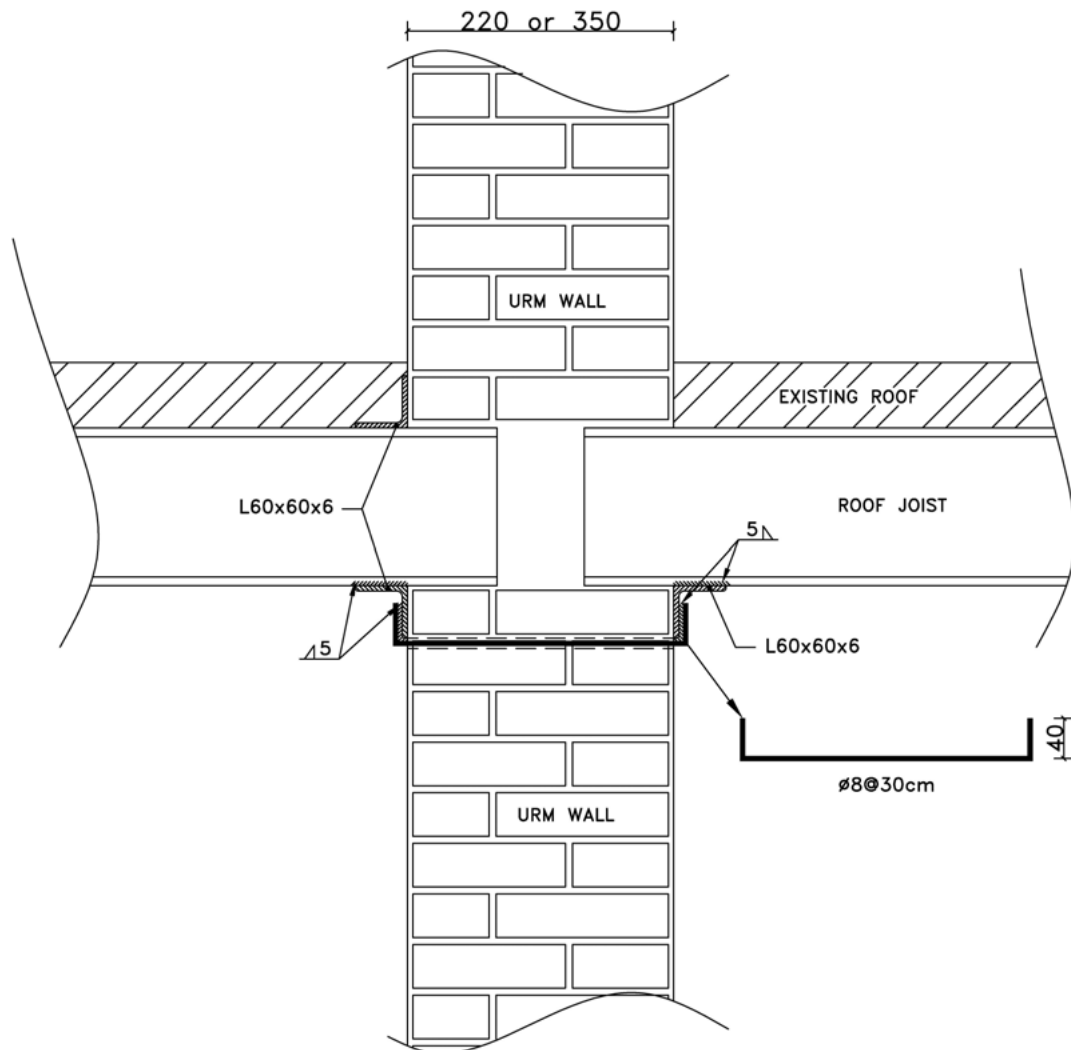
Figure 5. Adding an $60 \times 60 \times 6 \text{ mm}$ angle to connect the wall to the floor where the floor slab joists are perpendicular to the wall.

The floor to wall connection, as described in Section 3, is usually without enough strength. That is, a steel angle $60 \times 60 \times 6 \text{ mm}$ was added to all intersections between floor and walls. The function of the new angle can be summarized as (1) to connect the floor to the wall; (2) acts as a horizontal tie beam; (3) prevents relative movement of the steel joists in earthquake movements and (4) increases the steel joist support length. The details of the added angel are shown in Figure 5 and Figure 6, respectively, in the case of the floor slab joists are perpendicular or parallel to the wall.

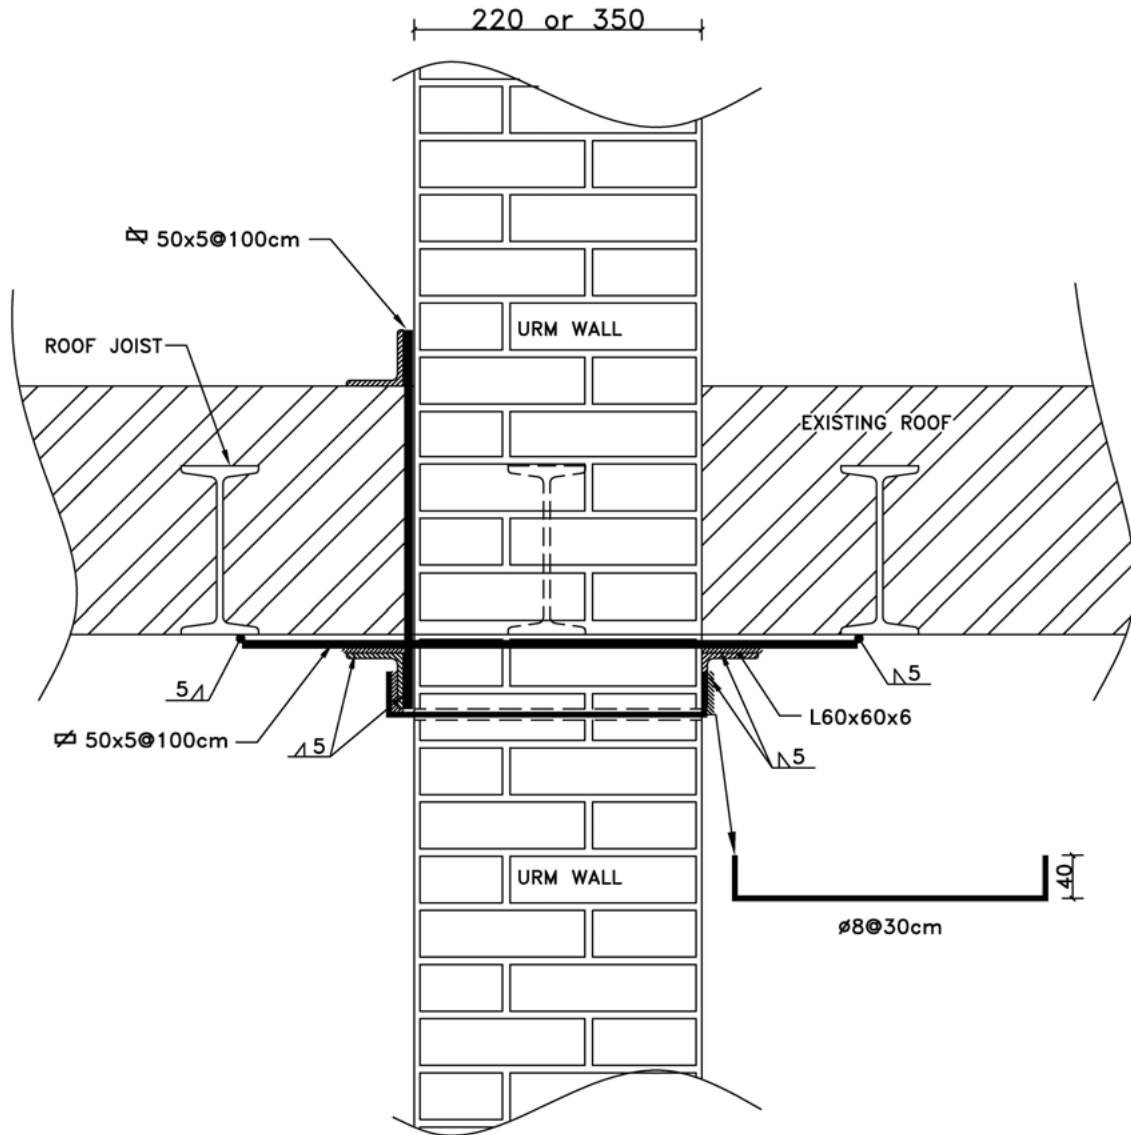
Figure 6. Adding an $60 \times 60 \times 6 \text{mm}$ angle to connect the wall to the floor where the floor slab joists are parallel to the wall.

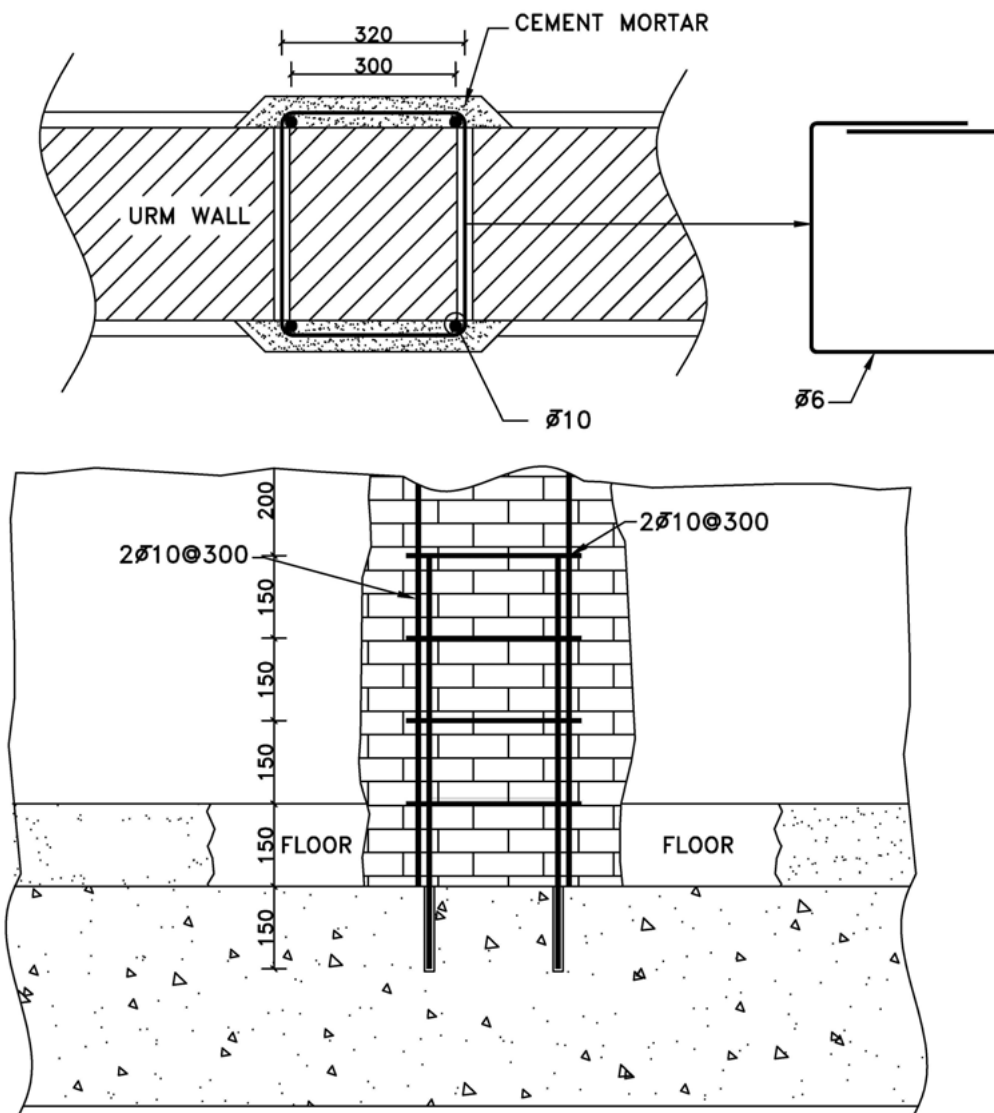
Figure 7. A typical view of the ties enhancement.

There is not any complete 3D tie system in the majority of the URM buildings, as discussed in Section 3. For construction of the 3D tie system, where necessary, a new vertical tie should be executed. Vertical rebars should be implanted in horizontal ties in the top and bottom of the walls. An alternative is the construction of masonry vertical tie beam as seen in Figure 7.

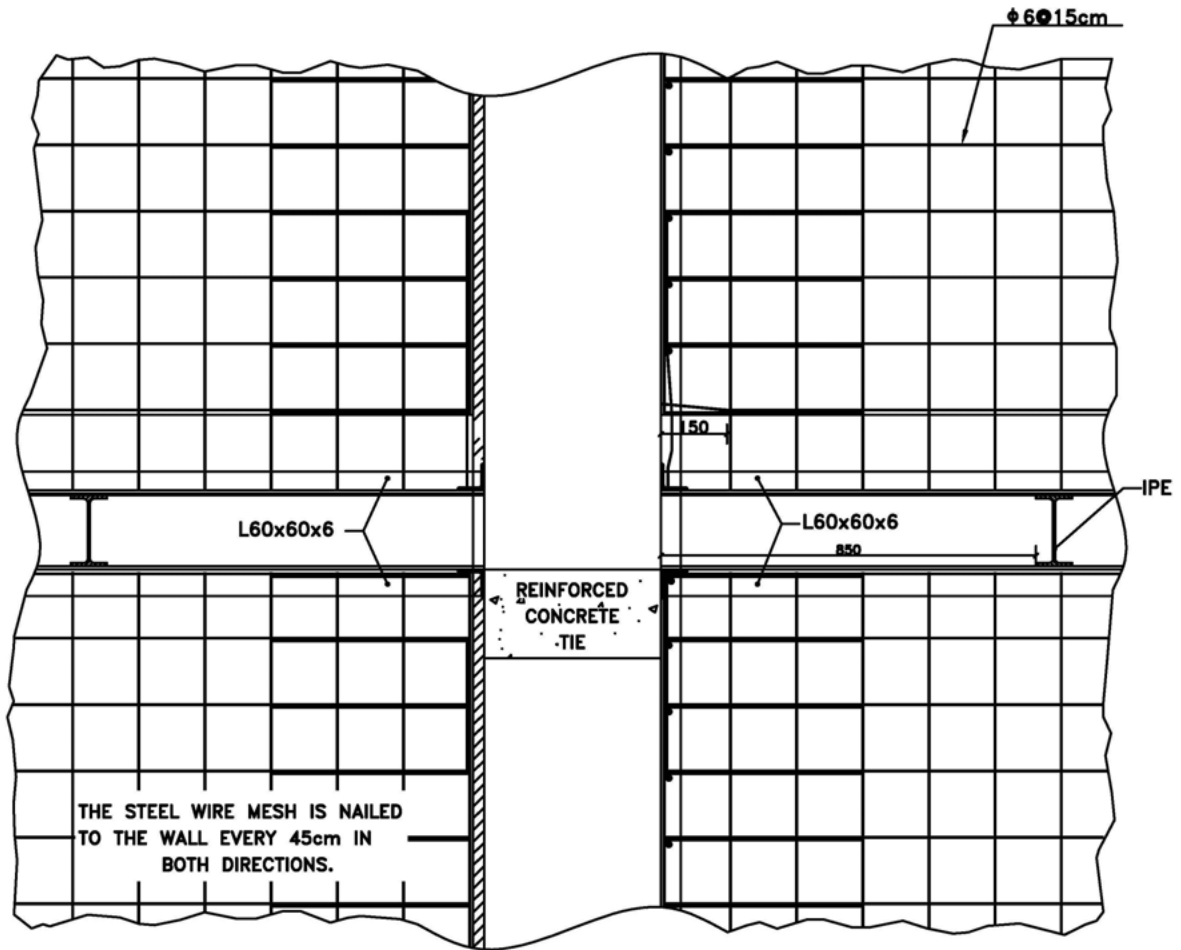
Figure 8. A typical view of the bearing wall enhancement through stories.

The masonry wall is enhanced by jacketing with the wire mesh and cement plaster where the capacity of the bearing wall is less than the induced earthquake forces. The details of this method, which is one of the URM wall enhancing methods, can be seen in Figure 8. The enhancement layer should be connected properly to the surrounded ties to be able to transfer the load through stories and deliver it to the foundation. Approximately nine bricks are pulled out from the existing masonry wall, as shown in Figure 9, to make the shear keys between the new layer and the existing masonry wall. The added steel mesh connects to the existing masonry wall by enough number of steel nails. The steel mesh is welded to the corner steel angels, as seen in Figure 10, to make a robust connection between the bearing wall and the floor slab. However the bearing wall is not always without openings. Hence, as shown in Figure 11, the bars should be placed around the openings and the 45° added bars should be placed around the electrical equipment boxes.

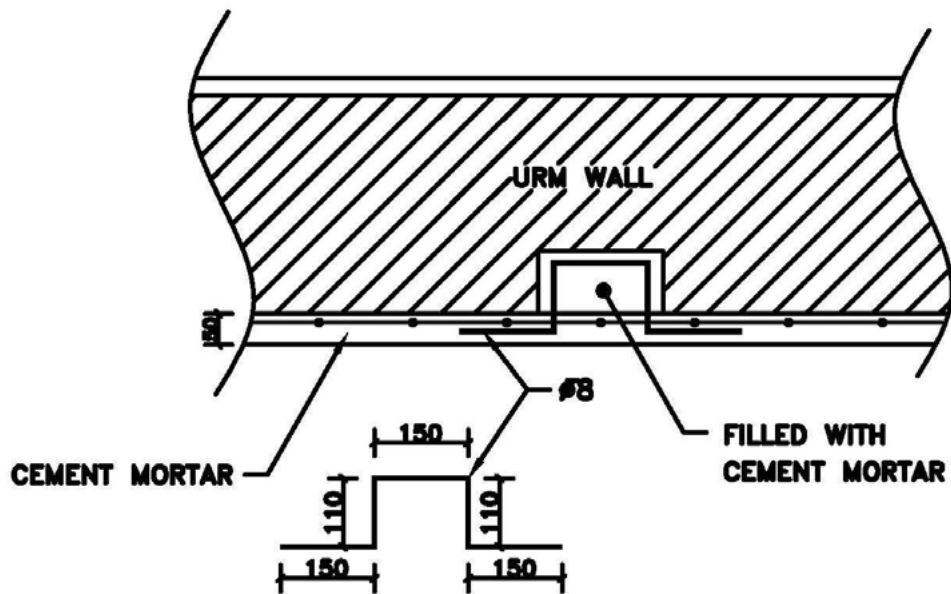
Figure 9. Increasing the strength of the URM wall.

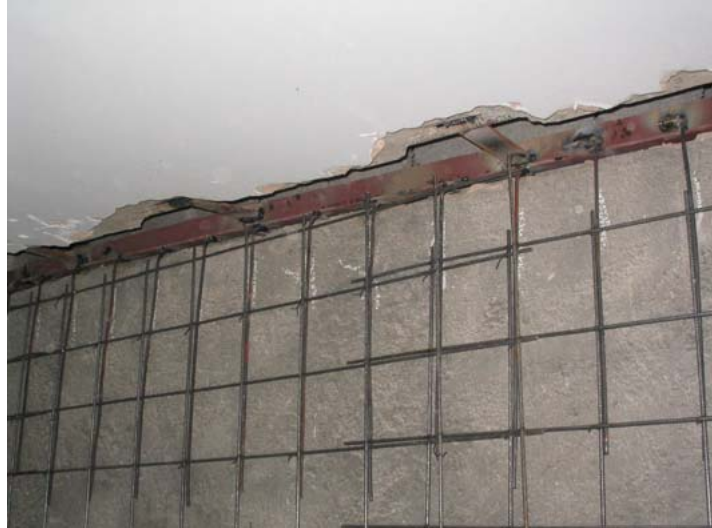
Figure 10. A typical view of the intersection between enhanced bearing walls and floor slab.

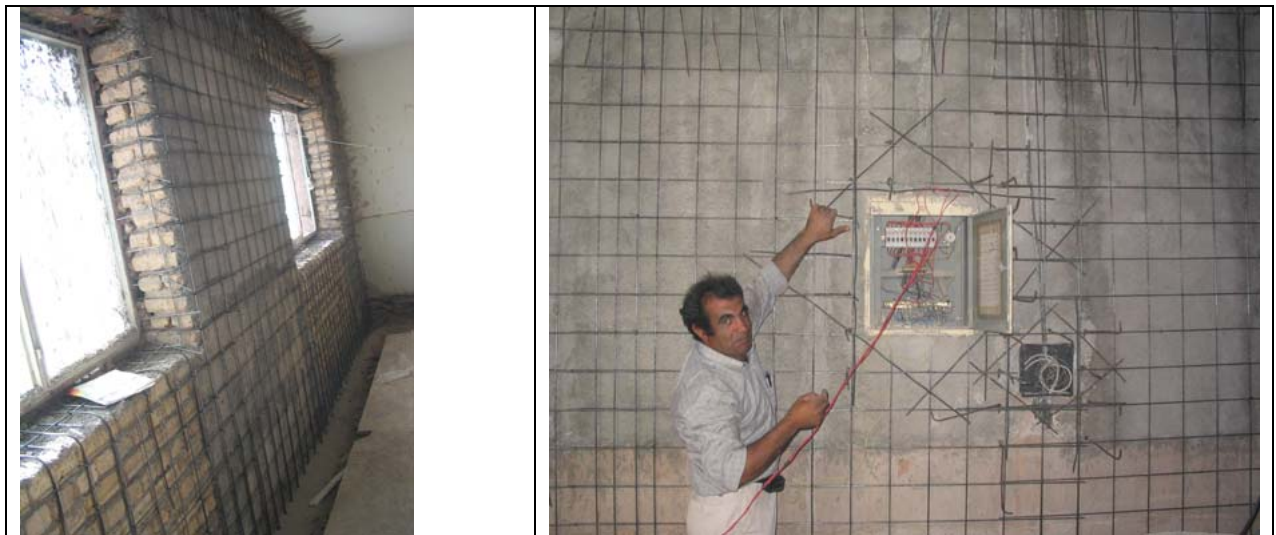
Figure 11. (left) A typical view of the enhanced bearing wall around the openings, (right) A typical view of the enhanced bearing wall around the electrical equipments box.
