The Structural Strengthening of a Masonry Heritage Shop House using Glass Fibre Based Materials

1 Introduction

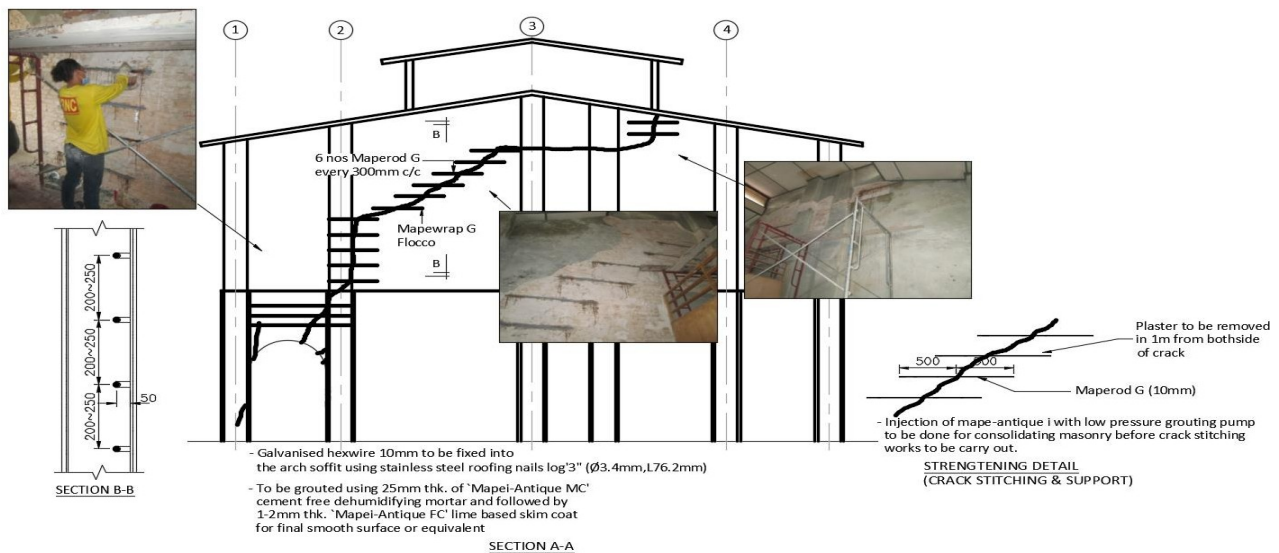
Figure 2. Significant Cracking of the Arch and Party Wall and the proposed approach to crack repair.

Several innovative techniques for intervention of the masonry building was considered and the use of the glass fibre based Maperod G and Mapewrap Foccio was adopted. The masonry wall cracks were repaired by a stitching method, using Maperod G a glass fiber rod. This was used due to the compatibility of modulus of elasticity (40,800N/mm²) to the lime mortar and good tensile strength of 760 N/mm² to help bridge the cracks in case of further movement. As glass fiber is also corrosion resistant it will be protected in future even though it is embedded in the highly porous masonry substrate. The materials used were easily transportable, flexible *i.e.* could be

prepared to requirements on site, and the supplier had the infrastructure to deliver the materials to site quickly despite this being imported. As the stitching could only be performed at one-side Mapewrap G Fiocco was used. This consists of an L-shaped anchor using epoxy impregnator Mapewrap 31SP and is bonded at both ends of the Maperod G, having been planted deep into the masonry wall to a depth of ~140mm to provide full anchorage. Structural bonding was achieved by using epoxy adhesive Adesilex PG2 TG and all contact surfaces of the masonry were primed with Mapewrap primer 1 SP to consolidate the porous surface and eliminate dust. The crack lines were reinforced at every 4-5 brick intervals and inserted into the pointing layer for a minimal impact on the existing masonry wall. The full extent of the repairs is illustrated in Figure 2.
