IN-PLANE DESIGN LOADS FOR SEISMIC ASSESSMENT AND RETROFIT OF WALLS IN UNREINFORCED MASONRY BUILDINGS

Keywords: Unreinforced masonry, Flexible diaphragms, Seismic Loads, Design guide.

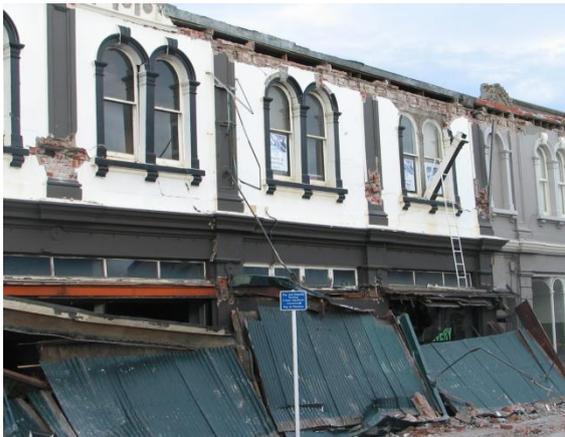
(a) Multiple front wall parapet failures

Numerous parapet failures were observed along both the building frontage and along their side walls, and for several URM buildings located on the corners of intersections, the parapets collapsed on both perpendicular walls (refer Figure 2). Restraint of URM parapets against lateral loads has routinely been implemented since the 1940s, so whilst it is difficult to see these restraints unless roof access is available, it is believed that the majority of parapets that exhibited no damage in the earthquake were provided with suitable lateral restraint. In several cases, it appears that parapets were braced back to the perpendicular parapet, which proved unsuccessful.

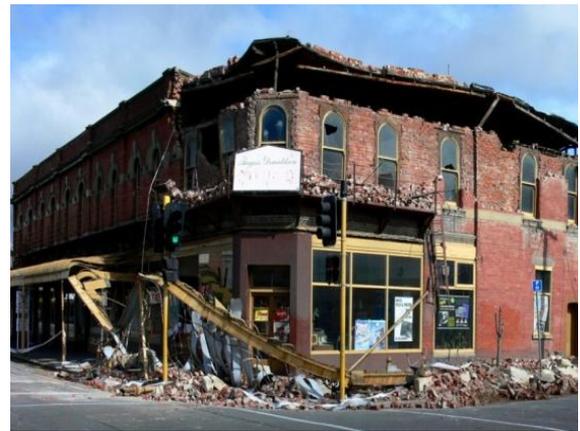
(b) Corner of Sandyford and Colombo Street

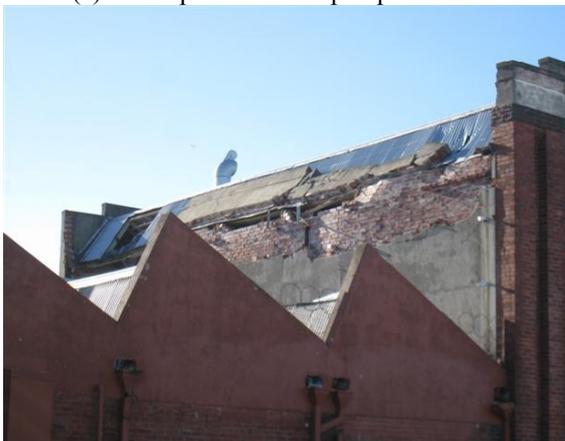
(c) Side wall parapet collapse onto roof.

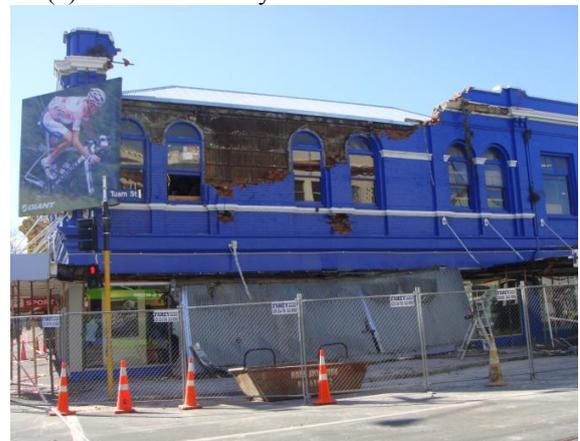
(d) Corner Colombo and Tuam Street

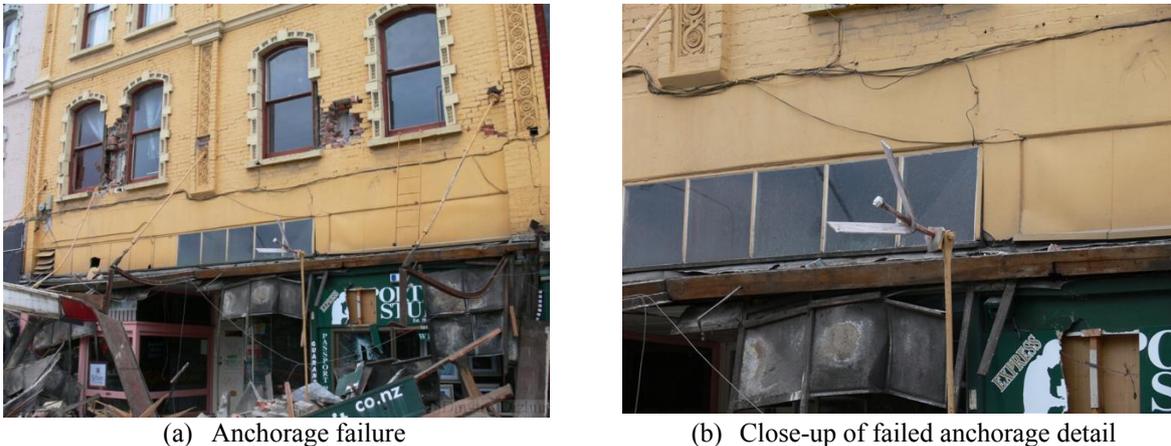
Figure 3: Anchorage failure of awning brace due to parapet collapse.

(a) Anchorage failure (b) Close-up of failed anchorage detail

Falling parapets typically landed on awnings, resulting in an overloading of the braces that supported these awnings and leading to collapse. Most awning supports in Christchurch involved a tension rod tied back into the building through the front wall of the building. Many of these connections appear to consist of a long, roughly 25 mm diameter rod, with a rectangular steel plate (about 5 mm thick) at the wall end that is about 50 mm wide x 450 mm long and fastened to the rod and positioned either inside the brick wall or in the centre of a masonry pier or wall. In most cases the force on the rod exceeded the capacity of the masonry wall anchorage, causing a punching shear failure in the masonry wall identified by a crater in the masonry (refer Figure 3).

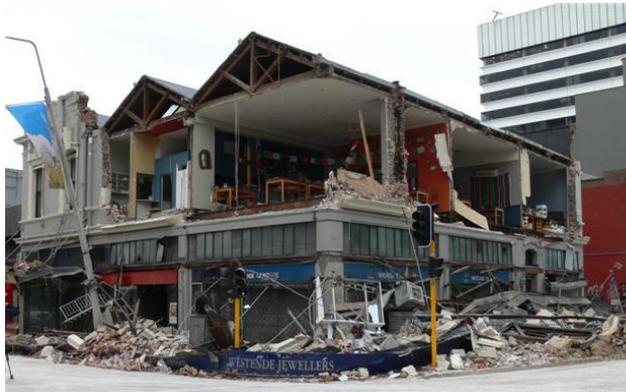
(a) Corner Worcester and Manchester streets

Out-of-plane wall failures were the first images to appear on television directly after the earthquake. Inspection of this damage typically indicated poor or no anchorage of the wall to its supporting timber diaphragm. Several examples of wall failure are shown below. Figure 4(a) shows a corner building that had walls fail in the out-of-plane direction along both directions. Figure 4(b) shows a 3-storey building where walls in the upper two stories suffered out-of-plane failures and Figure 4(c) shows similar damage for a 2-storey building. In all three of these instances, it appears that the walls were not carrying significant vertical gravity loads, other than their self weight, due to the fact that the remaining roof structures appear to

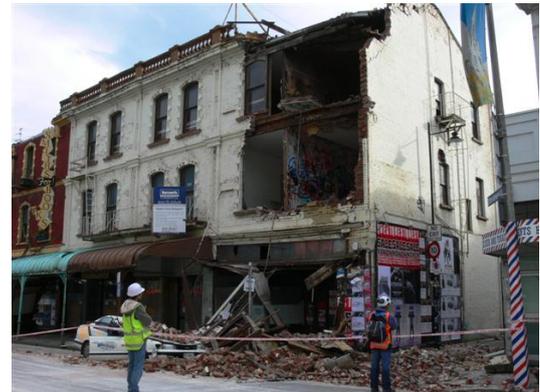
(b) 118 Manchester Street

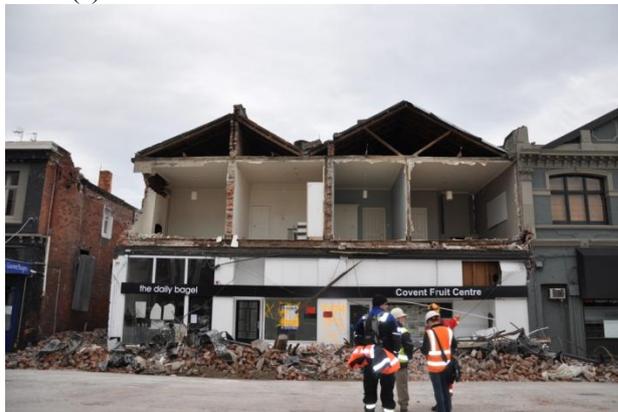
(c) 179 Victoria Street

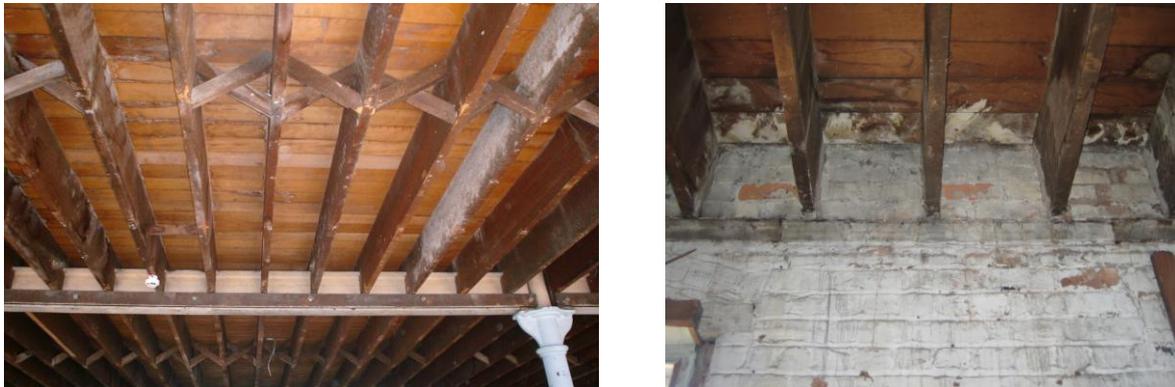
Figure 5: Typical timber diaphragm configuration

(a) Underside showing joists, sheathing and cross-bracing

(b) Joists pocketed into URM perimeter wall

While URM buildings outside of Europe are typically comprised of rigid clay brick perimeter walls, the floors are usually constructed of comparatively light timber framing. These floors are generally made up of either straight-edge or tongue & groove floorboards nailed perpendicular to joists that span between the URM walls. When perimeter walls are close enough (approximately less than 6 m) joists often span continuously between these elements. For larger spans, joists are typically lapped or butted over intermediate steel or timber cross-beams supported on columns. Diaphragm blocking and chord elements are almost never present, and timber cross-bracing is typically fitted intermittently between joists to prevent out-of-plane buckling. Joist ends are typically either simply supported on a brick ledge resulting from the perimeter walls reducing in width at each storey height, or pocketed into the wall to a depth equal to one brick width. Examples of timber floor configurations are given in Figure 5.

Diaphragms FS3a and FS4a were tested in the direction perpendicular to joists so that the diaphragm span to depth ratio was 1 to 1.88. Realistic conditions were created for this set-up by constructing URM walls on each side of the diaphragm for the joists to pocket into, similar to that illustrated in Figure 5(b). Sliding of the brick walls was prevented by post-tensioning the walls with M16 rods epoxied into the warehouse concrete slab (measurement of wall position during testing showed that no wall displacement was observed). Loading was introduced into the diaphragm using the same hinged steel frame as for the previous set-up but with only two points of loading. Diaphragms FS3a and FS4a were equivalent in construction except that diaphragm FS3a had continuous joists spanning between the brick walls while diaphragm FS4a had discontinuous joists with a two-bolt lapped central connection.

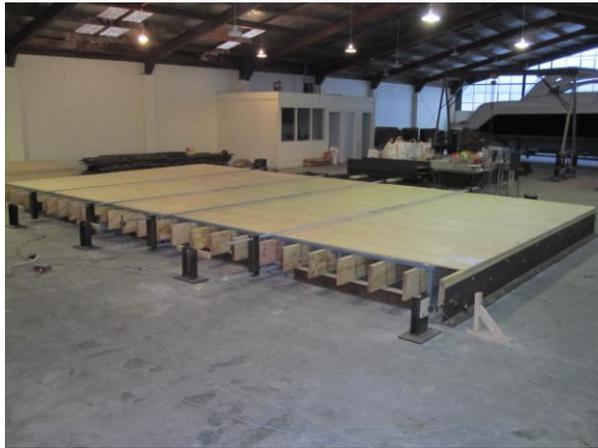
(a) Diaphragm FS1a

cally by Teflon pads that allowed the diaphragm to deform laterally without measurable friction. Diaphragm FS1a shown in Figure 6(a) was a homogenous diaphragm while diaphragm FS2a shown in Figure 6(c) included a corner penetration measuring 3.2 m x 1.08 m that represented a typical stairwell present in many timber diaphragms.

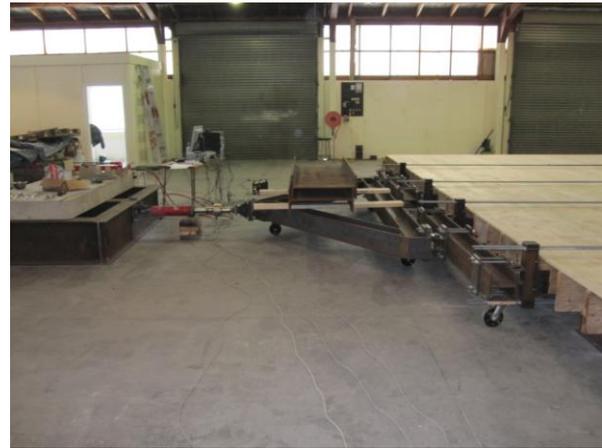
(b) Loading frame set-up

Diaphragms FS1a and FS2a were tested in the direction parallel to joists so that the diaphragm span to depth ratio was 1.88 to 1. In this direction the two side joists were bolted to steel frames that were fastened to the warehouse concrete slab which replicated in-situ boundary conditions where the edge joists would simply be bolted intermittently to the perimeter URM walls (see Figure 6(a)). Lateral loading was introduced into the diaphragm using a hinged steel frame ‘whiffle tree’ on castors that distributed the hydraulic actuator point load into four equal point loads. It can be observed in Figure 6(b) that the loading frame was comprised of a main truss and two secondary beams that were capable of rotating with the deforming diaphragm. Reversed cyclic loading was achieved by positioning loaders on both ends of the loaded joists, and post-tensioning these loaders together using M16 threaded rods that spanned the depth of the diaphragm (Figure 6(b)). The diaphragm was supported verti-
