NUMERICAL SIMULATION OF THE DYNAMIC AND EARTHQUAKE BEHAVIOUR OF GREEK POST-BYZANTINE CHURCHES WITH AND WITHOUT BASE ISOLATION

G.C. Manos¹, N. Karamitsios¹

¹ Department of Civil Engineering, Aristotle University, Thessaloniki 54006, Greece

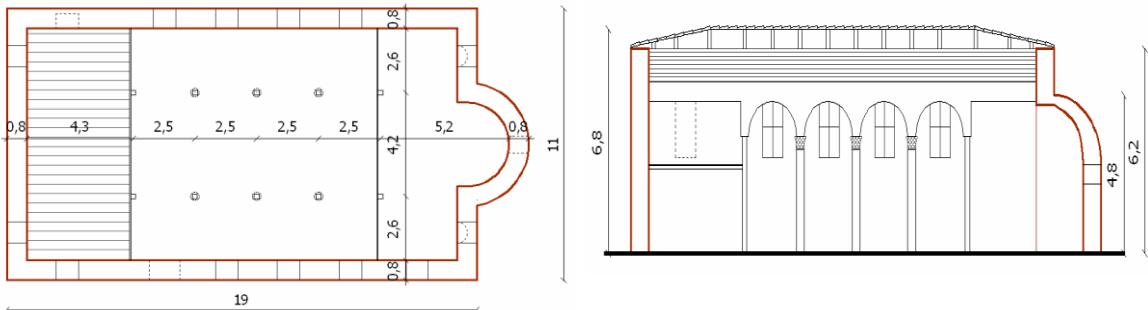
Figure 1a plan

Figure 1. Typical Post-Byzantine “Basilica”

The first case is a three-nave Post Byzantine “Basilica” structural formation which, in the overall geometry, is typical of a number of churches with similar geometry which were damaged by a strong earthquake sequence in the region of Western Macedonia, Greece during the Kozani Earthquake of 1995. The overall dimensions of this “typical” case are 19m length, 11m width and 6.8m height of the central nave (the level at the top of the roof). The internal colonnades are made of wood (figures 1a, 1b and 1c).

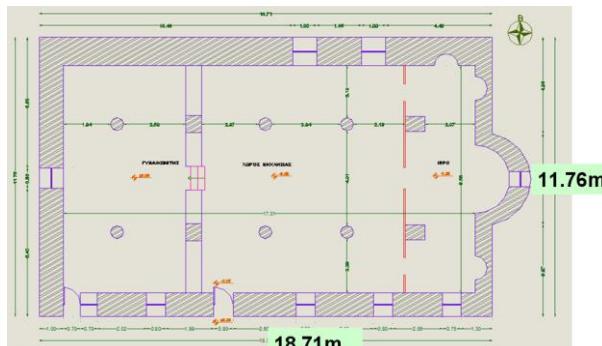
Figure 2a plan

Figure 2 “The church of Taxiarches”

This structural formation is also a 19th century Post Byzantine church of Taxiarches at the village of Rodiani in the prefectures of Kozani, Greece; it was also damaged by the Kozani Earthquake of 1995. The length of the longitudinal walls is 18.7m whereas that of the transverse walls 11.75m, almost similar to the plan dimensions of the 1st church. However, the height of the peripheral walls is 4.85m, lower than that of the 1st case. Moreover, an additional distinct difference from the 1st case is a system of masonry cylindrical vaults, spherical domes and arches which are utilized to support the wooden roof that rises another 2.0m from

the top of the peripheral masonry walls (Figures 2a and 2b). The thickness of the masonry walls varies from 700mm to 1200mm.

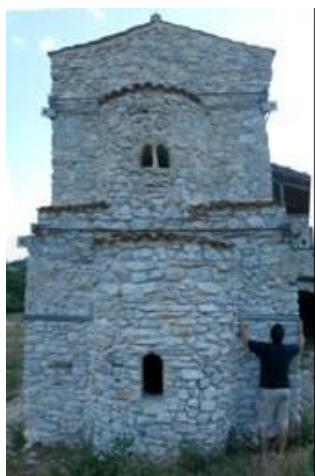
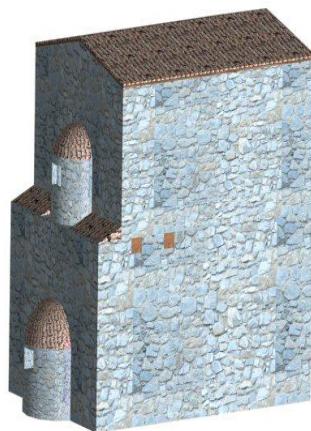
Fig. 3a.

Figure 3. of Virgin Mary of the Monastic complex of Tourniki

Such a two-story Basilica (Figure 3) is a rather rare structural system that can be found in the monastic complexes of Mt. Athos. The behavior of this two-story Basilica is numerically simulated by focusing on the super-structure and in particular on the influence of the cylindrical vaulting system that exists at the 1st story level as well as at the roof. The numerical investigation for this 2nd church is extended to study the introduction of a base isolation system.

two longitudinal walls (North and South) and two transverse walls (East and West) with a thickness of 700mm. The East transverse wall is dominated by two apses (one for each story) with a thickness of 700mm (Figs 3a and 3b). A relatively complex system is constructed at the East transverse wall with the two Apses in order to transfer the gravitational forces of the top East wall and Apse, which are offset by 700mm towards the interior of the church, when compared with the East wall and Apse of the bottom story (Figures 3a to 3d). The top story ceiling is formed by a longitudinal semi-cylindrical vault with a thickness of 350mm which supports the wooden roof together with the peripheral walls that extend appropriately for this purpose. Despite some small differences in the length of the North and South longitudinal walls, the structural system as a whole can be assumed to retain a mid-axis of symmetry with respect to the East-West longitudinal direction. Apart from the difference in the length of the longitudinal walls the exact location of the window openings deviates from this symmetry; however, these deviations are not believed to be very significant. This church was also subjected to the same 1995 strong earthquake when the monastic complex was not in use; damage visible at the cylindrical vaults cannot be linked directly to the event.

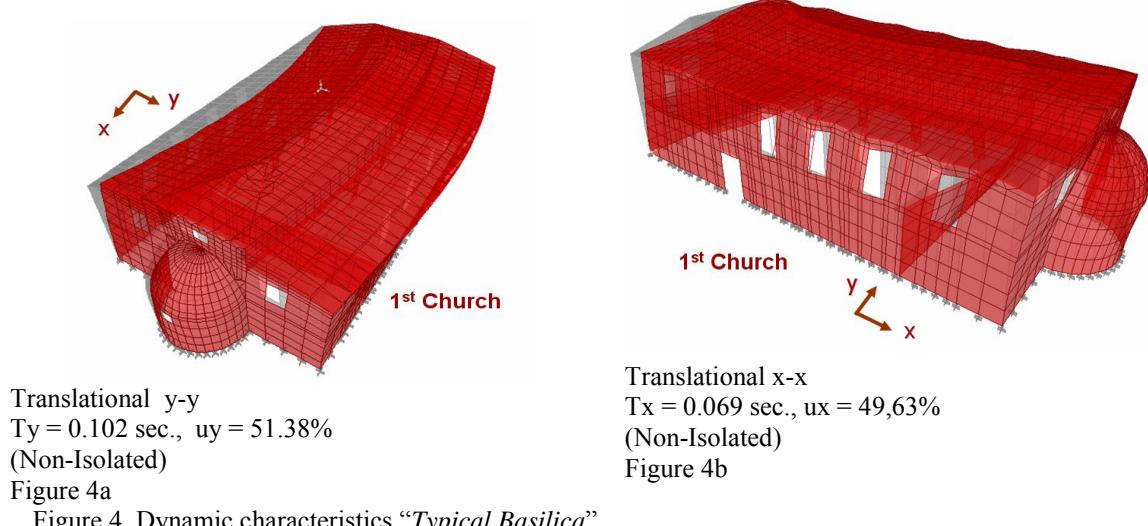
Figure 4. Dynamic characteristics “Typical Basilica”

Figures 4a and 4b depict the mainly horizontal translational eigen-modes for the 1st structure. The translational eigen-mode in the transverse North-South (y-y) direction is the one with the longest eigen-period (Figure 4a T = 0.102seconds). The structural response in this mode displaces the longitudinal peripheral walls mainly out-of-plane; this is done with the transverse peripheral walls resisting mainly in-plane. The translational eigen-mode in the lon-

itudinal East-West (x-x) direction is the next longest eigen-period (Figure 4b $T = 0.069$ seconds). The structural response in this mode displaces the longitudinal peripheral walls mainly in-plane; this is done with the transverse peripheral walls resisting mainly out-of-plane. Each one of these modes mobilizes approximately 50% of the total mass of the structure. These two modes are next followed by higher modes; however, these latter modes mobilize relatively small portions of the total mass.

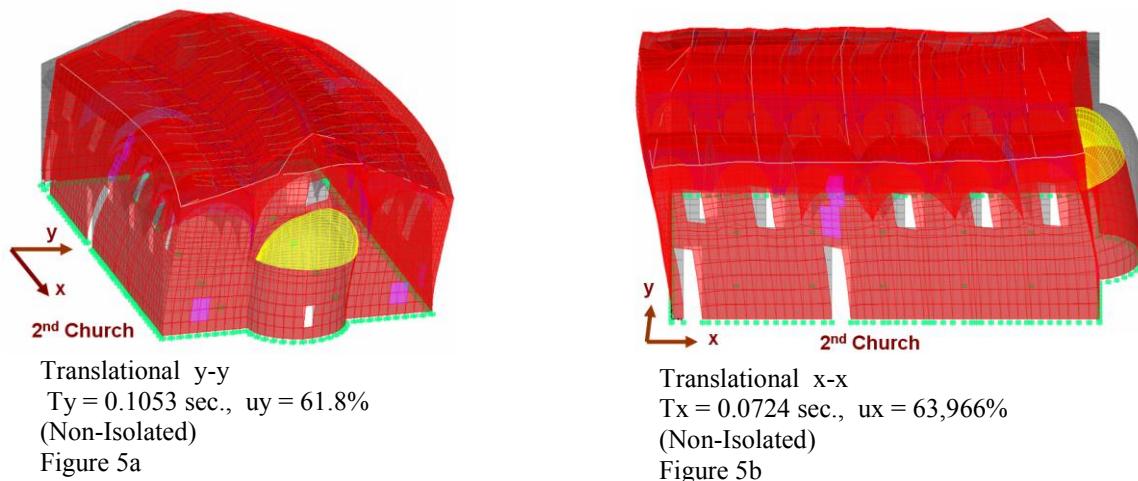
Figure 5. Dynamic characteristics “Church of Taxiarches”

In comparison, figures 5a and 5b depict the mainly horizontal translational modes for the 2nd structure. It can be seen that the eigen-periods in both the longitudinal and the transverse directions for the 2nd church are somewhat longer than those of the 1st structure. However, this time the modal mass ratios, that are mobilized by these two translational modes, are noticeably larger than those of the 1st structure. Both these effects must be attributed to the mass of the system of masonry cylindrical vaults, spherical domes and arches.

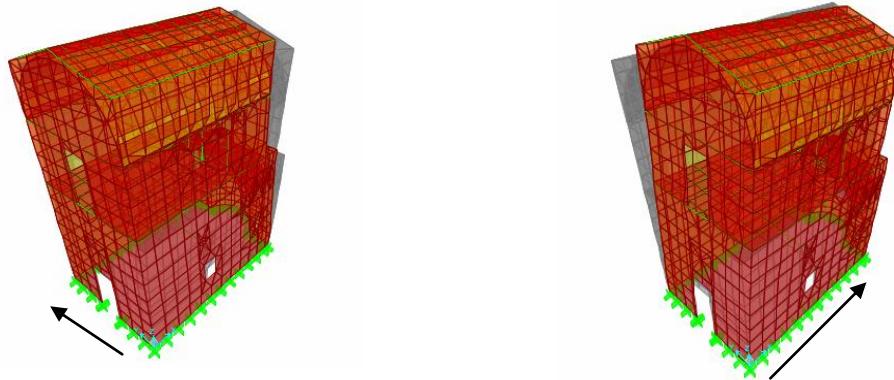
Figure 6a. 1st y-y
T=0.1375sec., $U_y = 73.94\%$
Non -Isolated

Figure 6b 1st x-x
T= 0.0942 sec $U_x = 68.02\%$
Non -Isolated

For this structural system the first two horizontal translational mode shapes and eigen-periods are shown in figures 6a and 6b. As can be seen, due to the two-story formation, these two eigen-periods are relatively longer than the corresponding values of the previously examined Post-Byzantine Basilicas. Moreover, these two eigen-modes also mobilize much larger modal mass ratios than the corresponding values of the previously examined Post-Byzantine Basilicas, a fact that must be attributed to the box-type form of this structure; moreover, the peripheral masonry walls have relatively small dimensions to excite them in an out-of-plane manner.

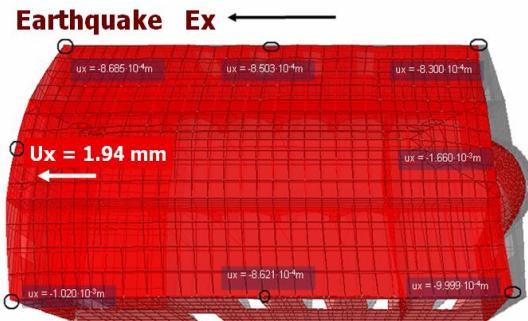
Figure 7a. Deformations for seismic forces Ex

The results for the 1st and 2nd Post-Byzantine Basilicas are depicted in figures 7 and 8, respectively. As can be seen in these figures, the structural system of both churches is more flexible in the transverse than in the longitudinal direction. The resistance of the internal colonnades to either the x-x or the y-y seismic forces is very small as these structural elements are quite flexible. The maximum horizontal displacement at the roof level is equal to 1.94mm for the 1st church (0.16mm for the 2nd church) for the loading case E_x whereas it attains the value of 4.447mm for the 1st church (3.86mm for the 2nd church) for the loading case E_y , more than double.

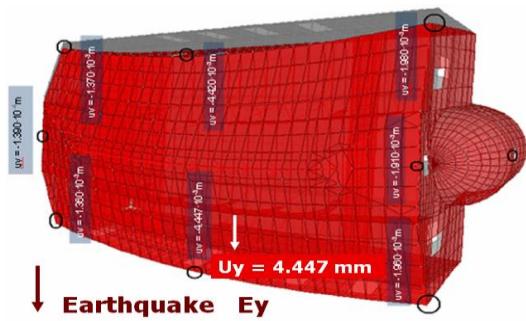
Figure 7b. Deformations for seismic forces Ey

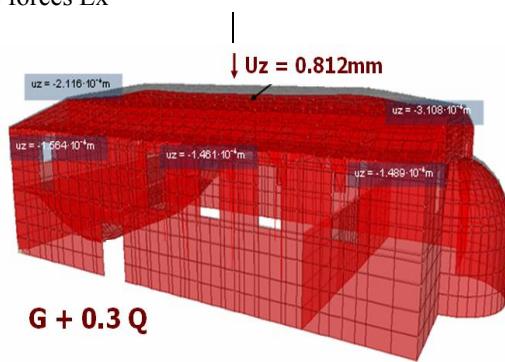
Figure 7c. Deformations for gravity forces

normal to the direction of these forces. The maximum value of deformations from the gravitational forces is equal to 0.812mm for the 1st church (1.0mm for the 2nd church); this occurs along the vertical direction at mid-span of the top of the roof. The vertical deformations at the top of the peripheral walls are of the order of 0.1mm to 0.2mm; moreover, the out-of-plane flexibility of the longitudinal walls results, at their top, in out-of-plane deformations of the order of 0.15mm when the structure is subjected to the gravitational forces.

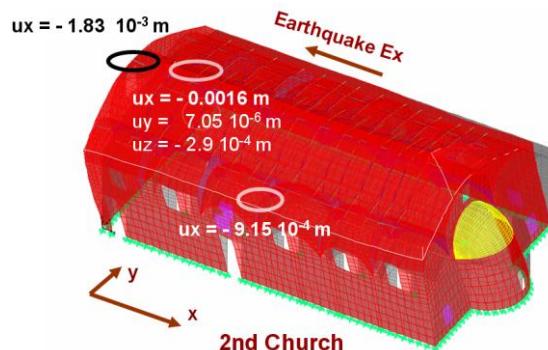
Figure 8a. Deformations for seismic forces Ex

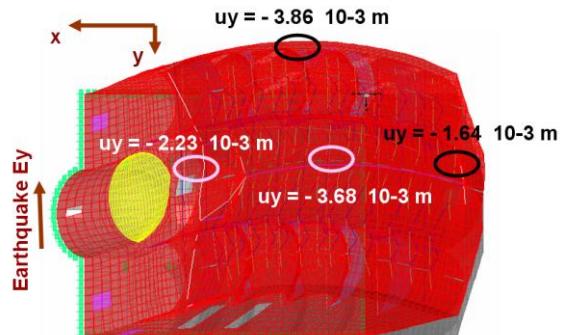
Figure 8b. Deformations for seismic forces Ey

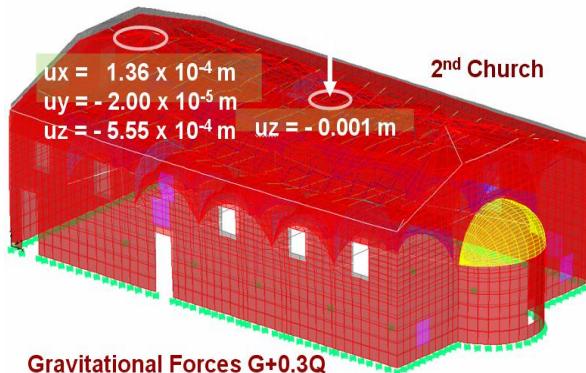
Figure 8c. Deformations for gravity forces

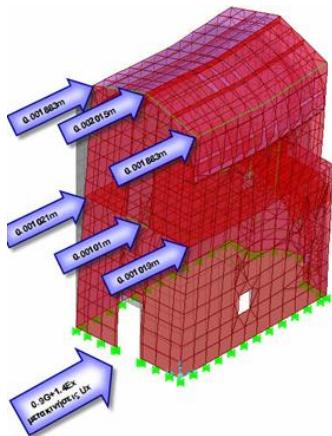
Figure 9a.
Non-Isolated, 0.9G + 1.4Ex
 $\delta_{max} = 2.015\text{mm}$

The small size in plan for this church and the box-type form results in relatively small horizontal displacement amplitudes at the roof level for the combination of gravity loads and seismic forces along the x-x and the y-y direction as depicted in figures 9a and 9b, respectively. The maximum value of the horizontal displacements at this level is approximately 3.1mm and develops, as expected, along the direction with the relatively smaller stiffness (North-South, y-y). This structural formation is designated in these figures as non-isolated to differentiate it with the same structure being isolated, as will be presented in section 5.

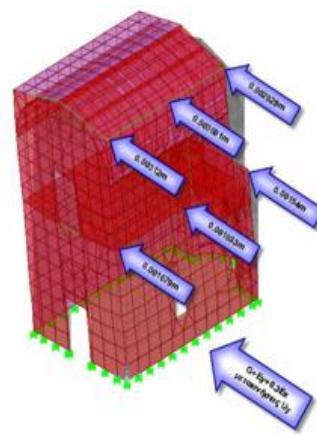
Figure 9b
Non-Isolated, 0.9G + 1.4Ey
 $\delta_{max} = 3.081\text{mm}$

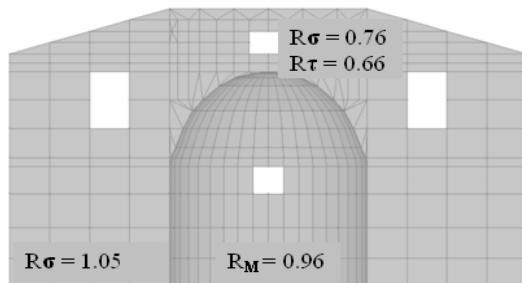
East wall – Ratio values of strength over demands
Figure 10. “Typical Post Byzantine Basilica”

churches, respectively. With $R\sigma$ or with $R\tau$ the ratio of the in-plane tensile or shear strength value over the corresponding demand is signified whereas with RM the ratio of the out-of-plane tensile strength value over the corresponding demand is denoted. Ratio values smaller than 1.0 predict a corresponding limit state condition.

As can be seen from the capacity over demand ratio values presented in figures 10, 11 and 12 there are regions on the masonry walls that these ratio values are well below 1, indicating damage. All these predicted zones of potential failure are credible, as can be deduced from such damage patterns observed in the three studied structural systems after the 1995 strong earthquake event.

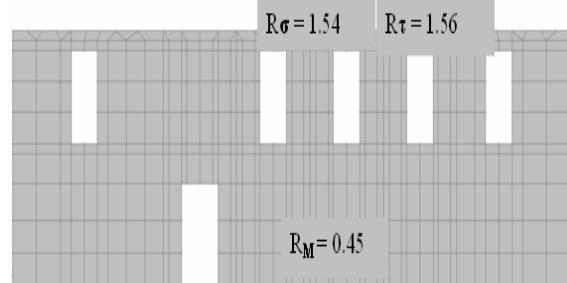
South wall – Ratio values of strength over demands

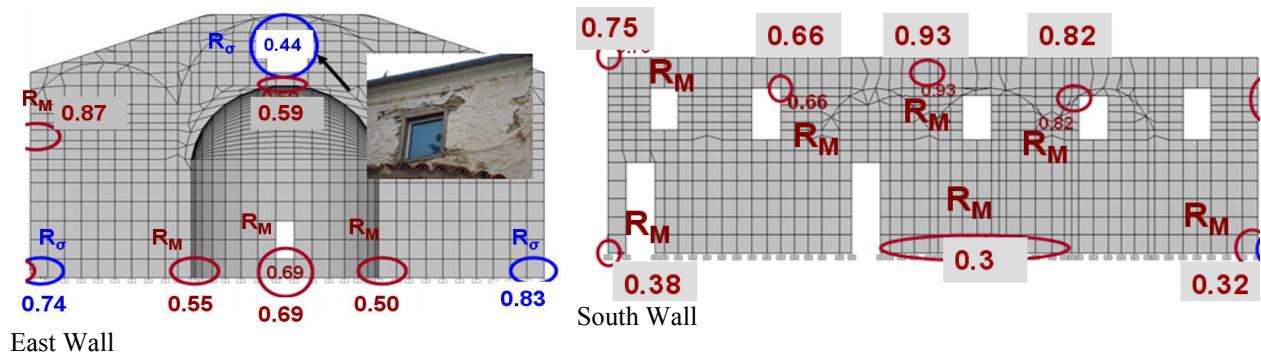
Figure 11. “Post Byzantine Basilica church of Taxiarches”

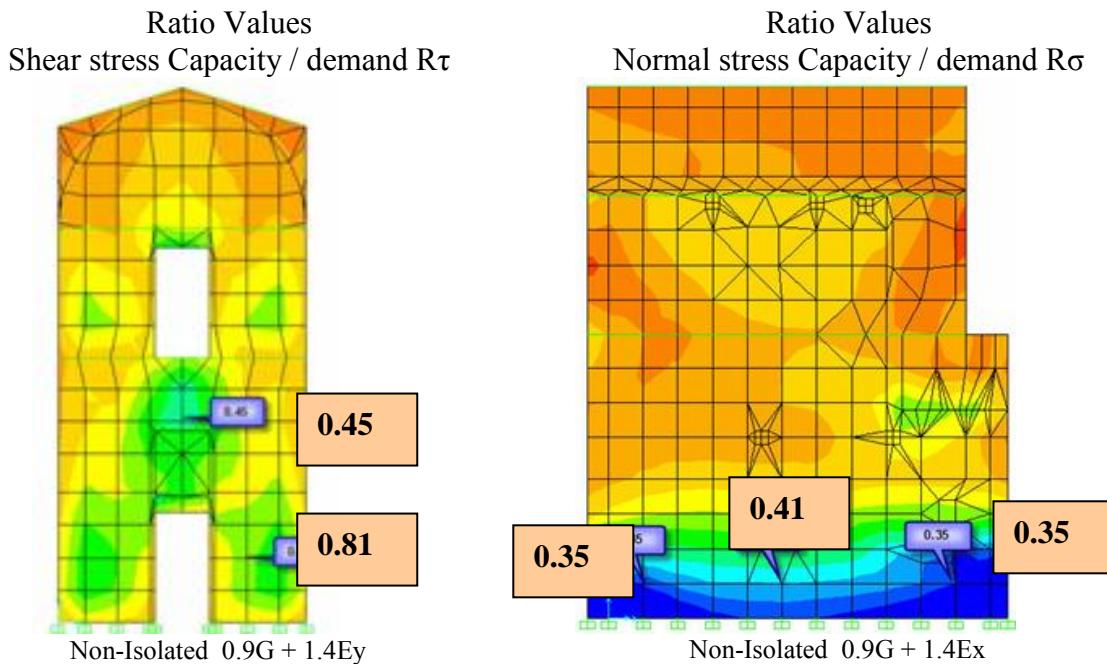
Figure 12. The “church of The Virgin Mary of Tourniki”

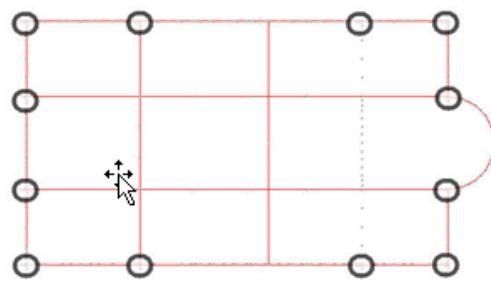
Fig. 13a. Typical Basilica

Figure 13. Arrangement of the base isolation scheme

This investigation is next extended to include a base isolation system which was introduced in the structural system representing the “Typical Post Byzantine Basilica”, as it is schematically indicated in figure 13a as well as the one representing the “church of The Vir-

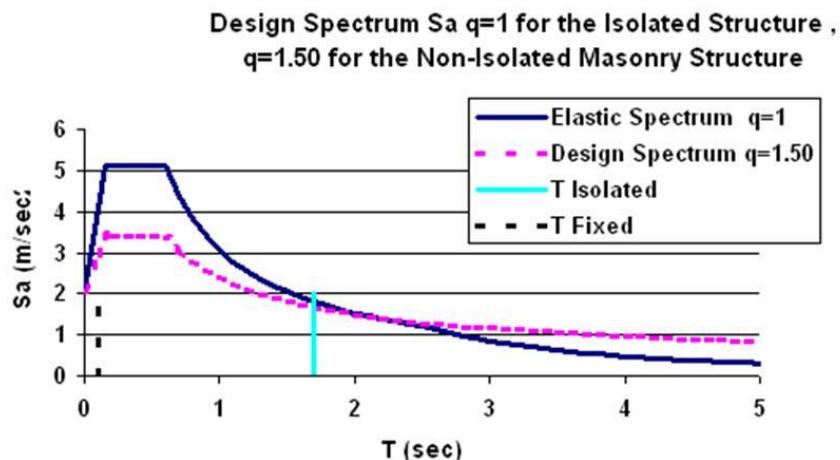
Figure 14. Design spectrum

gin Mary of Tourniki” as it is schematically indicated in figure 13b. In figure 14 the design spectrum considered for the non-isolated (fixed) and the isolated structural systems is shown together with the corresponding fundamental eigen-periods of the non-isolated (fixed) and the isolated structural systems. As can be seen in this figure, the dynamic amplification for the non-isolated and the isolated structures is approximately of the same order. This is due to the fact that for seismic isolated structures the response modification factor is given the value of $q=1$ instead of $q=1.5$ that was used for un-reinforced masonry structures. The possibility to use more flexible isolation base isolation schemes is currently investigated.

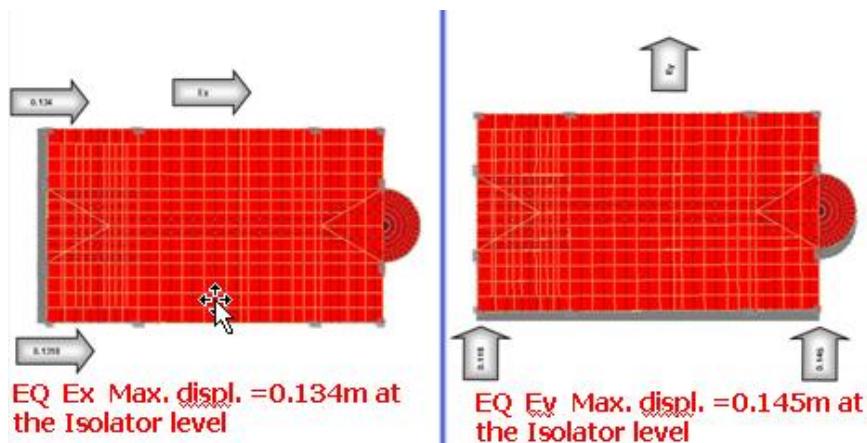
Figure 15. Horizontal displacement of base isolated “Typical Post Byzantine Basilica”.

In figures 15 and 16 the deformation demands at the isolation level are depicted for the “Typical Post Byzantine Basilica” and the “church of The Virgin Mary of Tourniki”, respectively. As can be seen they are of the order of 145mm maximum for the first structural system and only 163mm for the second structural system.

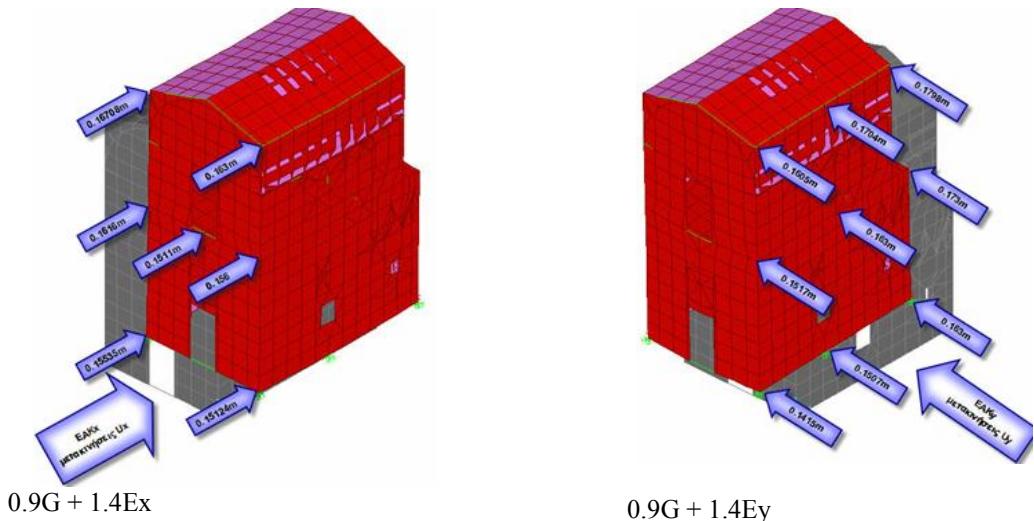
Figure 16. Horizontal displacement of base isolated Base “church of The Virgin Mary of Tourniki”

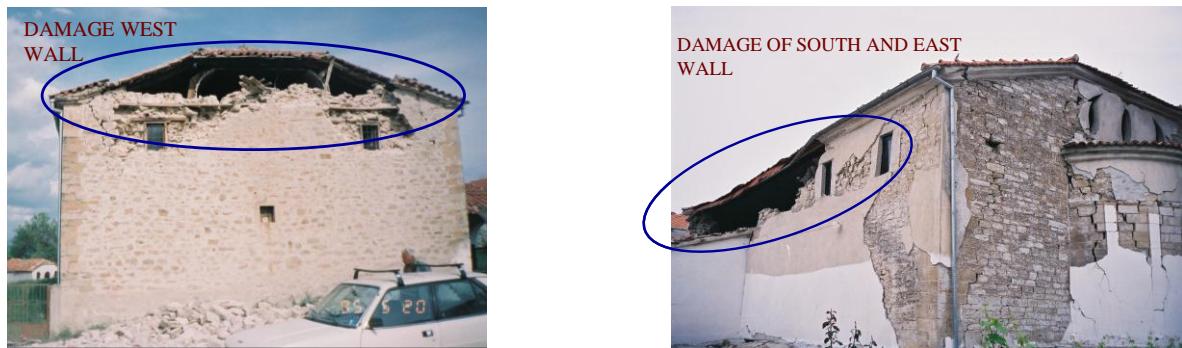
Figure 17. Representative damage patterns of the “Typical Basilica”

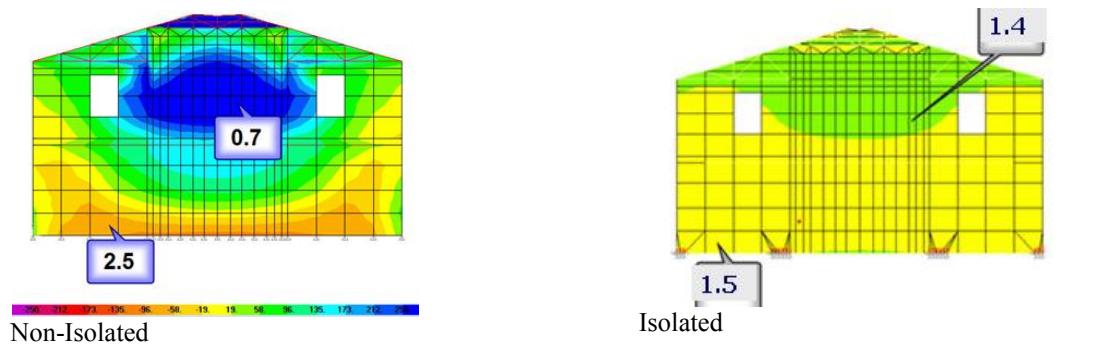
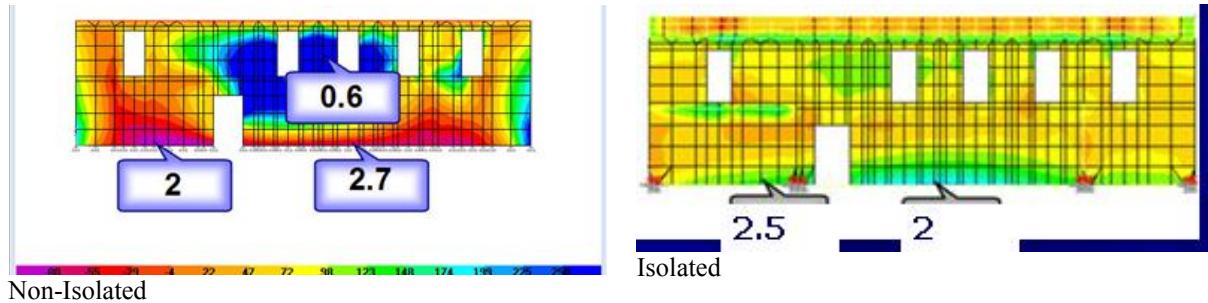
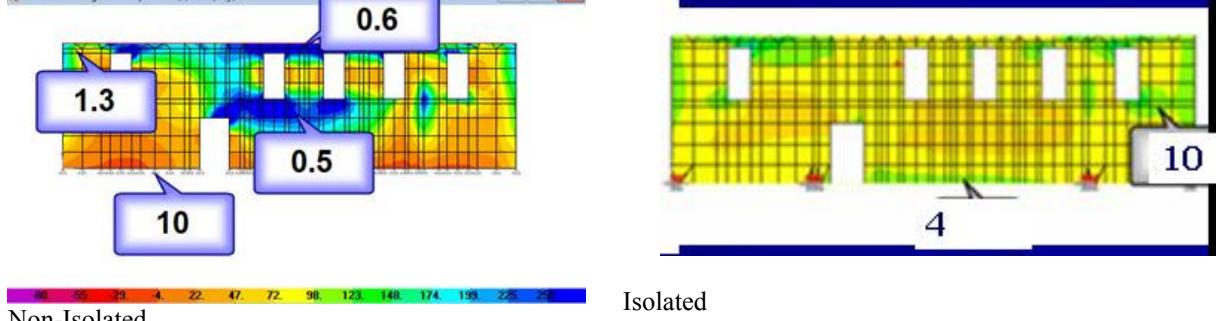
Fig. 18b. South Wall (Outside Face) 0.9G + 1.4 Ey , Out-of-plane S22 strength / demand ratio

Fig. 18c. South Wall (Inside Face), 0.9G + 1.4 Ey , Out-of-plane S11 strength / demand ratio

Figure 18. Strength over demand ratio values

In figure 18 the strength over demand ratio values for the “Typical Post Byzantine Basilica” structural system are shown for both the non-isolated as well as the isolated case. These selected results for the non-isolated structure correspond to ratio values well smaller than 1, which as explained in section 4 represents structural damage. As can be seen, for the case of the isolated structure the corresponding strength over demand ratio values at the same locations are well above 1, which indicates that with the introduction of the base isolation scheme structural damage from earthquake loads should be minimized.

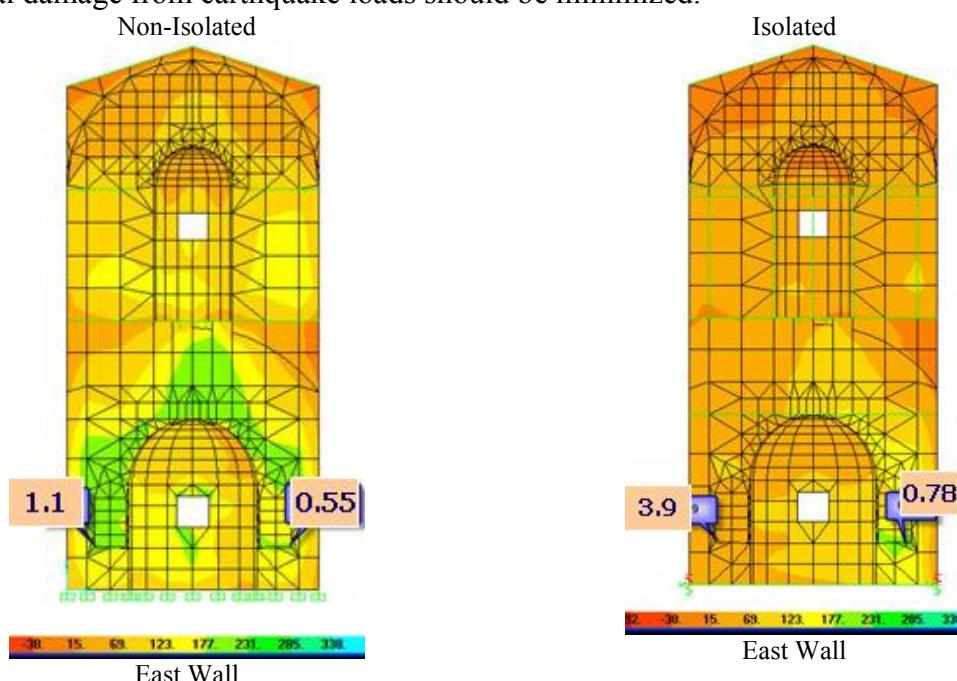
Figure 19. Shear Strength / Demand ratio $R\tau$, Loading G+Ey

In figures 19 and 20 the strength over demand ratio values for the “Virgin Mary of Tourniki” are shown for both the non-isolated and the isolated case. The selected results for the non-isolated structure correspond to ratio values well smaller than 1, which, as explained in section 4, represents structural damage. As was the case before, the corresponding strength over demand ratio values at the same locations are well above 1 in almost all cases for the isolated structure. Thus, as expected, structural damage from earthquake loads should be minimized with a base isolation scheme. This improvement in the expected earthquake performance of the studied structural systems will become even better if a more flexible isolation scheme than the one employed here is used.

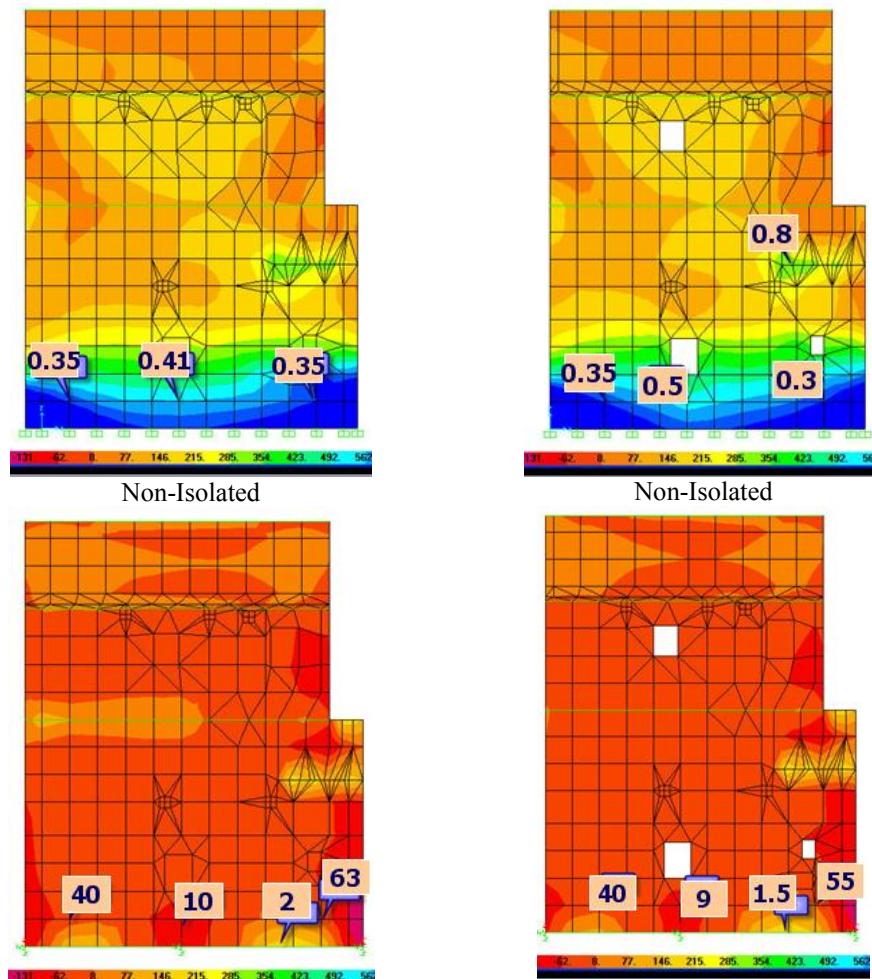
Figure 20. Normal stress Strength / Demand ratio $R\sigma$, Loading G+Ey
