REINFORCEMENT AND MEASUREMENT METHOD FOR EARTHQUAKE DAMAGED MASONRY BUILDINGS TESTED ON A SHAKING TABLE

M. Urban¹, L. Stempniewski²

Abstract: *Experimental investigations about the behavior of Unreinforced Masonry (URM) structures in comparison with masonry structures reinforced with Fibre Reinforced Cement (FRC) is carried out on the large shaking table at the EU Centre in Pavia. The tests were part of the EU project Polyfunctional Technical Textiles against natural Hazards POLYTECT and POLYMAST. Intention of both projects within the 6th and 7th EU Framework Program is the development of multifunctional textiles with embedded sensors.*

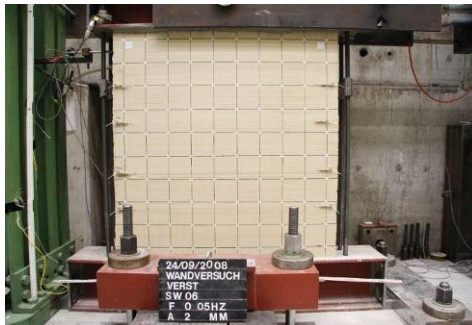
Figure 2: Wall 1.25 m x 1.25 m

Scaled wall tests were conducted with different test specimens to select the best materials for the matrix-fibre-system. Small initial shear test specimens with three stones (363 mm x 240 mm x 175 mm) first simulated the failure mode [2] for walls with textile. Maintain tense consistency scaled wall test (1.25 m x 1.25 m) and full-size wall tests (2.5 m x 2.5 m) were conducted. In these tests the different parameters were the mortar matrix, the textiles and the vertical load value. The shear loading in-plane was in the strong inertia force direction with a vertical load between 0.2 and 1.0 MN/m². For the horizontal cyclic displaced head beam the displacement and the horizontal force were measured. Integrated optical sensors were fixed on the edges of the walls and measured continuously the strains in the mortar and textile (see figure 2).

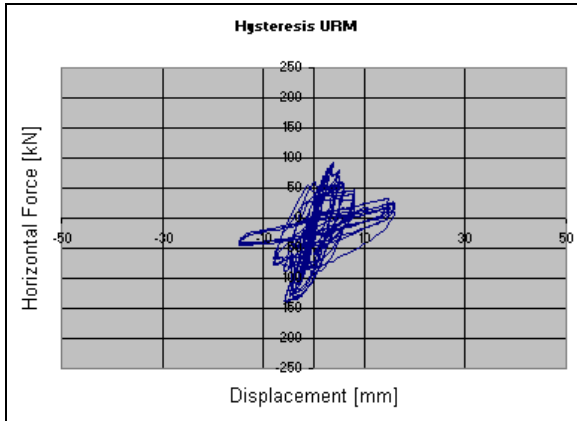
Figure 4: Hysteresis for the URM wall

Representative results of unreinforced masonry (URM) and reinforced masonry (RM) tests (1.25 m x 1.25 m) are shown below in figure 4 and 5. For the RM wall an optimized hybrid multiaxial textile and Sikagard 720 EpoCem was used. The maximum resistance force of the URM wall was 98 kN and the maximum load of the RM structure was 232 kN. This is an increase of 136%. But the more important effect is the increase of ductility of more than 200%.

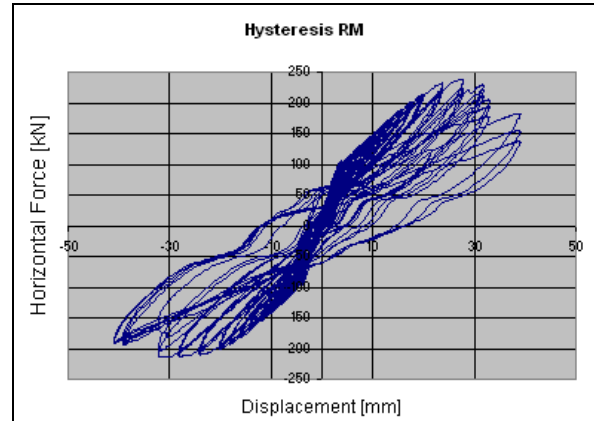
Figure 5: Hysteresis for the RM wall

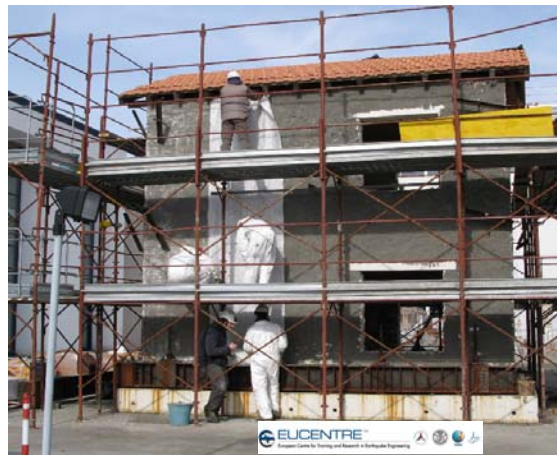
Figure 9: Masonry building with textile application

The base for the shaking table test with the reinforced building was the structure described in the chapter before. The pre damage structure was repaired and retrofitted with the mortar-textile system through full coverage application in a sandwich practice mortar - fabric - mortar (figure 9).

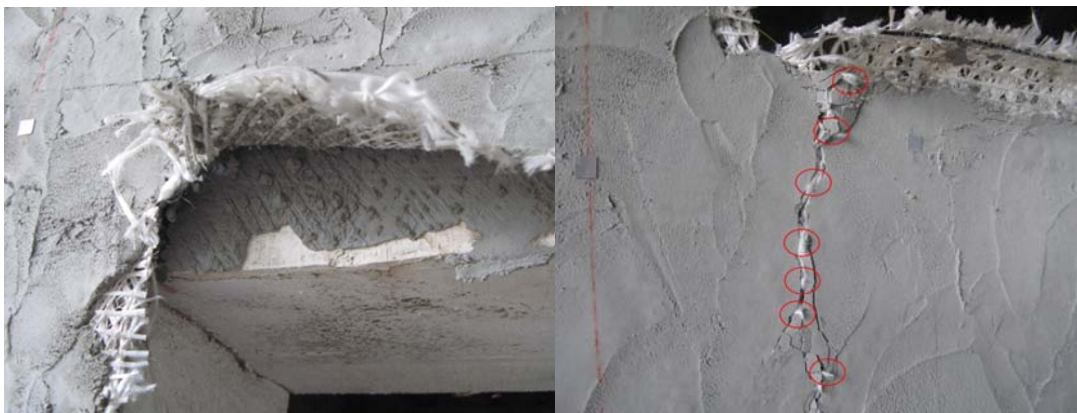
Figure 10: Crack pattern: a) delamination, b) broken glass fibers

Regardless to the higher accelerations, the building reached with marginal cracks under the window location in the front side (figure 10) a maximum peak ground acceleration of 0.6 g without any tendency of stability failure. This was an increase of 50 % compared the un-strengthened URM structure. After inspection of the applied textile only the projected cracks in the stiff glass fibers were visible while the soft polypropylene fibers hold the crack together and worked like a damping spring in the system. Further frequency and system analysis will be presented in the presentation in the workshop.

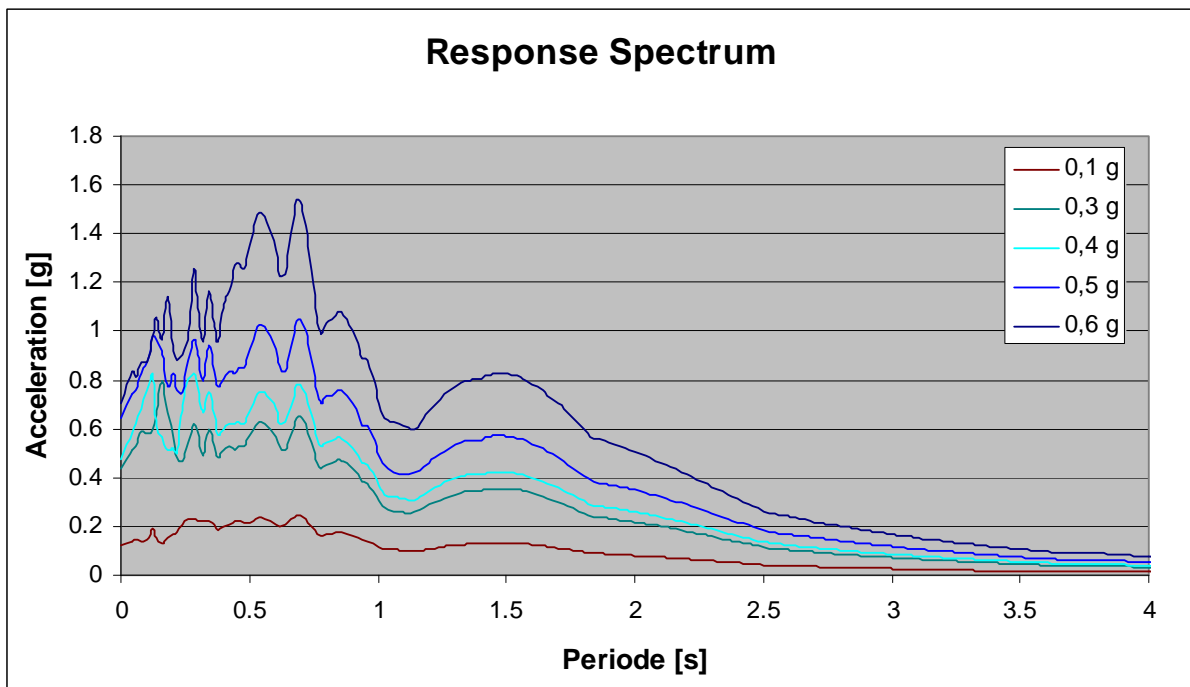
Figure 11: Response Spectrum of the Montenegro earthquake (1979)

The same earthquake load time history was used. The corresponding response spectrum is shown in figure 11. The applied dynamic load was different between the original and the pre-damage sample due to the damages and cracks. During the test the main frequency of the URM building dropped down from 11.55 Hz (0.107 sec.) to 9.31 Hz (0.086 sec.). This caused a slight increase in the horizontal load.
