NUMERICAL SIMULATION OF CEILING COLLAPSE IN FULL-SCALE GYMNASIUM SPECIMEN USING ASI-GAUSS TECHNIQUE

Key Words: Ceiling Collapse, Gymnasium, ASI–Gauss Technique, Finite Element Method

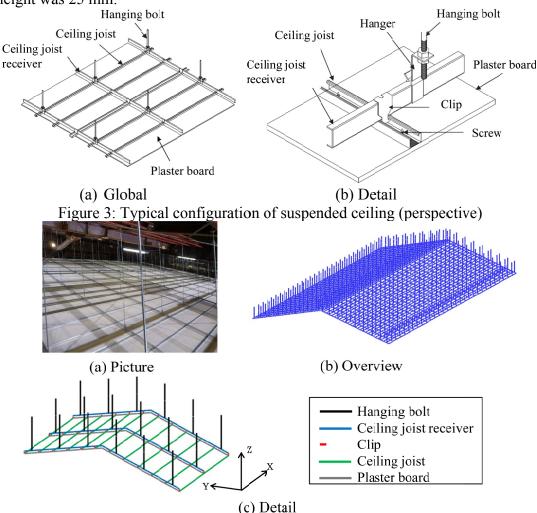
Figure 4: Model of suspended ceiling

The suspended ceiling was modeled accurately, according to drawings of the design of the specimen. A picture of the suspended ceiling in the gymnasium specimen is shown in Figure 4(a), and the numerical model of the entire suspended ceiling is shown in Figure 4(b). The numerical model of a part of the ceiling is shown in Figure 4(c), along with the details of the element assemblage. The hanging bolt were spaced 1,000 mm apart in the X-direction and 1,147 mm along the slope in the Y-direction. The hanging bolts were 1,500 mm long, and the clip height was 25 mm.

receivers with clips, and the ceiling joist receivers are attached to the hanging bolt with hangers. In previous earthquakes, many ceiling collapse accidents have been caused by the detachment of the ceiling joist clips and hangers, resulting in the plaster board, ceiling joists, and ceiling joist receivers falling down. Therefore, in the model, the clips and hangers were modeled using beam element that can simulate fracture.

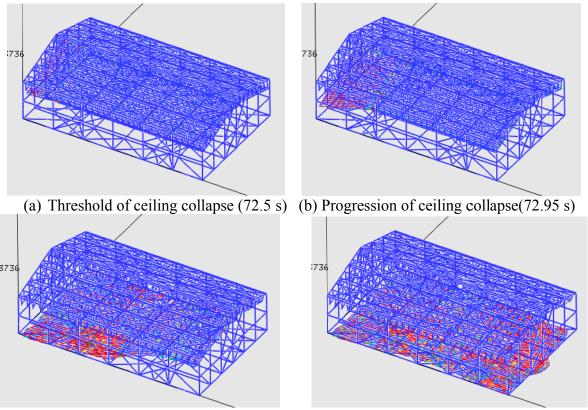
(c) Progression of ceiling collapse (74.2 s) (d) Complete falling-down (75.2 s) Figure 7: Simulation results

The simulation results are shown in Figure 7. The ceiling joists and plaster boards on the right side of the suspended ceiling started to fall down approximately 72.5 s after the commencement of the simulation, as shown in Figure 7(a). The ceiling collapse commenced at 72.95 s, as shown in Figure 7(b). The clips became detached from the ceiling joist receivers, and the ceiling joists and plaster boards fell down at 74.2 s, as shown in Figure 7(c). Finally, the suspended ceiling had fallen completely at 75.2 s, as shown in Figure 7(d). The ceiling joists and plaster boards were all piled on the first floor. These results show that the numerical simulation of the ceiling collapse could be successfully conducted using the ASI–Gauss technique.

A numerical simulation of the collapse of the ceiling in a full-scale gymnasium specimen, which was tested at the E-Defense shaking table facility in 2014, was successfully conducted utilizing linear Timoshenko beam elements and the ASI–Gauss technique. A preliminary simulation showed that the ceiling collapse progressed owing to the detachment of clips that connected the ceiling joists to the ceiling joist hangers and ultimately resulted in the ceiling falling down. The issues to be addressed in future simulations, including the contact of the suspended ceiling with the outer walls, are addressed.
