Analysis of the Degradation Condition of Elementary Schools

Buildings Department, Laboratório Nacional de Engenharia Civil, Av. do Brasil 101, 1700-066
Lisboa, Portugal, sraposo@lnec.pt

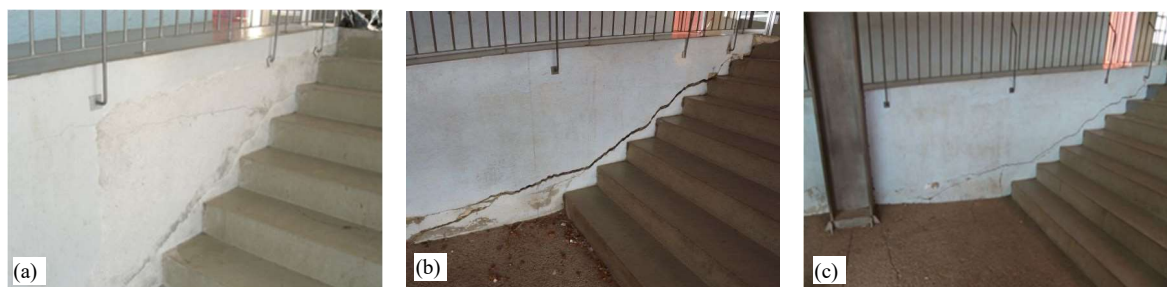
Table 1 shows the building characteristics of Prista Monteiro School (PM), Vale de Alcântara School (VA), Alto da Faia School (AF), Padre Rocha e Melo School (PRM), Alta de Lisboa School (AL) and Vasco da Gama School (VG) integrating the kindergarten and three levels of basic education. Figure 1 shows the result obtained through inspections carried out in 2007, 2013 and 2018, on the supporting wall located in the school's playground. It is possible to observe the existence of settlements and structural movements that remain unsolved.

Figure 1. Alto da Faia School-outdoor spaces: deformation and settlement of the supporting wall and the recurring appearance of cracks. Anomaly evolution in 2007 (a), 2013 (b) and 2018 (c).

This article presents the results of three inspections carried out in 2007, 2013 and 2018, on six school buildings built after 1997. The study revealed the existence of severe and unexpected degradation in these buildings. Anomalies related to the settlement of foundations and movements in the structure, are probable causes for the problems in other construction elements (cracking in interior and exterior walls and water infiltration). Observations made over the years showed that many of the structural problems are not stabilized what may have been caused by execution and/or design errors. Structural problems must be solved before carrying out many of the minor repairs, but they are complex and expensive and so postponed.
