# **Current Topics and Trends on Durability of Building Materials and Components**

Proceedings of the XV edition of the International Conference on Durability of Building Materials and Components (DBMC 2020)

Barcelona, Spain

20 – 23 October 2020

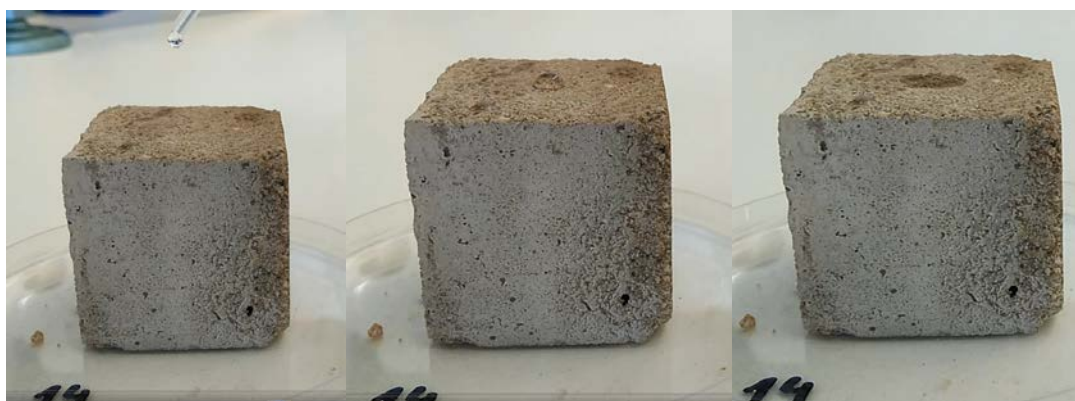
**Figure 1.**Steps of water drop absorption test.

Five days after the treatment, the repairing effect was assessed by a water-drop absorption test. This test allows evaluating the permeability variation of biotreated surfaces by monitoring the rate of absorption of a 0.1 cm<sup>3</sup> drop of water, that is, the time required for a material to fully absorb a water drop under open air conditions (Figure 1). The absorption period of time was video-recorded.

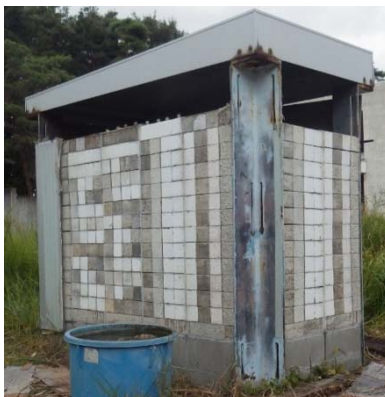
**Figure 2.** A photo of the model building.

Figure 2 shows a photo of the model building. It was constructed on a premise of the Building Research Institute (BRI) in Tsukuba City, Ibaraki Prefecture. The model building was constructed with concrete specimens piled up in a boxy shape, whose outer surfaces were coated with various types of finishing materials. It had a box-shaped metal roof inclined to the north side. Inside of the building was sheltered from rain, and its room air temperature and humidity were not controlled.

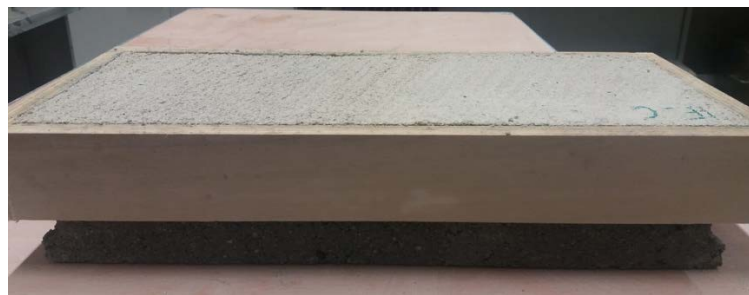
**Figure 1.** Lightweight concrete block with wooden frame and applied mortar.

To prepare the applied mortars, wooden molds were made in order to ensure a constant thickness (1.5 cm) of the mortar applied to the lightweight concrete block support, according to figure 1.

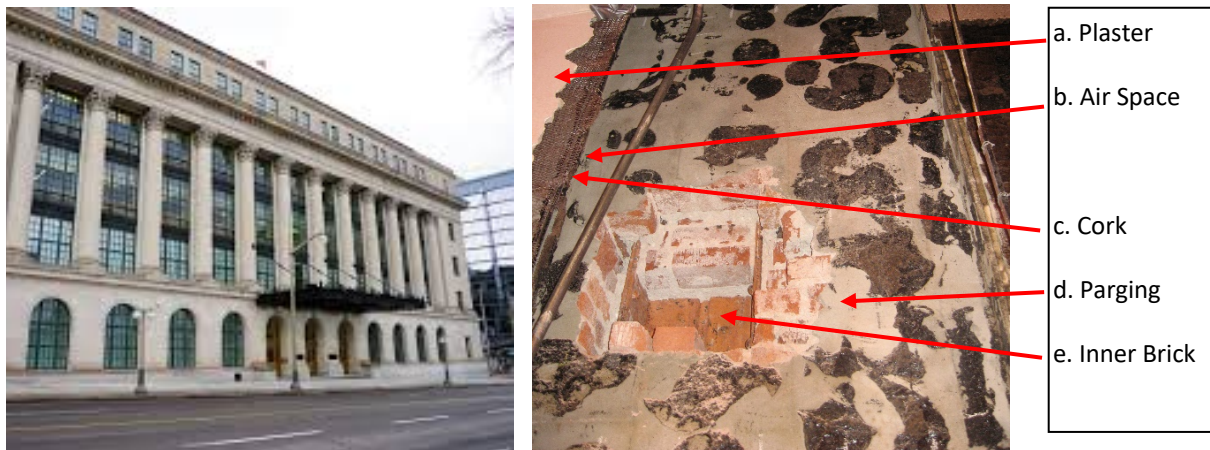
**Figure 1.** General elevation view and cross section of exterior wall showing parging and interior red brick behind Indiana limestone veneer. Black spots are mastic used to bond one-inch cork insulation (Interior photo courtesy of JM Carriere of Adjeleian Allen Rubeli Ltd.).

The Wellington Building was designed and substantially complete in 1927. Figure 1 shows the existing building and interior cross-section; the painted plaster, air space, parging over two wythes of red clay brick, faced by exterior Indiana Limestone veneer. The black spots on the parging are the remnants of mastic that was used to bond one-inch cork insulation to the interior face of the parging.

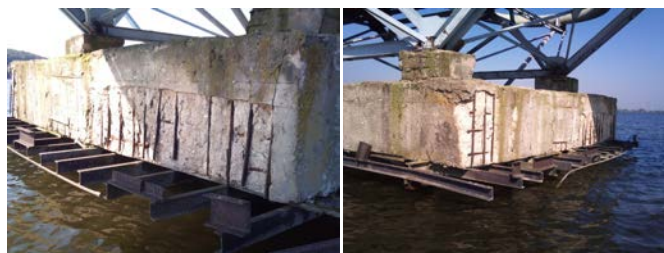
**Figure 1, 2.** Damages to pillars in the form of spalling corroded concrete and corroded reinforcing steel.

After many years of service, the supports of the hydraulic ash-removal bridge are in a bad technical condition. Corroded and spalling concrete can be seen, as well as the progressing corrosion of reinforcing steel (Fig. 1, 2).

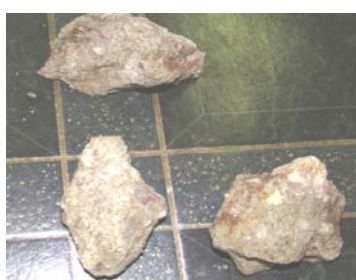
**Figure 9.** Pieces of Concrete B; completely carbonized concrete (all the way to the reinforcement bars) with visible remains of corroded reinforcement ( $\text{pH} > 9$ ).

In order to assess the estimated course of carbonization in the analyzed concretes, the cross sections of concrete samples were sprayed with 1% phenolphthalein solution. Piece samples (Concrete B) are completely carbonized (Fig. 9), whereas in the samples from the core drillings (Concrete A), the carbonized layer is 1-3 cm in thickness (Fig. 10). Carbonization is not noted deeper within.

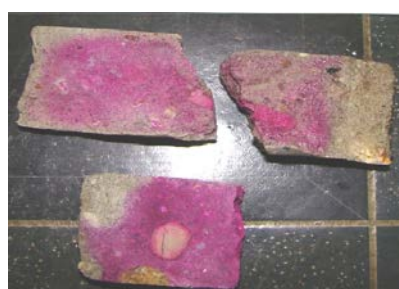
**Figure 10.** Pieces of Concrete A; visible layer into concrete with an alkaline pH, carbonized 1-3 cm in thickness.

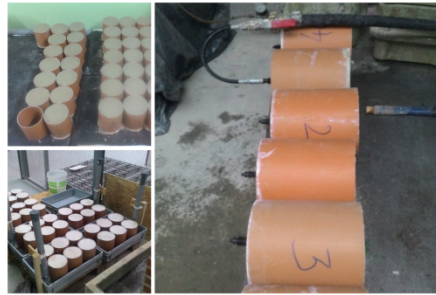
**Figure 1.** Mortar samples during moulding, dampening and carrying out injections.

Holes were made in the samples and gravitational injection, using an injection cream, and pressure injection (under a pressure of 0.2 MPa increased after 30 s to 0.5 MPa) using methyl silicates as well as silicone microemulsion (SMK), carried out. After a further four weeks, the mortar was taken out of its moulds and cut using a circular saw into cubic samples with sides

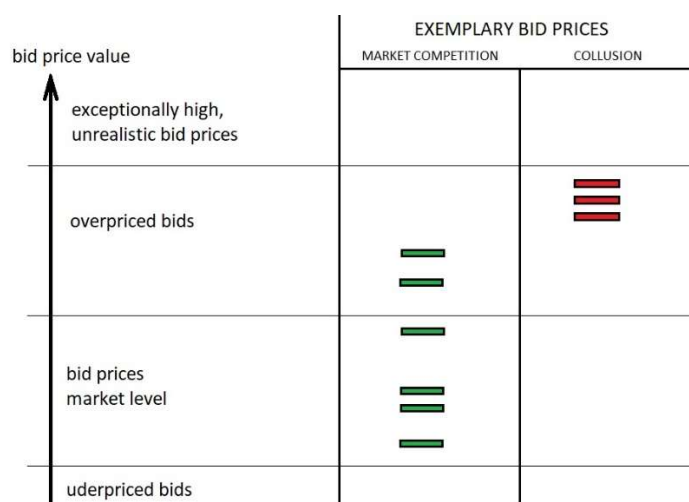
**Figure 6.** Exemplary bid price levels in case of market competition and collusion

The average  $R$  for examined 382 procedures is 13,5 %. In the case of collusion, where every bid price is over the market level, involved offerors increase their bid prices over the market level. However, their prices can't be recognized irrationally high. That makes the space for their bid prices much more narrow than in the case of market competition (see Figure 6). The range  $R$  is low then.

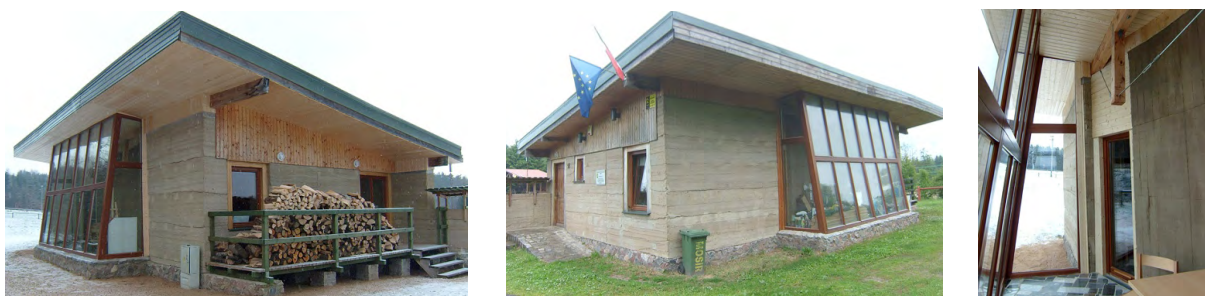
**Figure 2.** Left and in middle: View of the experimental earth building located in the Ecological Park in Pasłęk. Right: The inside of the veranda. Wooden structure glazed with low-emission composite panes. On the right there is an accumulation wall made of compacted raw earth and a door connecting with the main hall.

The fully glazed veranda with wooden construction has a southern sloping wall. It is separated from the main room by a thick, non-thermally insulated accumulation wall made of rammed earth and room is connected with veranda by two glass doors. The windows and exterior doors are made of wood. The building has a sewerage system, cold and hot water, and electricity. The main source of heating is a freestanding wood-burning cast iron fireplace.

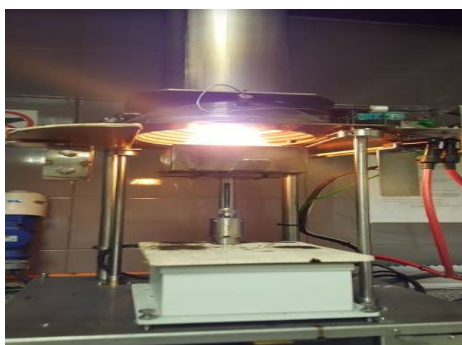
**Figure 1.** MLC apparatus set at 35kW/m<sup>2</sup>.

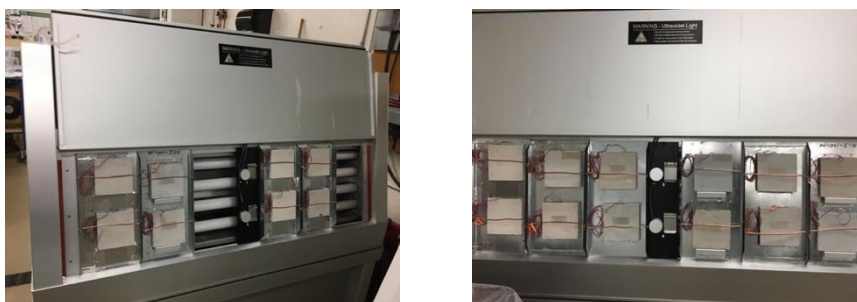
**Figure 3.** Cement plaster samples in the QUV aging apparatus.

The total UV intensity considered for the 340 nm UV lamps in the apparatus was set to 1.55 W/m<sup>2</sup>, and the total energy calculated for one day of operation of the machine is 12.5 kWh/m<sup>2</sup>. This setting represents the Cycle 6 configurations of the ASTM G154-16 standard. The average daily solar irradiance value for the city of Toronto is 126 Wh/m<sup>2</sup> obtained from Natural Resources Canada (2016). Therefore, the  $AF_{UV}$  calculated is 57. Based on the  $AF_{UV}$  and the exposure conditions determined by the standard, the samples were aged for seven days representing a two-year exposure to UV radiation. Figure 3 shows the testing apparatus and the cement plaster samples mounted on the QUV machine. The samples were subjected to an 8-hour cycle of UV exposure at 60°C, followed by a 4-hour cycle of condensation at 50°C.

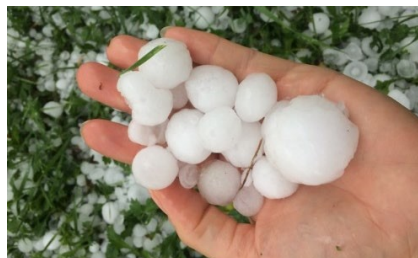
**Figure 1.** Hailstones of the thunderstorm on August 1<sup>st</sup> 2017 in Winterthur.

August 1<sup>st</sup> 2017 was a typical high summer day with a flat atmospheric pressure distribution over Europe. In the meteorological forecast for Eastern Switzerland the development of thunderstorms was expected with hail of hailstones up to 4 cm in diameter. Observations of hail in the neighborhood of the house under investigation stated hailstones of as large as 32 mm, s. Fig 1.

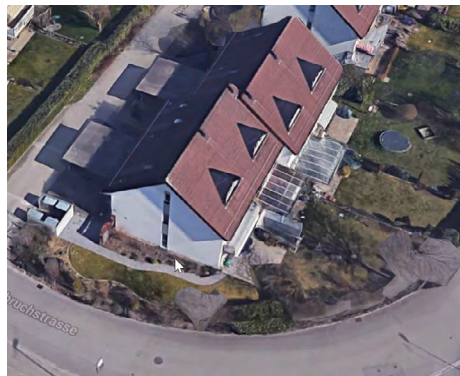
**Figure 2.** Aerial view of the façade from West.

The house was exposed to Northwest. An aerial view of the house with the affected façade from West is shown in Fig. 2. A detailed visual inspection showed 147 damage locations evenly distributed over the façade's area of 70 m<sup>2</sup>. The damages found were classified in three categories: cracks (low level damage), full circle fracture (medium level damage) and breakout of the render with uncovering of the reinforcement (high level damage). Typical representations of these three types of damage are shown in Fig. 3. 71 locations showed a low level, 51 a medium level and 21 locations a high level damage. The morphology of these damages was similar to damages found in artificial hail tests on ETICS (Steinbauer, 2016).

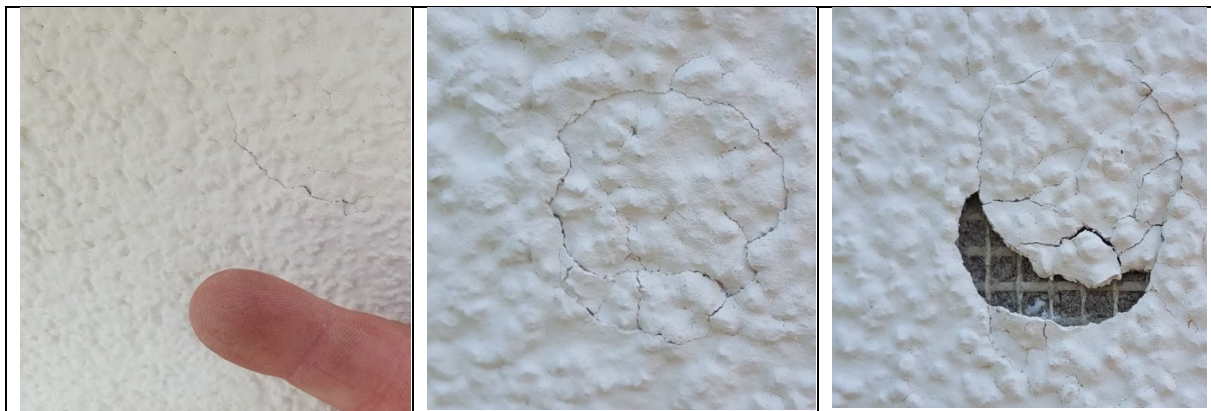
**Figure 3.** Representations of the damage classes: crack (left), full circle fracture (center) and breakout (right).

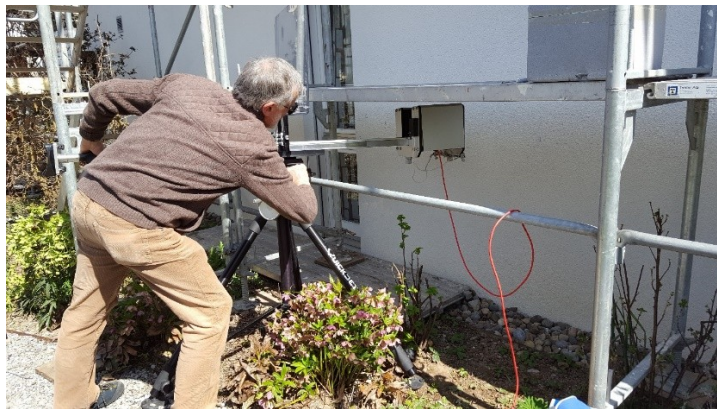
**Figure 5.** On-site determination of the hail resistance with an ice ball launcher.

The hail resistance was determined according to CFIA guidelines (ACFI, 2020). The test took place 8 month after the hailstorm in sunny weather (17°C / 40% r.h.). The facade was bombarded horizontally with clear ice balls at an angle of 45° with an ice ball launcher, see Fig. 5. This test equipment allows to precisely accelerating the projectiles.

In total 19 ice balls, 15 with a diameters of 30 mm and four of 40 mm, were shot. The aim was on the one hand to determine the hail resistance class according to ACFI regulations and on the other hand to assess the energy required to provoke damage of the levels mentioned above. An energy threshold for a full circle fracture and the threshold for a breakout of the render could be determined.

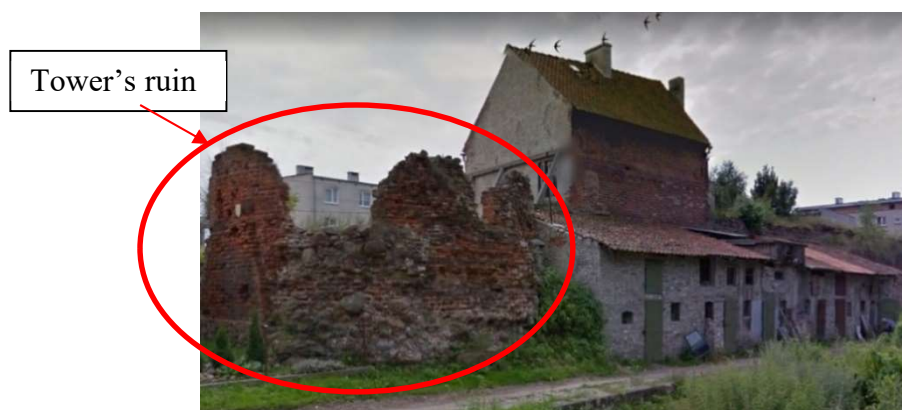
**Figure 2.** The ruins of historic tower.

Figure 2 presents the ruins of historic tower. In case of this tower's ruin important is to keep the fragments that are still in a quite good condition. Besides, in the underground of these

buildings there are also basements with no access to daylight. Due to the fact that there is no access to daylight or even artificial light and that the above ground remains of the tower are in a very poor condition, being in its underground is very dangerous. The technical condition of the basement is periodically checked and in this case, a terrestrial laser scanner can be a great tool because it doesn't require access to light during measurements.

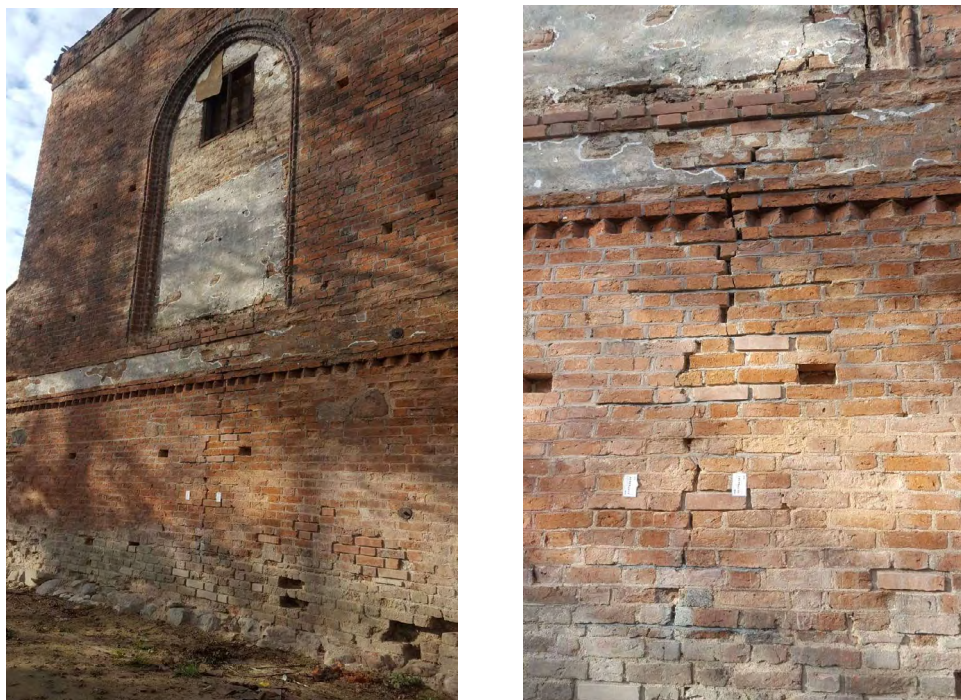
**Figure. 4** Slanting church wall.

The last example is an object exposed to deformation due to subsidence. This is a church and monastery of Franciscan fathers in Barczewo, that was built in the 14th century. The Gothic church needs urgent renovation because its technical condition has deteriorated significantly.

The main reason is age and the unstable ground on which the church was built. As a result one of the church walls tilted significantly and cracked what is presented in Figure 4.

The last object is the wall of the church, which as a result of subsidence of the soil leaned out of the vertical and on its surface also formed cracks. Again, the reduction of points allowed to observe (in the form of a darker areas) the place of cracks (red line marked).

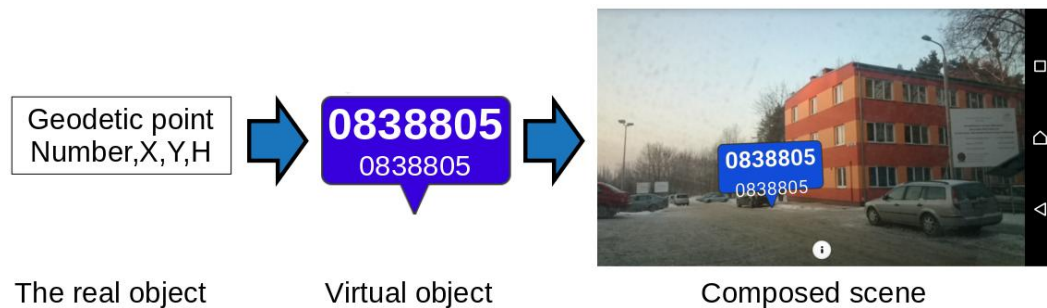
**Figure 1.** An example of geospatial based AR application supporting searching geodetic points in the field.

To compose a scene in geospatial based AR, algorithm needs the user's location and orientation in a geographic coordinate space. Determination of location is based on geopositioning techniques such as GPS/GNSS, WiFi or other (e.g. Bluetooth). Sometimes, location can be determined by scanning specially prepared marker for that purpose. Device's orientation parameters like rotation, slope or direction are approximated, using sensors such as a digital compass, accelerometer or gyroscope. Once approximated device's orientation may be also refined by using computer vision techniques. The virtual object can be any digital object like image or icon. To place the virtual object in the right place on the screen and compose the AR scene, the real feature's location is also needed. The augmentation occurs when user is in the vicinity of real object and points on it with a device's camera. The software will automatically determine the location and orientation of the device and display respectively generated image (virtual object) on the screen (Lechner 2015). Figure 1 demonstrates the example of augmentation performed in described way. In this case there's a database of geodetic points, which are placed in the field. AR application connects to database of points and selects these, which are in the vicinity of the device. Then the augmentation process occurs and the searched point appears on the screen (Bednarczyk 2017(b)).

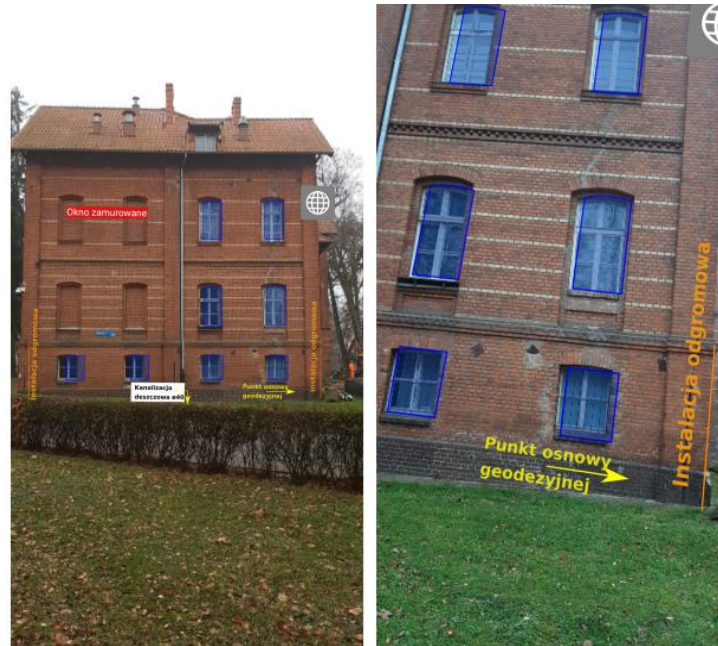
**Figure 3.** Additional, sample information about building facade presented in AR mobile application.

As mentioned earlier, AR technology can be helpful in visualizing information about the state of the building facade during inspection. By mixing the real view of the object with the previously collected data, a direct comparison of the current and historical status can be obtained. A working prototype of the application, shown in fig. 3 uses computer-vision based AR to recognize the facade of a specific building. After that, an image (drawing) is overlaid that can contain any previously collected information related to the building, such as:

- descriptions and markings of construction elements
- descriptions and markings of defects and damages
- installation descriptions and markings
- interactive elements - to get additional information or perform an action in the application
- historical facade photos
- other useful information

At present, the application prototype is able to recognize the facade and display AR content. This software works in client-server architecture. Client application runs on a mobile device and is responsible for mixing and displaying the final image. Building the virtual "world" and sharing data is done on the server side. Further work will be focused on expanding the system's functionality.

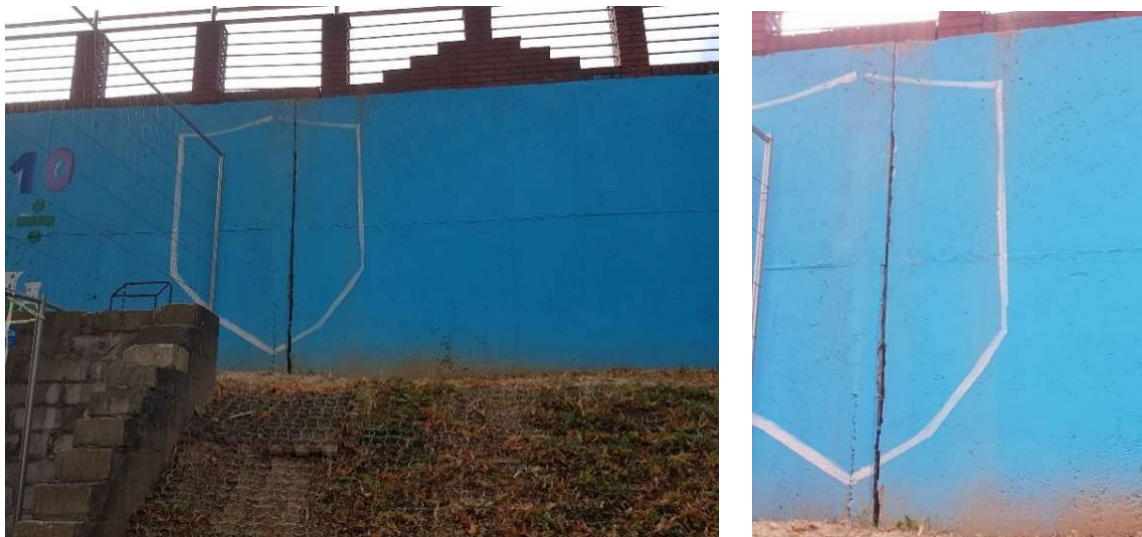
**Figure 2.** Two concrete slabs displaced due to ground washing.

Figure 2 shows the selected area of the retaining wall supporting the scarp. This scarp consists of several concrete slabs which as a result of the heavy rain were displaced and a crack was formed.

The selected fragment shown in Figure 2 was measured using the terrestrial laser scanner. The scanning resolution set to 1mm /10 m. The crack, that formed as a result of the plates displacement is about 6-7 cm wide. The selected point cloud representing the displaced slabs and a crack is presented in Figure 3.

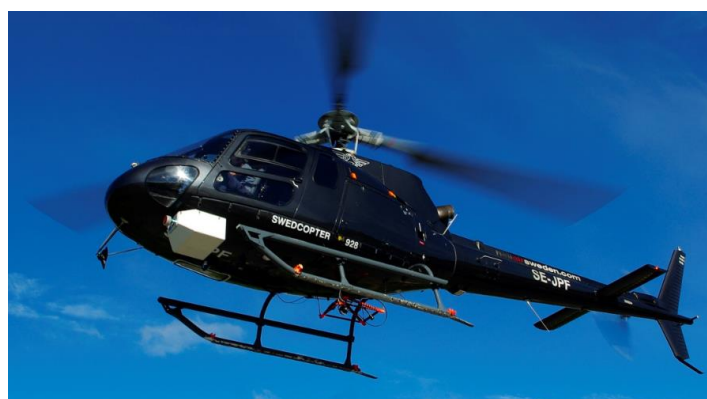
**Figure 2.** Mobile platform with the measuring system.

Vimap Mapping System was consisted of among other Riegl laser scanner, VUX1-UAV model, Trimble GPS receiver and IMU. All sensors were mounted on a helicopter. A mobile mapping platform with a mounted system presents Figure 2. The average flight altitude of the flying unit was approximately 40-50 m from ground level. Components of the system and flight parameters were set to fulfill requirements for the acquisition of 3D point cloud data of MV power line infrastructure and corridor of right-of-way.

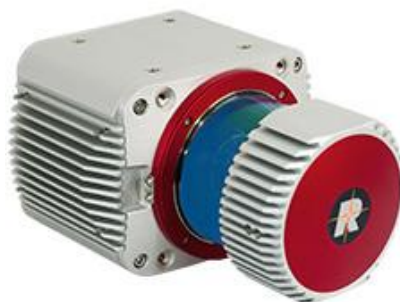
**Figure 3.** Laser scanner model used in ALS.

Laser scanner that was used in the measuring system, Riegl VUX1-UAV, is dedicated to agriculture, forestry, archaeology, cultural heritage documentation, as well as corridor mapping for power lines, railway tracks, pipeline inspection, topography in open-cast mining and other.

Figure 3 presents Riegl VUX1-UAV laser scanner used in Airborne Laser Scanning (source: <http://www.riegl.com/products/unmanned-scanning/riegl-vux-1uav/>, 2020-04-13).

Technical parameters of the laser scanner, altitude and speed of the helicopter flight allow achievement of the density of 40 points per square meter. The technical specification of the laser scanner used in the Airborne Mobile Mapping System presents Table 1.

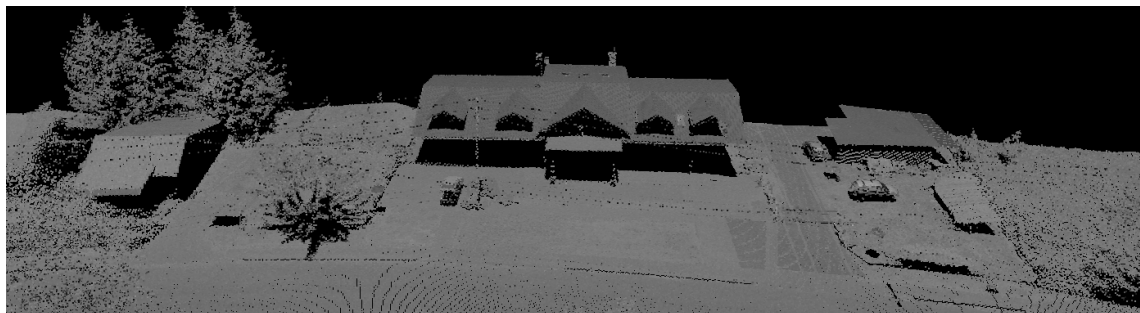
**Figure 4.** Point cloud with no classification - color by point intensity.

Classifying of the LiDAR data into categorical object instances is the most critical step for further 3D analysis and modeling. It's a process of assigning a label to the points that represent a specified object, like the ground, building construction, power lines infrastructure, vegetation, etc. Classification allows us to group bunches of points into the specified representative of an object class, which helps to provide further 3D analysis. The correctness of classification has a big impact on the results of analyses that might be performed on classified data. Figure 4 presents a point cloud acquired by a laser scanner, as an input data for the classification process. Figure 5 presents the point cloud after classification.

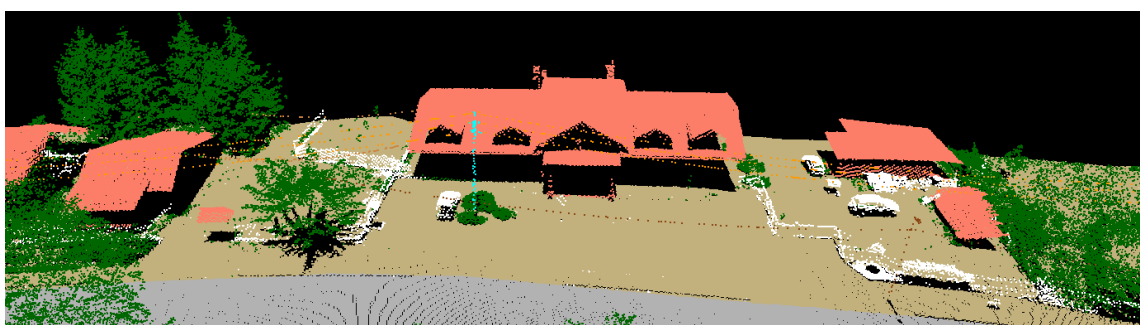
**Figure 5.** Point cloud with classification.

Sample of acquired LiDAR data was classified semi-automatically - using an automatic segment-based classification strategy and manual corrections of segment-based classification. There were extracted objects of following classes: ground, building, vegetation, power line wires, power line pylons pipeline, paved road, unpaved road, water, railway and not classified. Figure 5 presents classified objects in the following colors: ground – light brown, building – red, vegetation – green, power line wires – yellow, power line pylons – blue, paved road – gray, not classified – white. Classified objects were set due to restrictions that have to be checked for a power line infrastructure on the point cloud data.

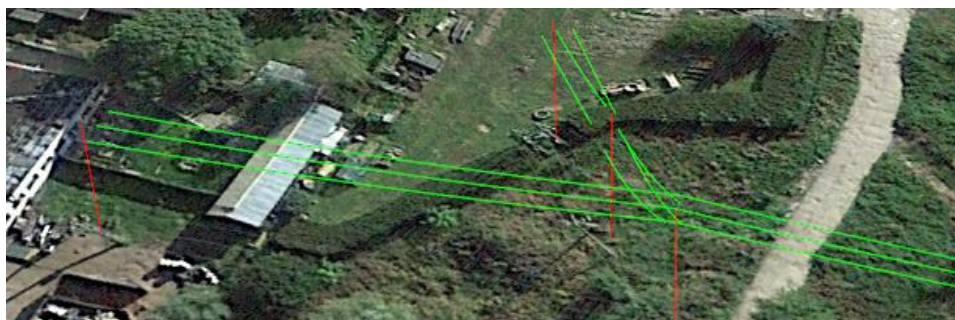
**Figure 6.** Visualization of the digitized 3D model in Google Earth Pro.

Poles and phase cables of the MV power line were digitized based on the point cloud and save to 3D ESRI shapefile. Visualization of the digitized 3D model in Google Earth Pro is presented in Figure 6.

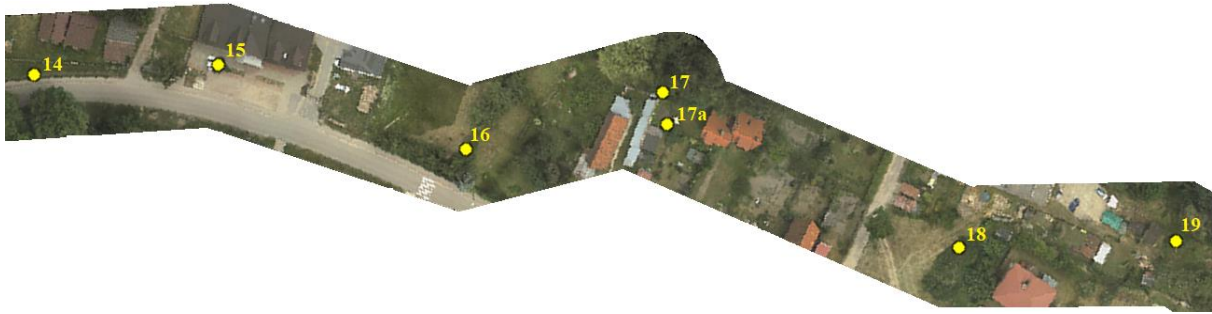
**Figure 8.** Analyzed the MV power line corridor in the urban area.

Based on acquired ALS data of the middle voltage power line corridor in an urban area, the detection of collisions with buildings was performed for digitized phase cables of the line for seven spans, from 14th pole to 19th pole (total length: 367m). Figure 8 shows the analyzed area on an orthophotomap, poles positions with their numbers are presented in yellow color.

The radius of a virtual cylinder was set at 5m. It means, that from each digitized phase cable detection of buildings point will be done in 5m distance and 360° range along the course of the conductor. The collision analysis for seven spans took 19 seconds in vMatic software.

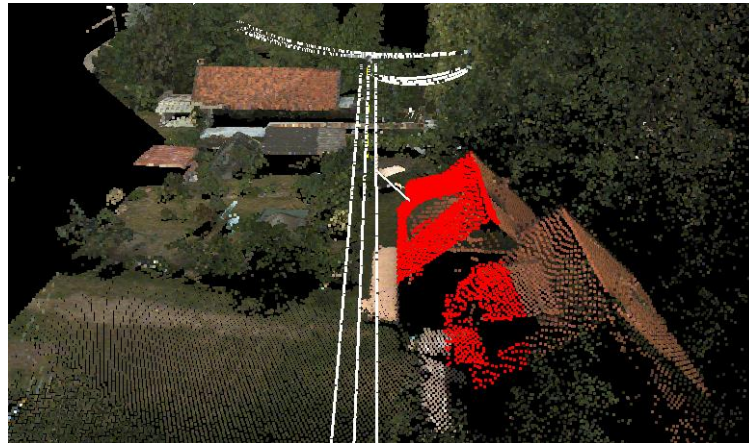
**Figure 9.** Found building close-up to the power line in vMatic software.

Figure 9 presents in vMatic software visualization of the closest collision from the power line wires to the building point with a distance of 2.64m (span from pole 16<sup>th</sup> to 17<sup>th</sup>). The point cloud is visualized in RGB colors, the area of collision of building points closer than 5m from power line wires is highlighted in red color.

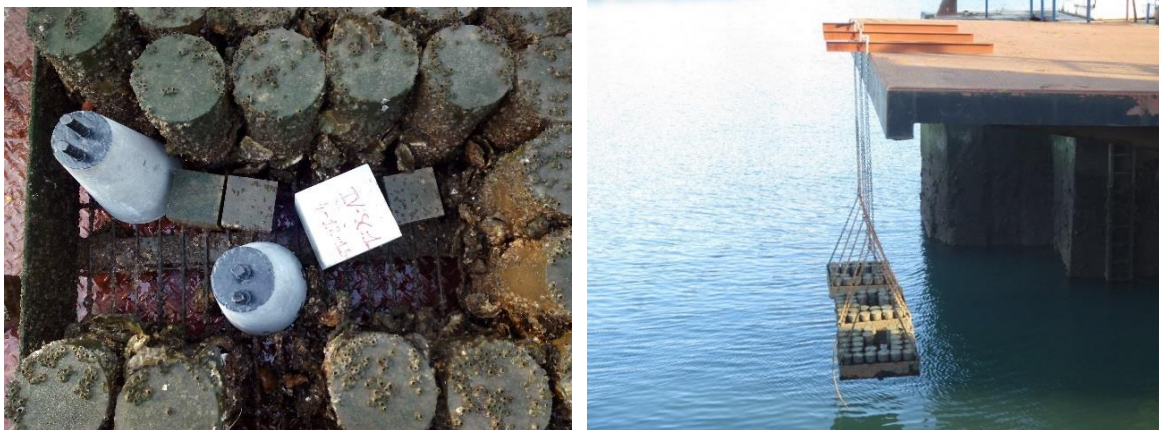
**Figure 3.** Arrangement and location of test samples in tidal race in the port of Bilbao.

After keeping the specimens in the humidity chamber for 28 days, one of each mix was transferred to the port of Bilbao. There they were distributed on two metal grids together with other specimens from other research centers (Figure 3 left). With the help of a crane, the grilles were suspended a few centimeters from the surface of the sea leaving the specimens exposed to tidal changes for 10 months, (Figure 3 right).

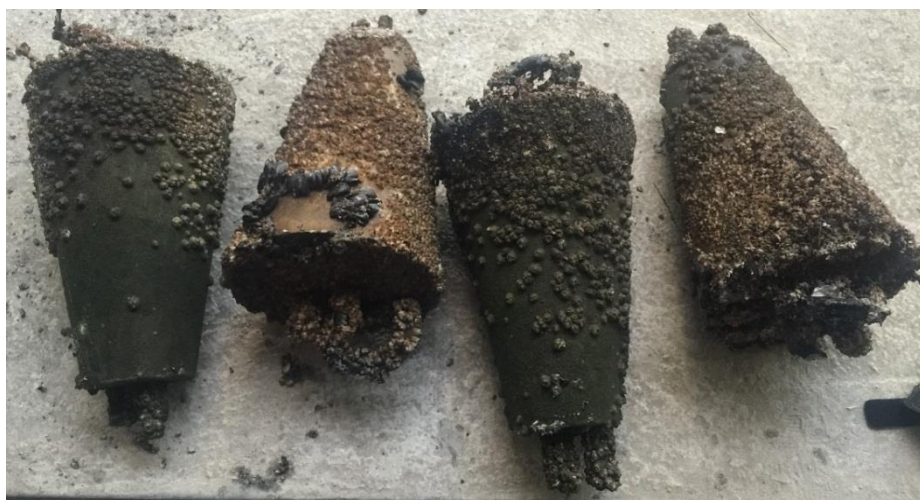
**Figure 4.** Appearance of the specimens after exposure to the weather and tidal cycles.

After 10 months, the specimens were removed and moved back to the laboratory. During the visual inspection, the abundant presence of mollusks adhered to the surface of the concrete specimens, the corrugated bars and the steel hook was observed (Figure 4). In the areas where

these colonies were not present, the formation of an organic greenish layer was observed.

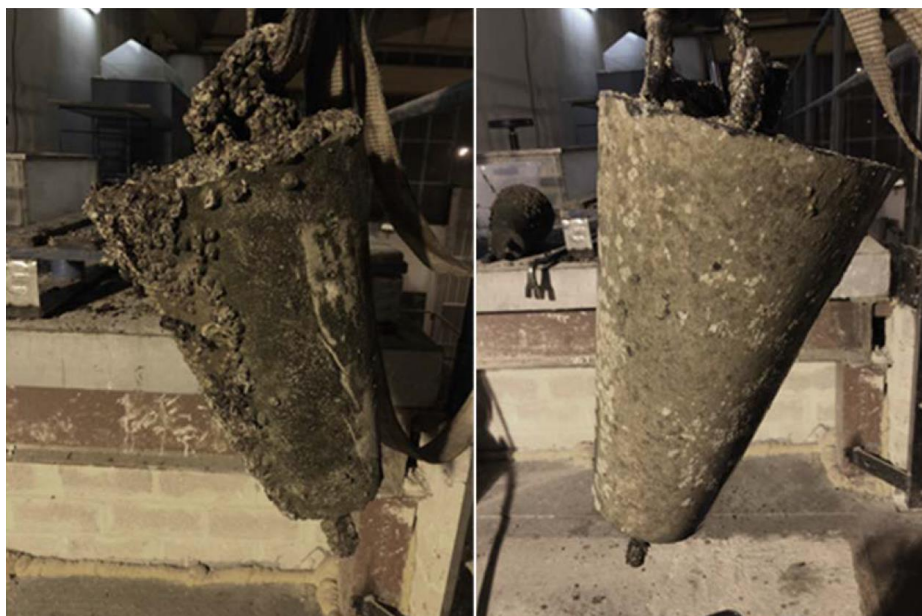
**Figure 5.** Appearance of samples before and after cleaning.

With the help of a crowbar, the mollusks stuck in the concrete were removed, while those attached to the bars and the metal piece were crushed with a hammer. The surface was then rubbed with a scourer to remove the organic layer (Figure 5). Finally, they were rinsed and placed in the oven at  $110 \pm 5$  °C until constant mass.

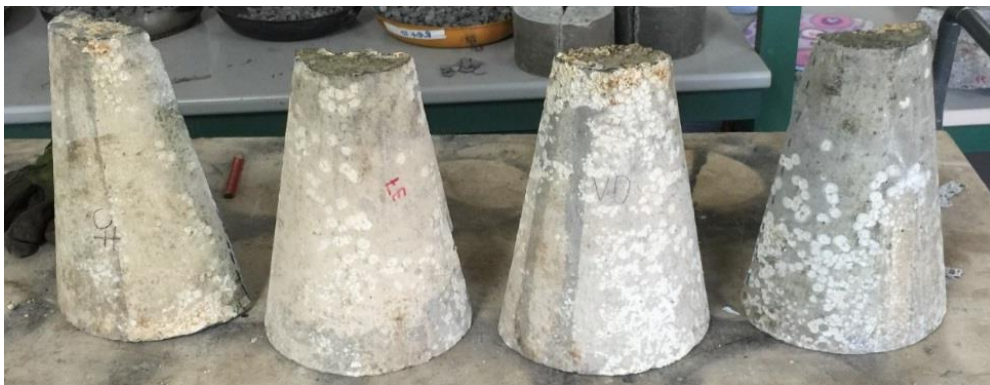
**Figure 6.** Exterior of conical specimens SCC-DC-LF, SCC-DC-CS, SCC-DC-FA and SCC-SC-CS after exposure to contact with seawater.

Figure 6 shows the appearance of the specimens after continued exposure to the marine environment and to the tidal race for 10 months, after cleaning the exterior faces and the longitudinal cut.

The absence of pathologies on the outside of the cone trunks can be verified as chipping or loss of material, while, in Figure 7, the intact state of the bars inside the concrete can be seen after making a longitudinal cut in the specimens. Direct exposure to seawater has not negatively affected embedded steel bars, with no deterioration observed. It should be noted that in the narrowest area of the specimens, the minimum coating thickness is only 10 mm.

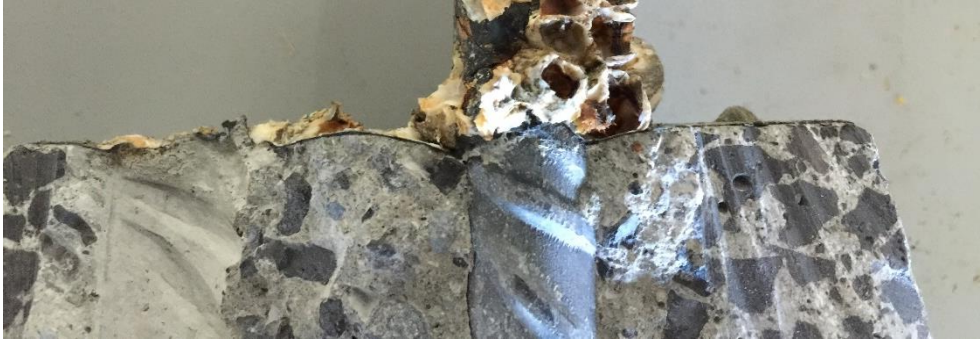
**Figure 8.** Aspect of SCC-SC-CS and rebars after exposure to tidal race.

Figure 8 shows in detail the appearance of the steel bars at the narrowest end of the conical specimens for the SCC-SC-CS mix. In some cases, pitting corrosion is observed in the bars, caused by the penetration of seawater from the top of the specimen as a result of the loss of the applied waterproofing paint.

Due to the appearance of the steel bars inside the concrete, the cut was only made at the smaller diameter end of the cone to determine the penetration of the chloride ion in a scanning electron microscope.

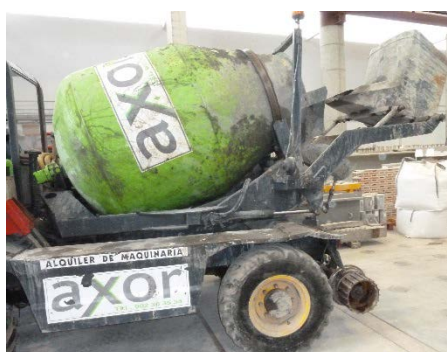
**Figure 1.** Concrete mixer.

The NATI mix was manufactured in a conventional laboratory mixer and cast in different molds. An industrial concrete mixer, depicted in Figure 1, was rented to prepare the mixes for the manufacture of EAFSI and EAFSIV. From the total batch of 600 lts., two beams of each mix and several molds were precast and their mechanical and durability properties were evaluated.

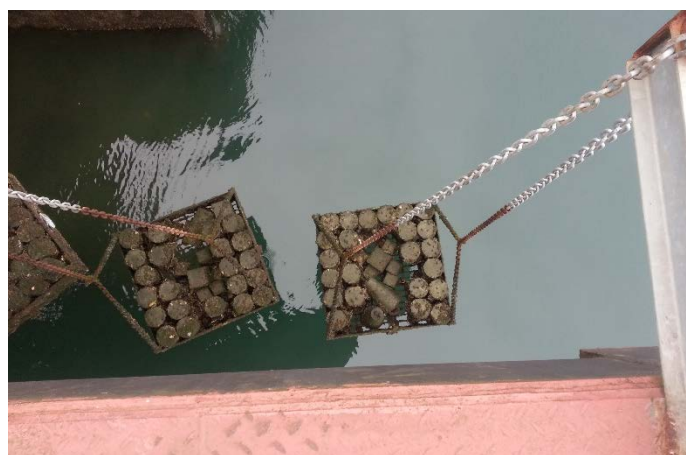
**Figure 2.** Specimens placed in cages at Pasaia Port.

Three batches of specimens (100x100x100mm<sup>3</sup>) of each mix, as shown in Figure 2, were enclosed in cages suspended from a dock wall in Pasaia Donibane port, with the purpose of analyzing EAFS concrete durability in marine environments. The cages were suspended in an intertidal zone where they would be submerged under the seawater at high tide and exposed to the atmosphere at low tide. The specimens were left in the cages for one year. After their removal, chlorine and sulphate ion infiltration was evaluated, by cutting each specimen and placing it in a vacuum chamber that was filled with nitrogen at low pressure for Scanning Electron Microscopy (SEM) analysis. Energy-dispersive X-ray spectroscopy was used to obtain the chemical composition of the first 50mm of the fracture surface and to generate backscattered electron images.

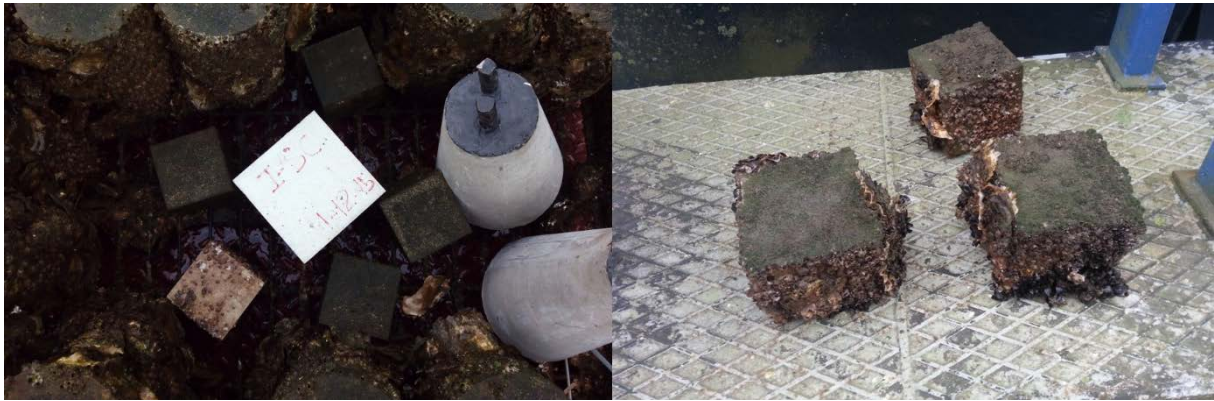
**Figure 5.** Specimens before and after the marine environment test.

In Figure 5, it is possible to see the specimens before and after exposure to a highly saline marine environment after one year. It would appear, *a priori*, that this concrete has no compounds that could harm the marine ecosystem, as the specimens were teaming with mussels, oysters, and small crabs.

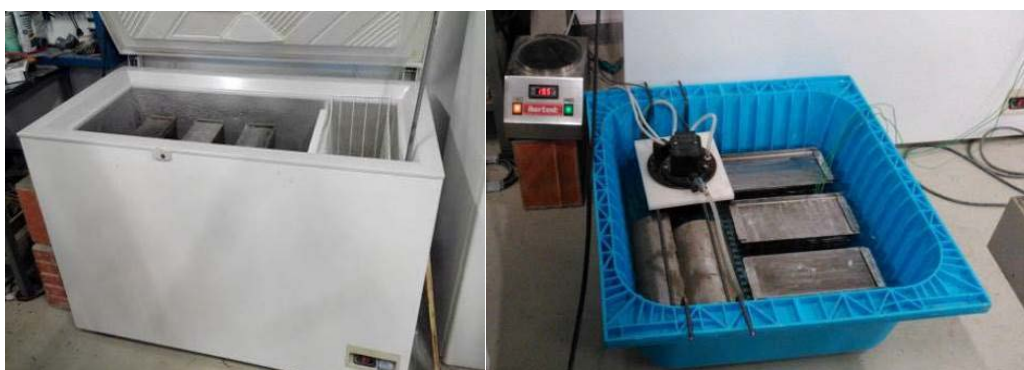
**Figure 2.** Arrangement of the freeze/thaw test: a) freezer at  $-29^{\circ}\text{C}$ ; b) container with water at  $20^{\circ}\text{C}$ .

In the freeze/thaw test, cubic specimens, in duplicate, were introduced into a container filled with a solution of 3% sodium chloride (NaCl). These containers were placed in a freezer over 16 hours, at a temperature of  $-29^{\circ}\text{C} \pm 1^{\circ}\text{C}$ , and in a container with water circulation at  $20^{\circ}\text{C} \pm 1^{\circ}\text{C}$  for 8 hours, and those test cycles were repeated 56 times throughout the duration of the test. Figure 2 shows the arrangement of the freeze/thaw test.

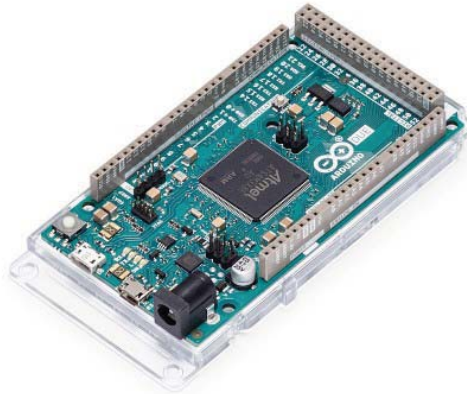
**Figure 1.** Schematic of an Arduino Due.

Arduino is an open-source electronics platform based on easy-to-use hardware and software. The Arduino Due (Fig.1) is a microcontroller board based on the Atmel SAM3X8E ARM

Cortex-M3 CPU. It is the first Arduino board based on a 32-bit ARM core microcontroller. It has 54 digital input/output pins (of which 12 can be used as PWM outputs), 12 analog inputs, 4 UARTs (hardware serial ports), an 84 MHz clock, an USB OTG capable connection, 2 DAC (digital to analog), 2 TWI, a power jack, an SPI header, a JTAG header, a reset button and an erase button. Unlike most Arduino boards, the Arduino Due board runs at 3.3V. The maximum voltage that the I/O pins can tolerate is 3.3V. Applying voltages higher than 3.3V to any I/O pin could damage the board (Blum, 2013).

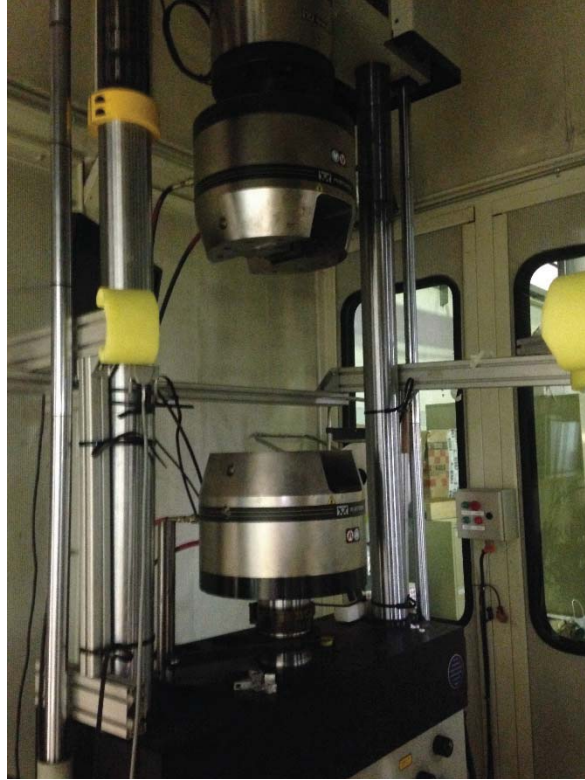
**Figure 3.** The hydraulic jack subjected to the experiment.

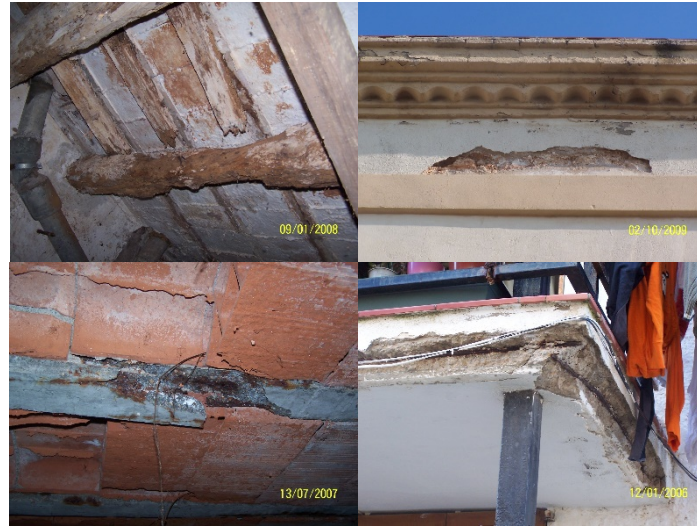
**Figure 1.** Images of four zones of construction elements.

Each system can be divided into zones which constitute the last and smallest proposed unit to value. A zone is defined as a specific part of a constructive element, as for example an area of a wood beams floor, an area of a façade, an area of a reinforced concrete beam floor, an area of a balcony, etc. Figure 1 shows some images that represent what is named zone.

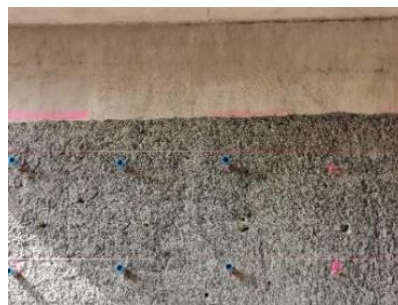
**Figure 3.** Visual inspection of the front wall of the bridge.

The bridge was divided into elements, which were evaluated separately. As an example, the visual condition of the bridge front wall showed a reparation during the visual inspection (Figure 3).

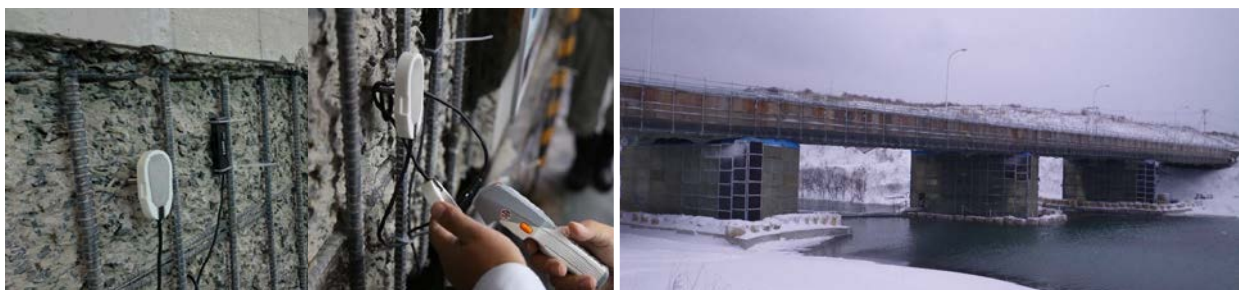
**Figure 8.** Application of the system to bridge pier repairs.

The sensor has also been used to evaluate the repair effects of concrete structures. Figure 8 show the application of the sensor to bridge pier repairs. The subject bridge was constructed in 1973, in Hokkaido, Japan, and has undergone one round of repairs in 2007 following the occurrence of rebar corrosion-induced flaking. However, in just two years, the repaired area degraded. Therefore, we placed these sensors at six locations on the bridge following a second round of full-scale partial patching in 2011. Subsequently, corrosion was measured, once a year, for five years, followed by another measurement in the seventh year. One of the sensors detected salt-induced corrosion at a location, while the other five locations were observed to be stable. We confirmed that there was no issue with the measurement performance of the sensor, and established its durability and utility as an effective maintenance management system. Corrosion at the subject structure will be measured again in 2021 and subsequent repair plans will be made based on the measurements captured by the sensors.

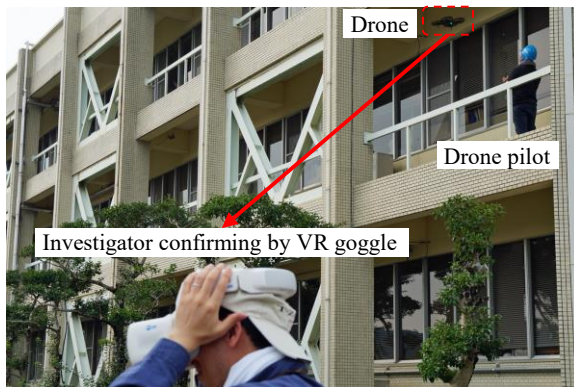
**Figure 15.** Remote investigation by drone in damaged building.

Many natural disasters such as earthquakes, typhoons and floods occur in Japan and it is expected that drones will be used following such events to assess damage. A demonstration experiment using a drone was conducted on a three-story building damaged by the earthquake in Kumamoto Prefecture in 2016. The flow of the experiment is shown in Figure 15. Initially, the drone operator takes a picture of the building near the crack. The investigator wears VR goggles at a position away from the building and verifies whether the image information taken by the drone can be determined by extracting cracks that the investigator wants to confirm. Based on this assessment, it is considered possible to investigate damaged buildings via drone by remote control.

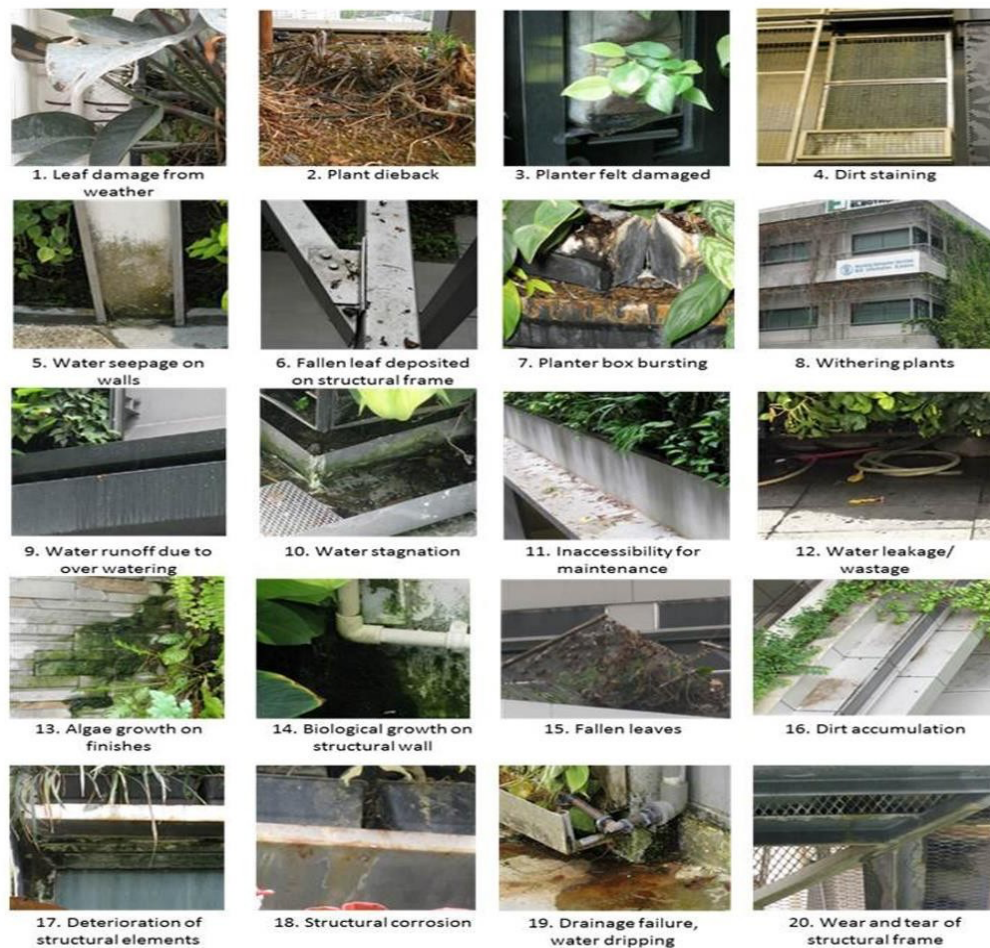
**Figure 1.** Some Defects of Vertical Greenery Systems.  
(Source: Chew and Conejos, 2016).
