# **Current Topics and Trends on Durability of Building Materials and Components**

Proceedings of the XV edition of the International Conference on Durability of Building Materials and Components (DBMC 2020)

Barcelona, Spain

20 – 23 October 2020

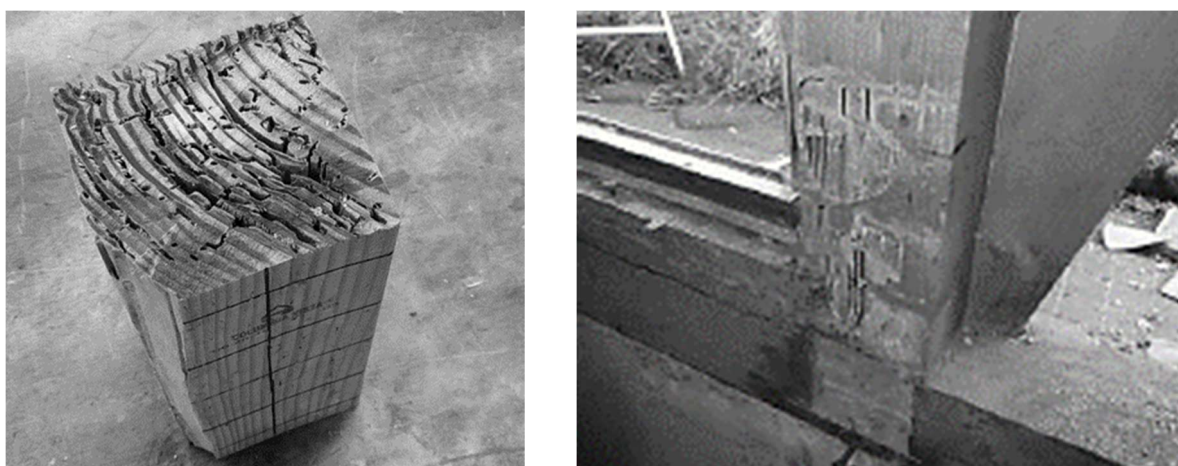
**Figure 1.** Timber damaged by termites. (Source: KAWATA Tasturo, 2017)

The damage caused by termites is one of the main degrading factors of timber structures. Termites are active in wet conditions; hence, they can cause damage to the base of timber that is close to the ground. In addition, in timber buildings, joint strength is very important. It is clear that the deformation and strength capacity of the joint strongly affects the deformation and structural capacity of the building. Therefore, in this study, the authors focus on the reinforcement of the base joint.

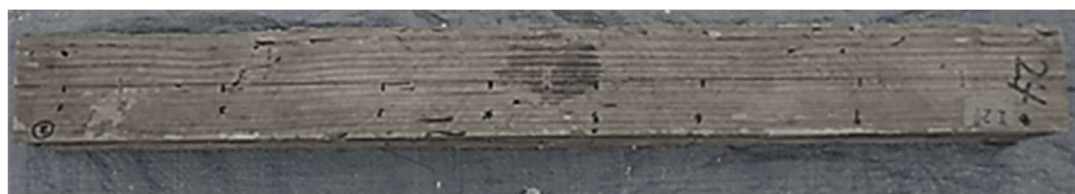
**Figure 2.** Timber filled with resin.

The authors examine the reinforcing method of injecting synthetic resin into the deteriorated parts of the timber. The reinforcing method is characterized by a little change in appearance, as shown in Figure 2.

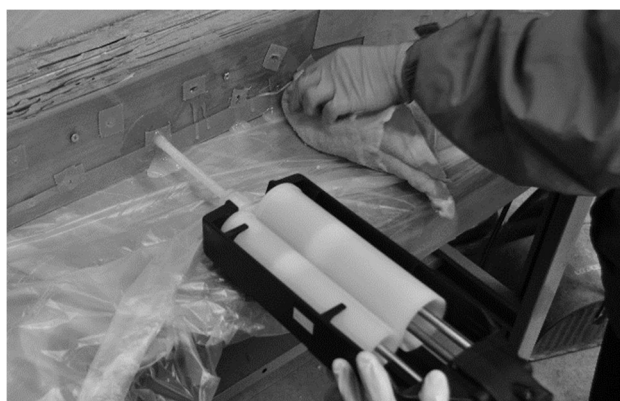
**Figure 4.** Resin filling work.

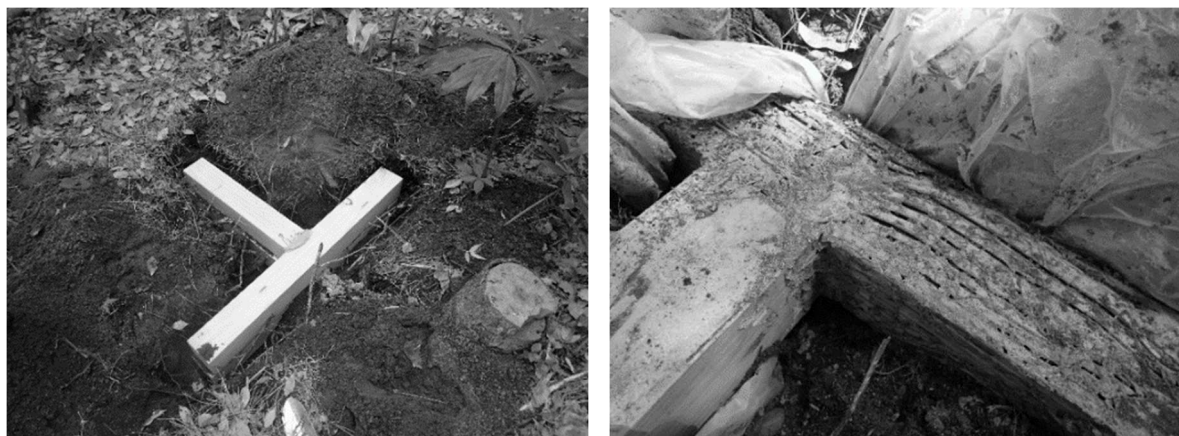
**Figure 5.** Soil exposure due to feeding damage caused by termites.

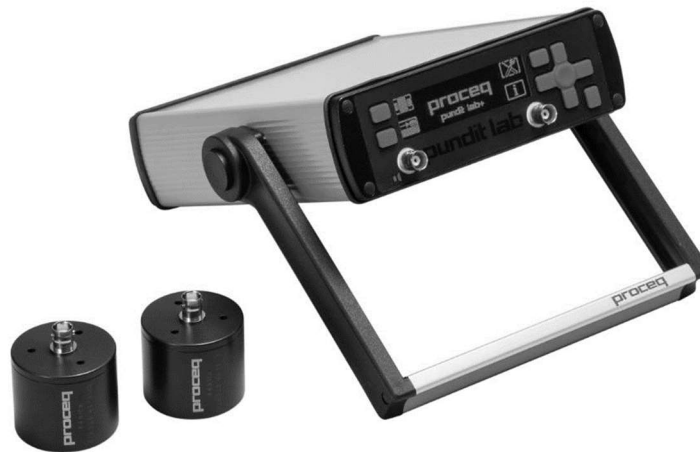
Figure 10. Ultrasonic testing machine. (pundit)

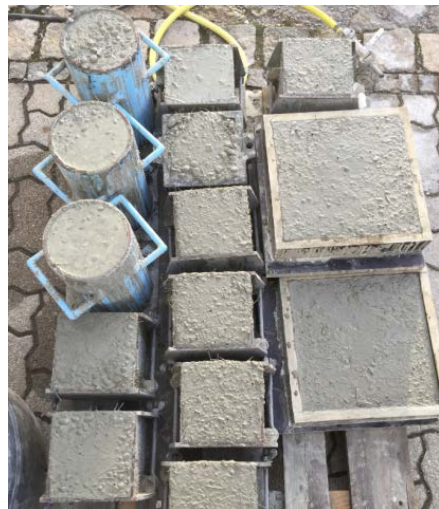
**Figure 3.** Production of test specimens.

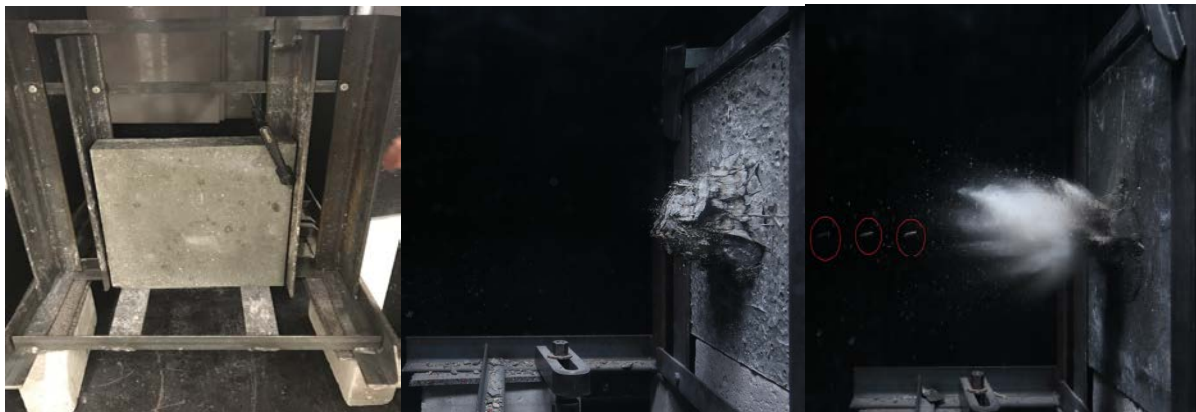
**Figure 4.** Setup and execution of hand gunshot test.

The 300 x 300 x 60 mm thick fiber concrete plates were shot with both soft- and hard-core shot caliber 7.62 mm x 51 308 Winchester. The projectiles have a weight of 9.5 g for soft core and 9.8 g for hard core. These were fired by the ammunition tester series 1055, which can be seen in the foreground in Figure 4.

The velocities of the projectiles were determined by measurement of two light barriers LS 23 F3/K2. These measure the speed with an accuracy of  $\pm 0,1 \%$ . An average bullet speed velocity is 842.75 m/s and an average projectile energy computed 3373.03 Joule. The camera was used in the bullet trap (Figure 4) which was triggered as soon as the projectile hit the plate.

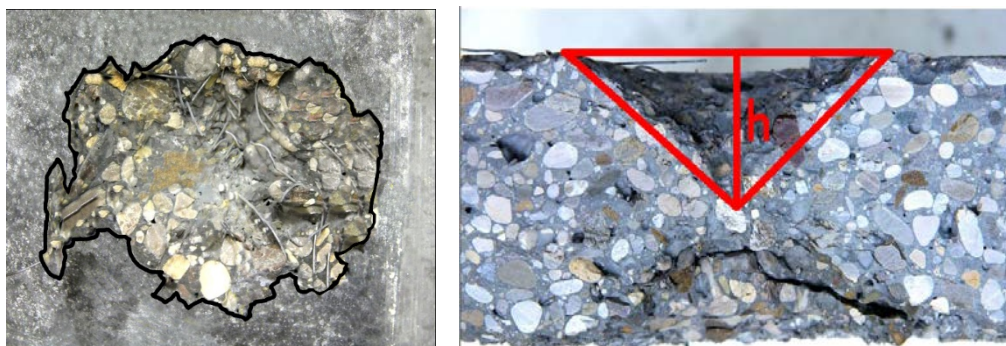
**Figure 5.** Crater volumes.

In order to measure the damage caused by the projectile, the 6 cm thick plates fired on were analyzed with regard to the crater volume (Figure 5).

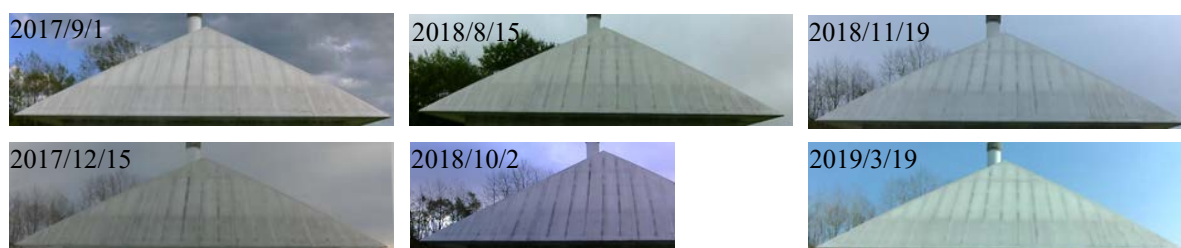
**Figure 5.** Photographs of NW roof from September 2017 to February 2019.

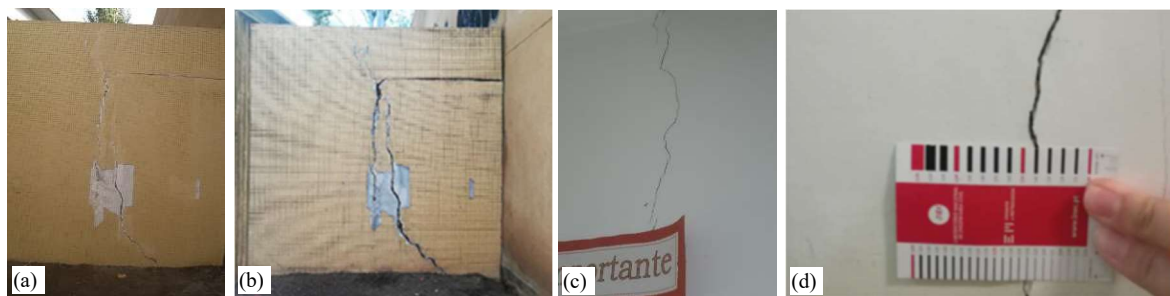
**Figure 1.** VA School: deterioration process of the exterior partition wall in 2007 (a) and 2018 (b). Cracks in walls in 2007 (c) and 2018 (d).

The structure of VA School building is a system of slabs, columns and beams in reinforced concrete. The inspection carried out at this school in 2018, revealed the existence of serious anomalies in the structure namely, the existence of extensive structural deformations and the existence of wide opening cracks in multiple walls and ceilings on the two floors of the building.

Figure 1 shows the result obtained through inspections carried out in 2007 and 2018, where it is possible to observe the degradation mechanism of the building's structure and interior and exterior partition walls. They were identified foundations settlement problems and water infiltration through the roof in several classrooms (Vilhena *et al.*, 2019). Following this inspection, the school was closed for further rehabilitation intervention.

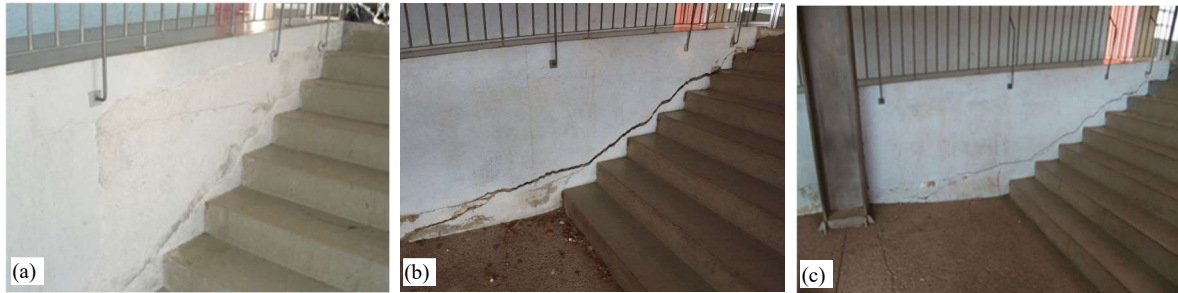
**Figure 2.** AF School-outdoor spaces: deformation and settlement of the supporting wall and the recurring appearance of cracks. Anomaly evolution in 2007 (a), 2013 (b) and 2018 (c).

The 2018 survey, carried out in AF school, revealed the existence of anomalies in the outdoor constructive elements. The most frequent anomalies in these elements are oriented cracking,

severe fracture, differential settlements and deteriorated expansion joints without sealant. Some of these defects were detected since 2007, when only six years had passed on handover of the building. Figure 2 shows the result obtained through inspections carried out in 2007, 2013 and 2018, on the supporting wall located in AF school's outdoor spaces. It is possible to observe the existence of settlements and structural movements that remain unsolved.

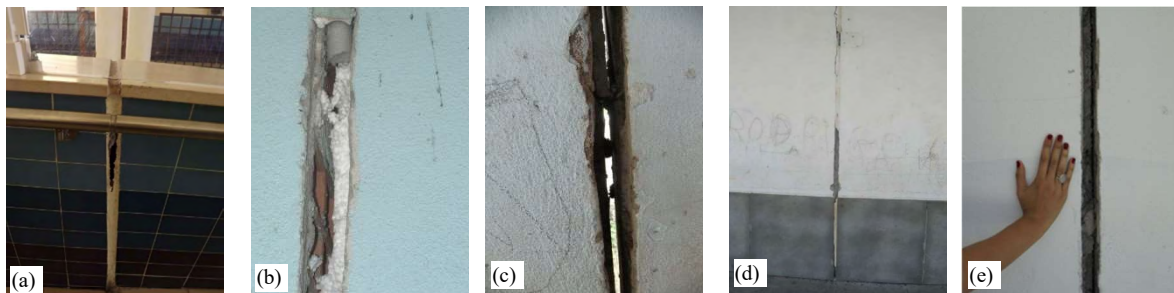
AL School was implanted on a landfill site, which is very steep along the longitudinal and transversal development of the building. The building structure is in reinforced concrete and is made of two blocks connected by an access ramp and stairs. In 2007, the existence of several anomalies resulting from the differential settlement of the two blocks was already visible (cracking in walls and broken elements). Although several repairs have been carried out in the building, 2013 and 2018 surveys revealed that the settlement movement remains active and the cracks in the walls and floors continue to appear (Fig. 3a). In AL, AF and PRM Schools, deteriorated expansion joints without filling material and sealant was observed (Fig. 3b,c,d,e). Lack of repair of the joints exposes the building elements to water infiltration and mechanical actions.

**Figure 3.** AL School: foundation settlement movement: broken stone and construction joint opening in 2013 (a). Expansion joints without sealant: AF School in 2007 (b) and 2018 (c); PRM School in 2007 (d) and 2018 (e).

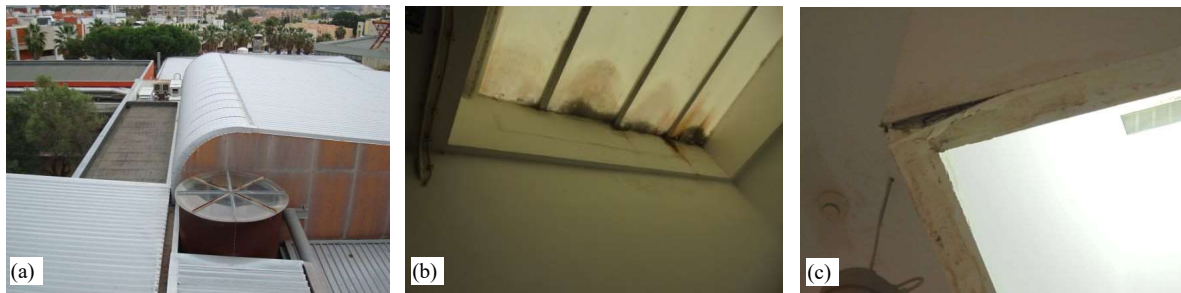
ceramic tiles, and VG School presents a non-traditional roof covering made of ceramic pellets. In PM School, infiltrations water problems continue to be observed since 2007 survey, in the area of the gymnasium affecting both the ceiling and the floor. The AF School continues to present problems between the several flat and sloped roofs boundary buildings (Fig. 4a). Skylights are the element that most frequently presents anomalies caused by water infiltration. It was possible to observe the degradation mechanism in ceilings, walls and floor coatings, caused by water infiltration through skylights in PMR School (Fig. 4b,c).

**Figure 4.** AF School: mixture of flat and sloping roofs in metal sheet (a). Water infiltration problems between the building's roofs. PMR School skylights problems in 2018 (b), (c).

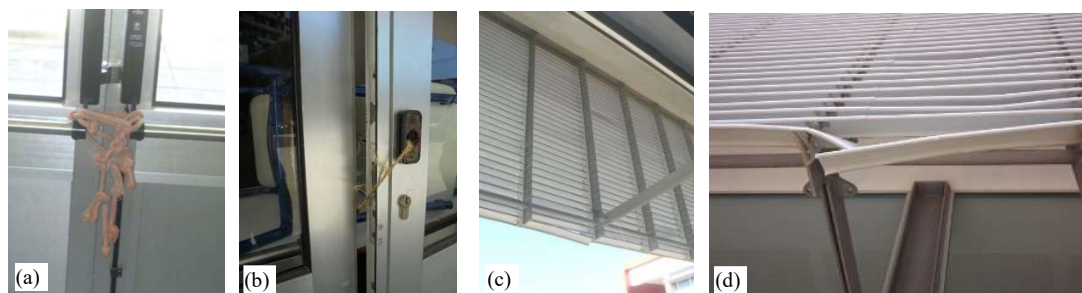
In PRM School, damaged or missing door locks and handles were observed in the surveys. These failures severely reduces the adequate serviceability of the exterior doors (Fig. 6a,b).

These anomalies were detected in 2007 in doors with 5 years of service life. In general, some problems with rain penetration were observed in windows and non-operational interior polystyrene blinds is a very frequent anomaly. In AF School the outdoors shading were broken and deformed caused by its proximity to the playing field (Fig. 6c,d).

**Figure 6.** PRM School: missing door locks and handles 2007 (a) and 2018 (b). AF School: outdoors shading broken and deformed in 2007 (c) and 2018 (d).

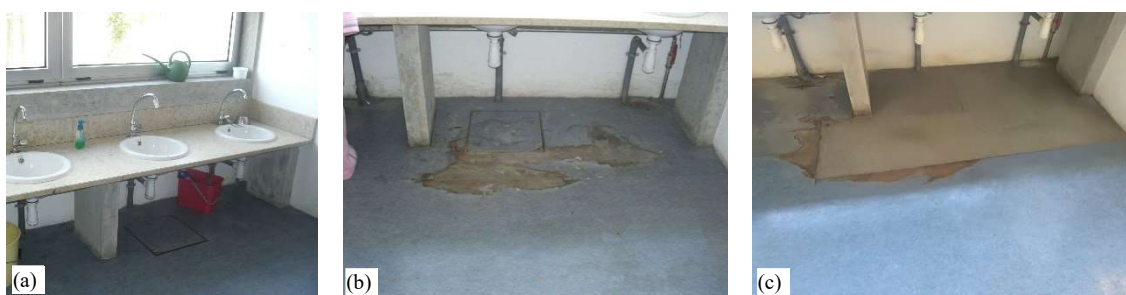
At PRM School, the degradation mechanism of the floor finishes, in the arts and crafts areas, next to the classrooms, caused by frequent water leakages from the washbasin siphons, has been observed since the 2007 inspection. In 2018, the placement of floor covering patches in this area was observed. Figure 7 (a,b,c) shows three stages of the vinyl floor covering degradation process caused by wet-dry cycles exposure conditions.

**Figure 7.** PRM School: vinyl floor degradation process caused by wet-dry cycles exposure conditions. Area in good condition and severely damaged area in 2007 (a,b); floor repaired in 2018 (c).

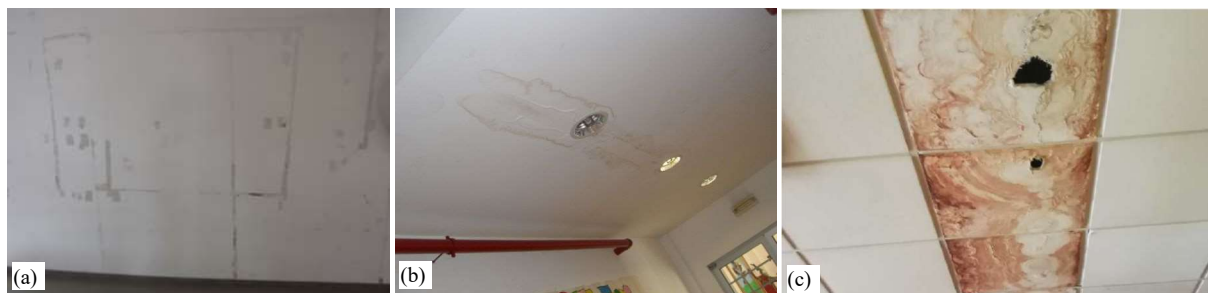
Degradation in wall painting due to the use of adhesive tape for the exhibition of students' work was observed in the inspection carried out in 2007. In 2018 survey this anomaly was observed more frequently and over a larger area of walls (Fig. 8a).

In ceilings, moisture and water ingress are the most frequent anomalies. Figure 8 (b,c) shows the increased severity of this phenomenon in VA School, that may have resulted initially from lack or loss of waterproofing capacity of the building envelope (in 2007) and later resulted from the combination of several causes including building structural and foundations settlement problems (in 2018).

**Figure 8.** AF School: degradation in wall painting due to the use of adhesive tape for the exhibition of students' work in 2018 (a). VA School: water infiltrations in the ceilings in 2007 (b) and in 2018 (c).

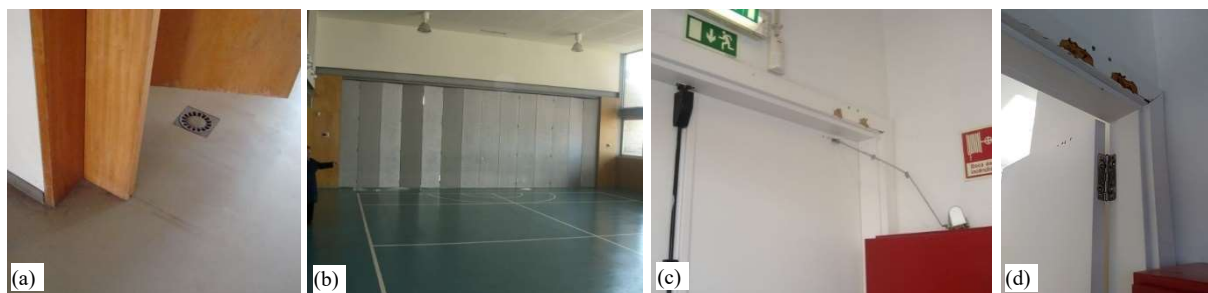
The model of the sliding doors used to separate the classrooms from the arts and crafts areas and in bathrooms (PRM, PM and AF Schools) presented several functional problems related to unsuitable serviceability, vertical misalignment and deficient fixation tracks causing localized wear on the floors finishes (Fig. 9a). The use of large bellows doors to separate the gym from school cafeteria is a widely used solution in these recent buildings schools. This solution aims to open the spaces with an area for students to perform shows/theaters an area for the audience. Due to their characteristics, these doors are large (length and height) and are heavy, which makes manual maneuvering difficult. These doors are now permanently closed and are not used because they require maintenance and repair actions without which their safe use is not guaranteed (Fig. 9b). At PRM School, door closer need to be repaired in interior fire doors. In 2007, these elements were damaged (Fig. 9c), while in the 2018 survey it was found that the element was not placed where it was supposed to be (Fig. 9d).

**Figure 9.** AF School: sliding door anomaly (a) non-operational bellows doors (b). PRM School: door closer anomaly in fire doors in 2007 (c) and 2018 (d).

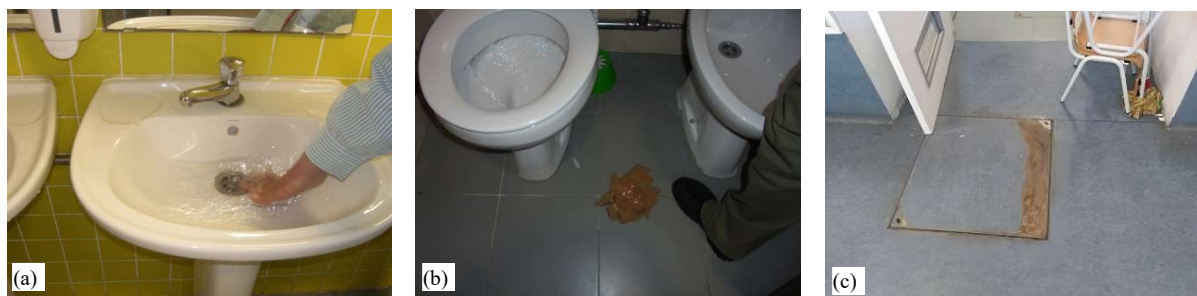
anomalies in these systems continue to be (i) the breakdown of the toilet flushes, (ii) fixing problems of water faucets and (iii) problems with the drainage capacity of the wastewater network. The lack of proper maintenance and misuse, results in nonfunctional equipment and sometimes in floods. Figure 10 (a) shows the poor fixing of the water tap and deficient drainage of the wastewater, (b) failure in the flushing system causing waste of water and (c) anomaly in the floor box of the wastewater network.

**Figure 10.** PRM School: anomalies on water tap and in the water flow, 2007 (a) failure in the flushing system, 2018 (b) and anomaly in the floor box covering finish of the wastewater network, 2018 (c).

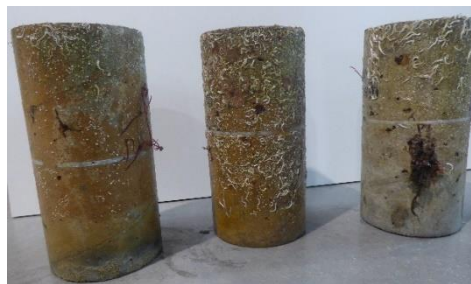
In order to choose the best concrete formulation, several mechanical strength and durability tests were carried out. The 11x22 samples were colonised by sessile fauna and some macro-algae after 3 months of immersion in natural seawater. We could count some bryozoans, sponges, serpulid and spiral tubes of *Spirorbs* (Figure 2).

**Figure 2.** Concrete samples (11x22) after immersion for 3 months in natural seawater.

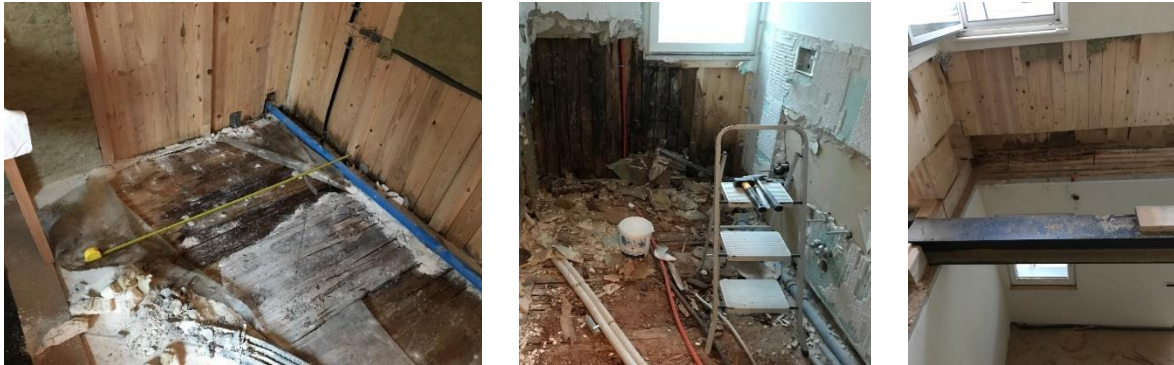
**Figure 3.** Pictures of damaged CLT slab and wall elements in hotel room.

- Moisture damage with related wood decay inside buildings is a relevant problem,
- Such damages are difficult to detect because the damage mechanisms are acting slowly,
- Massive, planar structural components are particularly affected by slow decay mechanisms,
- Wood decay effects are mainly occurring due to defective water pipes on top of the floor.

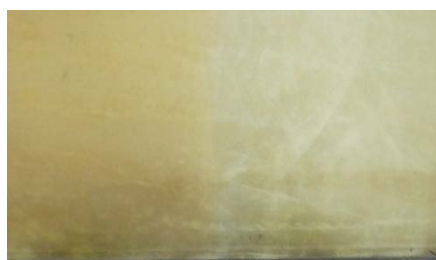
After 2,000 hours of exposure to simulated solar radiation, a considerable change in colour was observed between the exposed and unexposed areas of both panels (Figure 3). In the case of the glass-marble-glass composition, the difference in colour in the three selected areas before and after aging was less than 2.3 and in the case of the glass-marble-honeycomb composition the difference was greater than 2.3.

**Figure 3.** Exposed area of the panel (left) and unexposed area of the panel (right).

There is no requirement as to allowable colour difference after ultraviolet exposure for these innovative solutions. However, according to Sharma (2003) a colour difference  $\Delta E^*_{ab}$  of approximately 2.3 is considered just noticeable difference. Therefore, in the case of the glass-marble-honeycomb composition the differences are clearly noticeable.

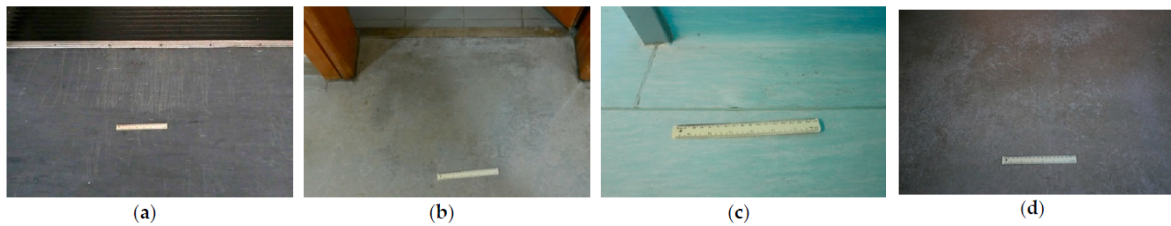
As for the location of anomalies, in some situations, a specific type of anomaly is predominant. For example, anomaly “scratches/wear” is often seen in poorly executed transition areas or at the rooms’ entrance (Figure 3a and b). It is also the case of anomaly “brightness changes”, which often occurs immediately below the alcohol-based disinfectant dispensers (Figure 3c).

**Figure 2.** Anomalies: (a) scratches; (b) wear; (c) brightness changes; (d) brightness changes on a linoleum flooring due to inadequate maintenance.

According to Carvalho *et al.* (2019), there are some repair techniques that should be adopted in the maintenance program, according to the different types of anomalies detected in the regular flooring inspections. For example, the application of a surface protector is a technique widely used for scratches/wear, staining/dirt/colour changes and brightness changes, to reduce its aesthetic impact by smoothing the surface. When scratches exist, partial or total replacement of the flooring should only take place when the area has a high aesthetic value. Stripping is a technique exclusively used in linoleum floorings, being less associated with stains than with brightness changes. In some cases, the floorings are cleaned and waxed regularly, but stripping is only partial and not in the required timings, often resulting in alternated areas with different wax thicknesses, as seen in Figure 3d.

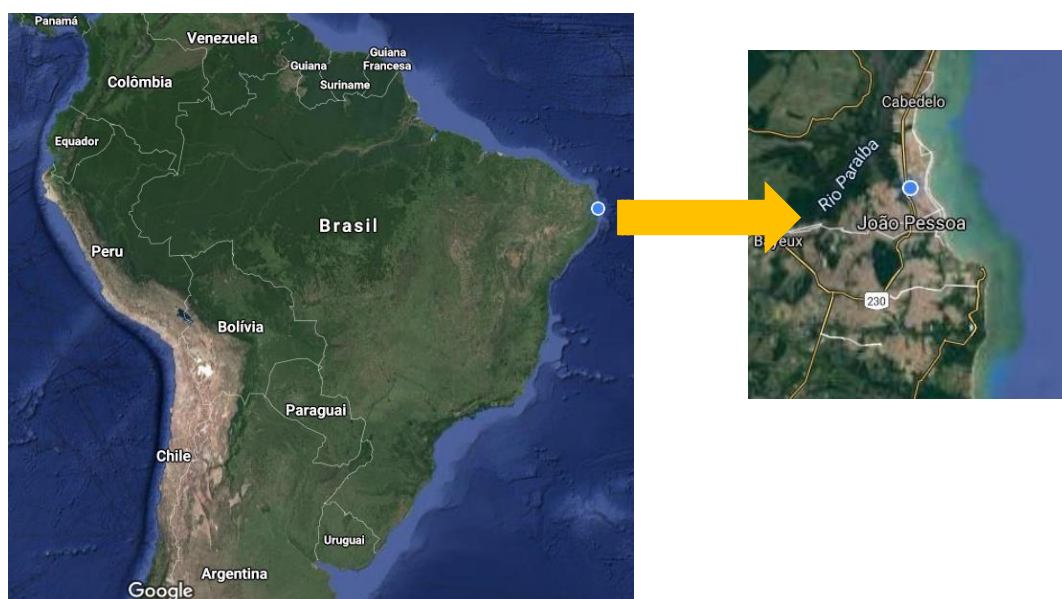
at places 10, 100, 200 and 500 m far from the sea (Figure 1 and Table 2) using the wet candle method, according to ASTM standard G140 (ASTM, 2014).

**Figure 1.** Region where wet candle devices and concrete specimens were exposed.

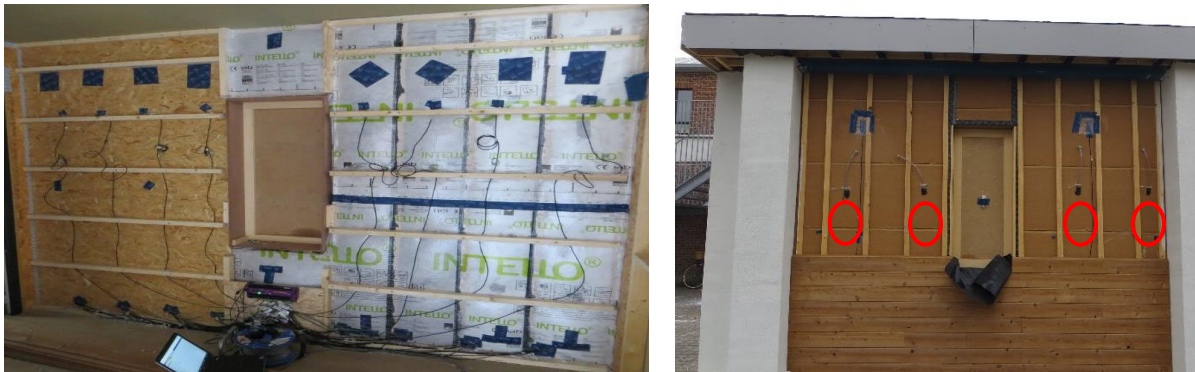
In 4 compartments (2, 4, 6 and 8) 0,2323 l water was injected into the insulation layer. Figure 4 (photo on the right) shows the outside of the test wall with the infiltration tubes at half height. The tubes were installed in such a way that the water infiltrates between the wood fibre board and the insulation layer.

**Figure 4.** View on the compartments from the inside (photo left) and view on the outside with water infiltration tubes, indicated with a red circle (photo right).

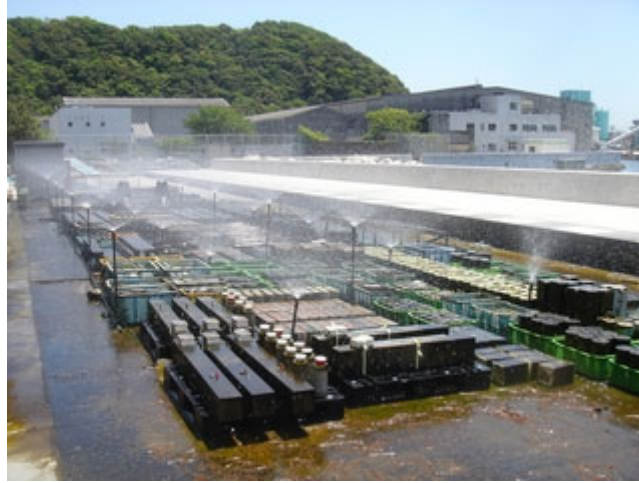
The specimen after repairing was exposed to seawater splayed condition. The seawater was pumped up from Kurihama bay and splayed to specimens as shown in Figure 2. Seawater was splayed twice in a day and specimen was exposed for 6 months.

Figure 2. Seawater splayed environment.

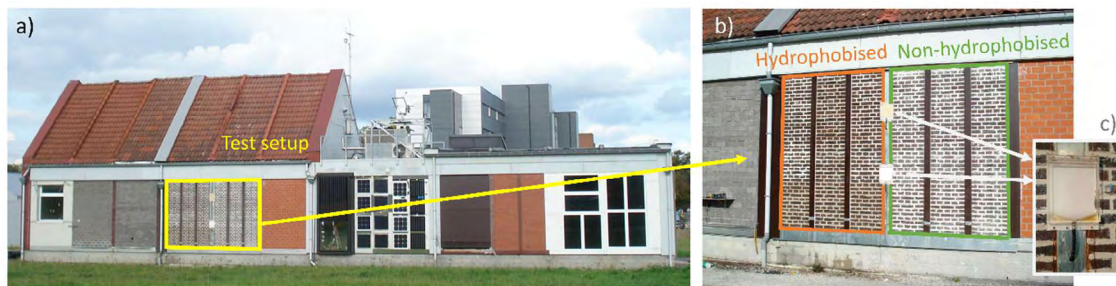
To study the impact of hydrophobisation on internally insulated walls, six 1.5-stone thick masonry test walls of approximately 32 cm thick, 0.6 m wide and 2.7 m high were constructed in two south-west oriented wall frames of the VLIET test building of KU Leuven (Figure 1a).

**Figure 1.** Outside view of the field test setup: (a) south-west oriented side of the VLIET-test building, (b) hydrophobised and non-hydrophobised masonry test walls with (c) wind-driven rain gauges.

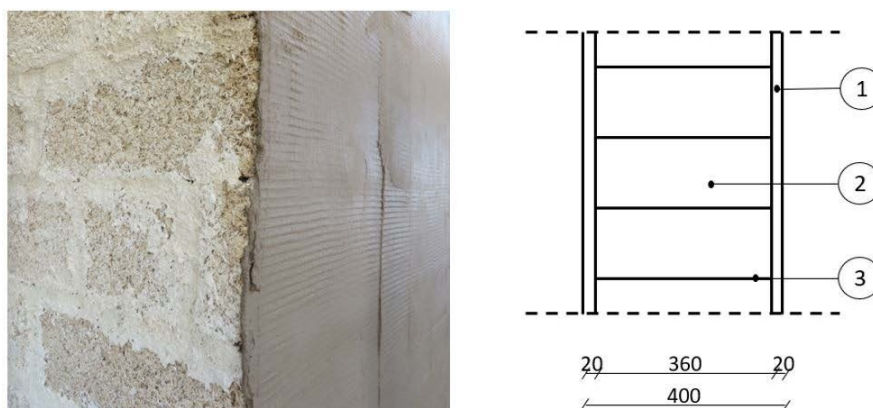
Currently, the data collected in the Sicilian campaign have been elaborated, the reference standards are UNI EN 15026:2008 and UNI EN ISO 13788:2013. The measurements have been performed on the South-West, South-East and North-West walls for 13 days (in August) during which the inhabitants where not present to exclude the influence of the air conditioning system. The wall system is 400mm thick (Figure 2): the hempcrete blocks have a thickness of 360 mm, the ratio between dolomitic lime and hemp shives is 3:1; the plaster is premixed, constituted by hydraulic lime NHL 5 and it has thickness of 20 mm both on the internal and on the external face of the walls. The bedding mortar is characterized by a dolomitic lime-to- hemp shive ratio of 3:1.

**Figure 2.** Wall system: 1-plaster(thickness: 20 mm); 2-hempcrete blocks(thickness:360mm); 3-bedding mortar.

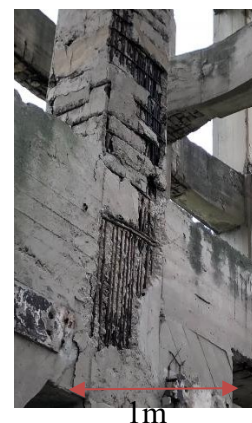
**Figure 4.** Rebar exposure due to spalling.

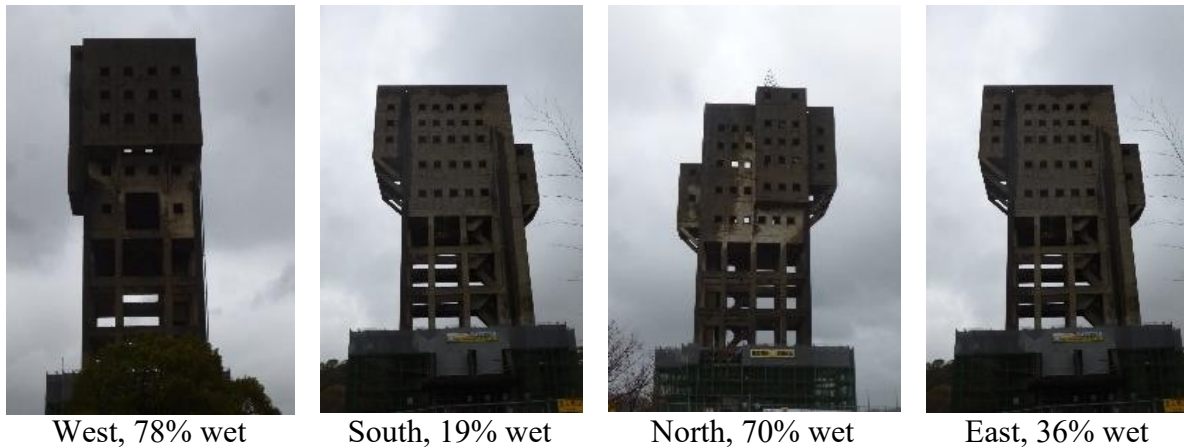
**Figure 9.** Percentage of wet area (wet/total area of each side) after rainfall.

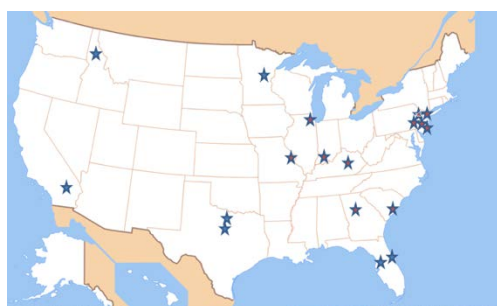
**Figure 1.** To date, samples have been collected from 20 roofs across the United States.

Samples were taken from 20 different roofs across the United States (See Figure 1). Climatic conditions of the United States cities were matched up with their European counterparts, and are shown in Figure 2 to illustrate the approximate European climate equivalents captured in this study. These roofs were installed over office buildings, manufacturing facilities, retail outlets, libraries, automotive repair shops, warehouses, and a grocery store. All data gathered was used in the analysis.

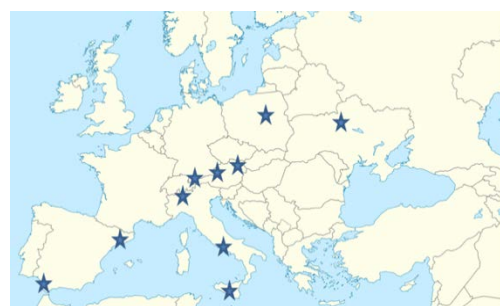
**Figure 2.** European climatic equivalent locations to the samples collected across the United States.

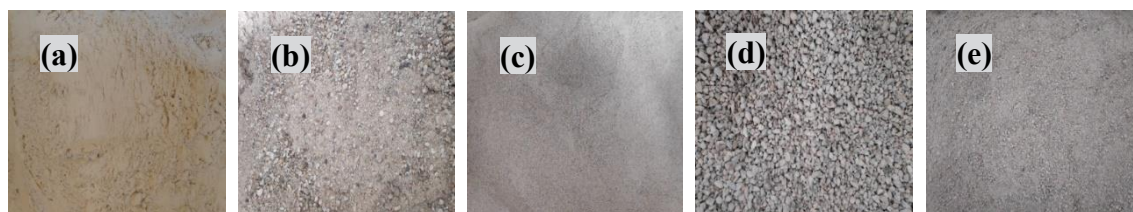
**Figure 1.** Appearance of the aggregates used for the manufacture of the SCC: a) Limestone filler  $<0.063 \text{ mm}$ ; b) Siliceous sand 0/4 mm; c) Limestone sand 0/1.2 mm; d) Coarse RCA 4/12.5 mm; e) Fine RCA 0/4 mm.

The appearance of the aggregate and their granulometry are shown in Figure 1 and Figure 2.

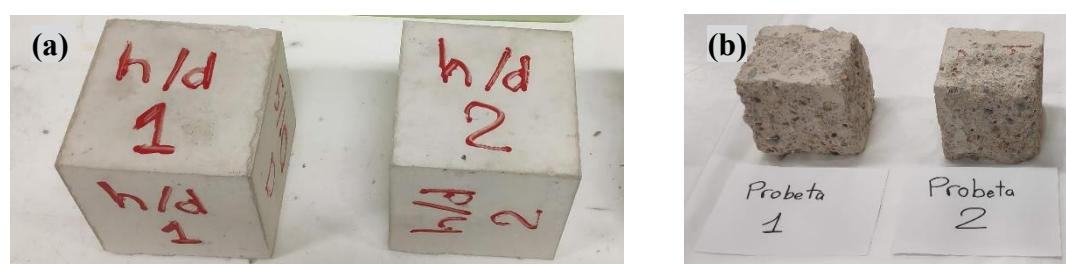
**Figure 5.** Freeze/thaw test: A) Initial state; B) Final state.

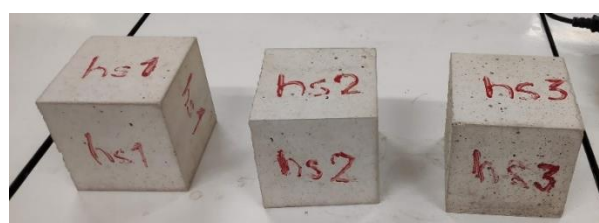
**Figure 6.** Moist/dry test. Final state of the samples.

The external appearance of each sample after the test is shown in Figure 6. Every 10 cycles, each specimen was weighed and its UPV was measured, a parameter that had also been measured before the beginning of the test. When the trial ended, the samples were tested to compressive strength. The results obtained can be seen in Table 2.

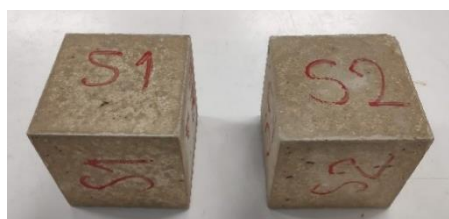
**Figure 7.** Sulphate attack test. Final state of the samples.

Neither the variation in either mass or length nor in the external appearance of the concrete samples showed relevant changes. The only noticeable effect was the reduction in compressive strength and the logical decrease in UPV. Nevertheless, compressive strength was less effected by the sulphates than by consequences of exposure to water in the moist/dry test. This difference can be explained by the high flowability of SCC, which implies that the concrete had a very low number of small-sized surface pores in the hardened state. Hence, the penetration of higher density solutions within the concrete was less likely, because water with no salt solutions penetrates with greater ease through surface pores than a sulphate solution, meaning that the sulphate effect would be lower towards the interior of the sample.

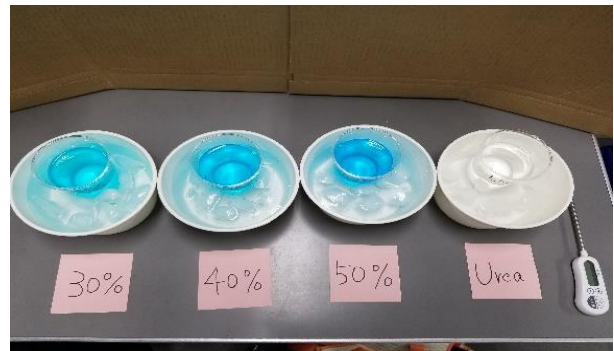
**Photo 1.** Antifreeze concentrations in a solution.

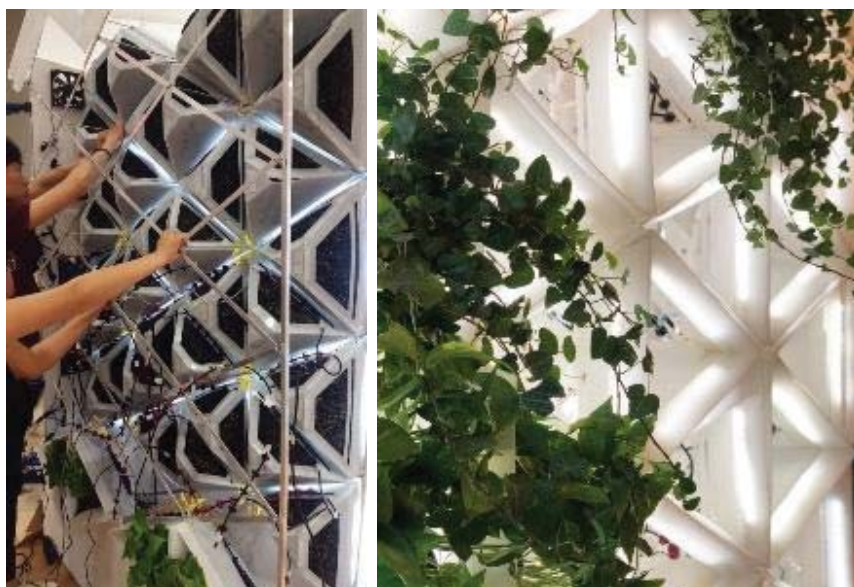
**Figure 4.** a. Assembly of the prototype; b. Plant assembly of the prototype.

In this prototype, different materials and techniques of fabrication are investigated. Emphasis is placed on designing a lightweight and collapsible scissor structure, which allows the project to be easily transported and assembled. Subtractive manufacturing methods are selected to be used to conduct the base and the cassettes of the prototype. Computed-numerically-controlled (CNC) machine is used to cut the 1" wood base and sides. Precise  $3/4$ " deep grooves are routed on the interior faces of the base so that the steel structure would snap into its designated shape. The structure's geometry is designed to hold two abutting cassettes per one parallelogram (Figure 4a and Figure 4b). While the base's hidden grooves and inserted cassettes hold the metal scissor structure in place, it is the 1" plywood walls on both sides that provide support against shear stresses. These sidewalls are holding the fans that are used to distribute the air, which was cleaned by the plant cassettes.

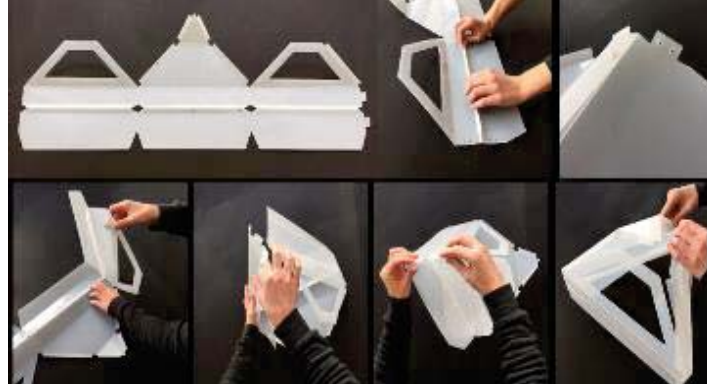
**Figure 5.** Cassette assembly by folding.

17 sheets of HDPE are used to CNC cut the cassettes of this prototype. A total of four cassettes are cut from a 49" × 96" sized sheet. The cassettes are designed and assembled by folding technique (Figure 5).

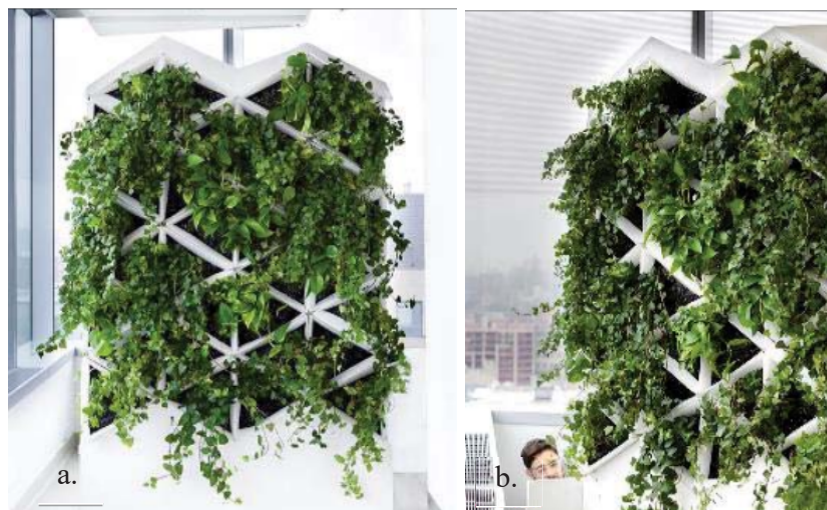
**Figure 6 a and b.** The plant-based air filtering system prototype.

In this project, a prototype containing 68 modules was designed and fabricated (Figure 6a and Figure 6b). Folding technique for the structure and cassettes seemed to be a practical solution, however; due to connection problems on the corners, the fabrication technique needs to be revisited for the cassettes. Using CNC for cutting the material was not the ideal solution due to time-inefficient and waste of material concerns. Two different solutions were generated to solve this problem.

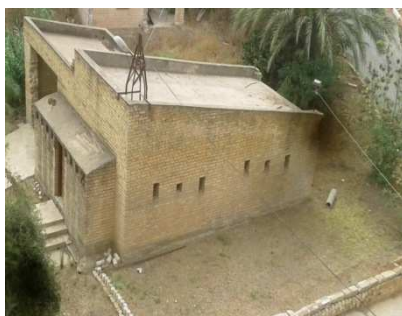
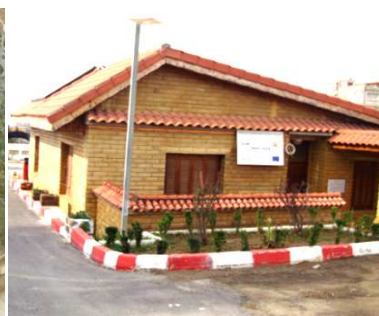
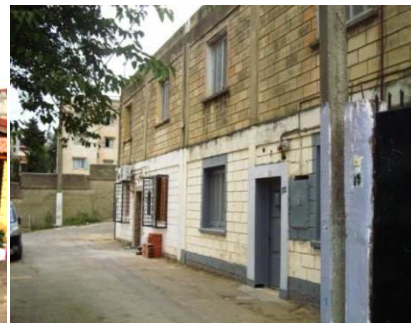
**Figure 2.** Load bearing soil–cement block residential building in the northern region.

The buildings are ground dwellings except in one residential site situated in the north region (see figure 2.c). The stabilisation of the earth blocs are both chemical and mechanical. The portion of cement exceeds 7 % and could be in some places more than 10 %. The second stage of stabilisation relies on reducing the pores volume by applying a compactive effort with at least 7 MPa of stress, using as a matter of fact a manual or a hydraulic semi-automatic press. This moulding pressure raises the bulk density of the block as it improves the block performance against the water runoff erosion phenomenon. The cure process involves a storage of the blocks under roofing or hat for 28 days. It requires also a light watering for a week with a wrap. The dimensions of the blocks used in these constructions are different from one site to another. For instance, the dimensions of the blocks manufactured and used to build the first bioclimatic prototype at Souidania in 1984 (Algiers, figure 2.a) are 250 mm in length, 125 mm in width and 70 mm in height. In 2007, blocks with the dimensions of 295 mm in length, 140 mm in width and 90 mm in height were prepared to construct the second bioclimatic prototype (figure 2.b). Over all the surveyed houses, the earth blocks are entire except in the site of Beni Messous where compressed earth hollow blocks were used.

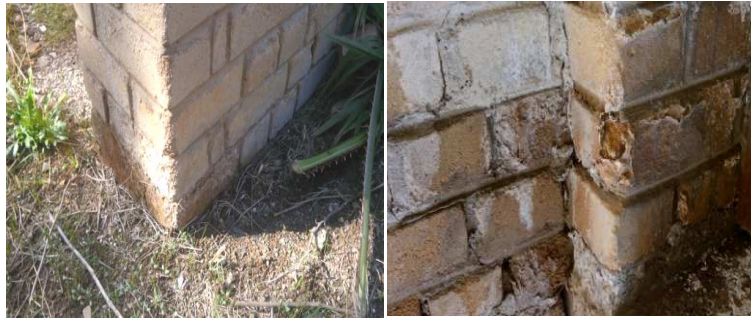
**Figure 8.** Degradation observed in the north region (humid pathology).

The inattention on removing the element likely to cause seasonal variations in humidity in particular the vegetation near the building participate actively on the development of humid pathology (figure 8).

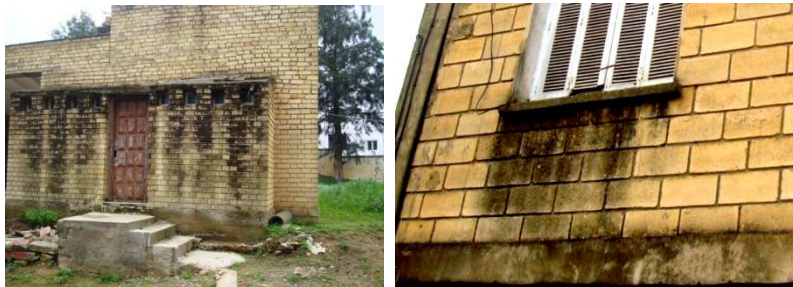
**Figure 9 :** Wall Pollution.

Furthermore, due to the high humidity rate, the pollution released in the air is fixed on the structures' external envelopes by dirtying the contact surfaces and favouring biological colonization (figure 9).

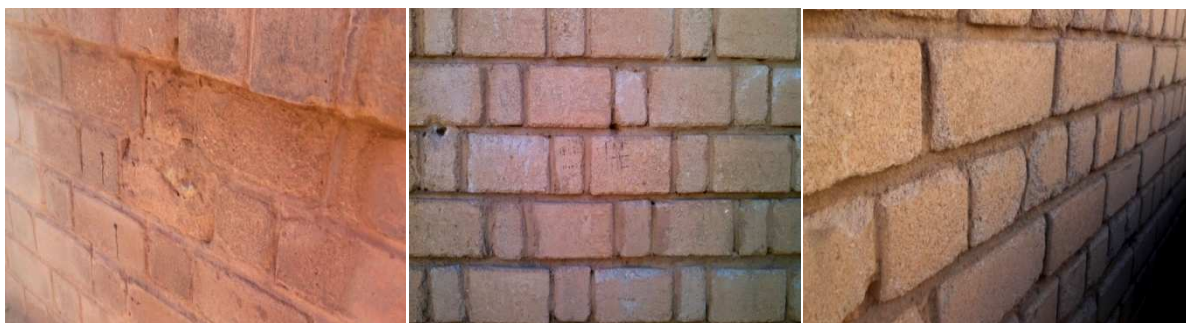
**Figure 10.** Direct impact of the mechanical action of the wind.

For the southern region, the investigation has ultimately identified very little pathologies due to exposure to climate, characterized by very low rainfall. On the other hand, the very frequent winds activity in this region has a stronger mechanical action when they carry suspended particles, such as the sands. The most common defects observed included: surface roughening, erosion and surface pitting. However, the inspection in the North and South regions has highlighted significant degradation resulting from poor design, production and implementation of the blocks, as well as others due to human intervention such as undertaking fitting out works or installation of air conditioning equipments.

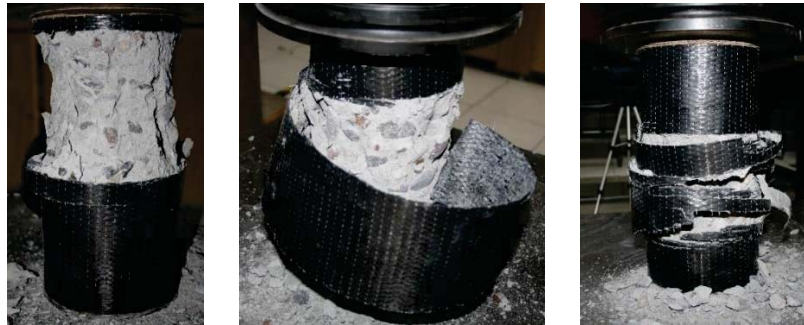
**Figure 2.** FRP specimens after compression test.

On Figure 2 it is shown, from left to right, FRP 1 with total detachment of CF; FRP 2, total detachment of CF; FRP 3, partial detachment of CF.

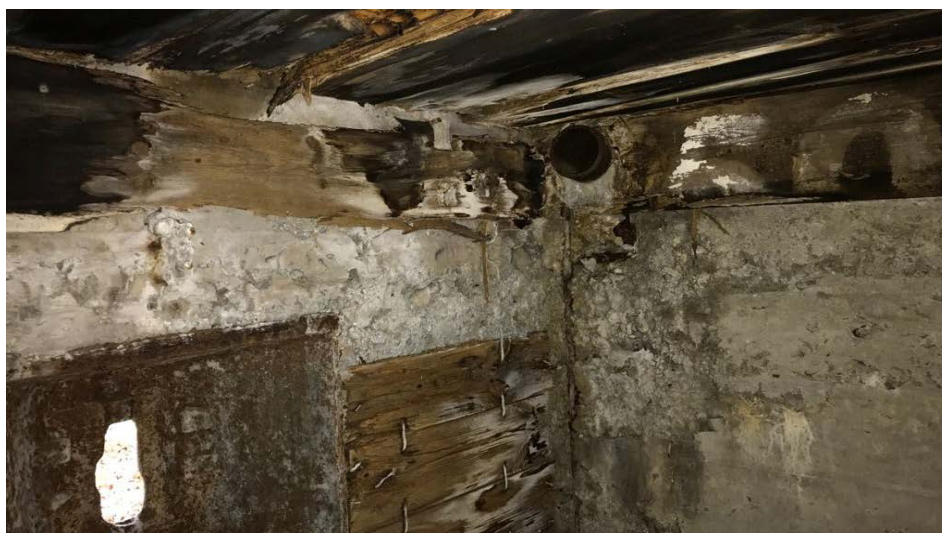
**Figure 2.** Residuum of internal timber cladding, poor quality of surface layer of concrete.

Analyzed bunkers are situated in one location and were built in approximately in the same period of second half of 1937. Their entrances are not locked, which means that the bunkers are not protected against vandalism. We can still observe the residua of original timber cladding in the interior part, as shown on Figure 2 and also on Figure 3. These timber elements were exposed to moisture and the effects of fungi and microorganisms. An important finding is that the quality of concrete within a single object is variable. We can observe excellent quality of surface layer, without any cracks or cluster of aggregate. There are places with very poor quality

of compaction in the same bunker. We can see reinforcement uncoated by concrete, clusters of coarse aggregate and other imperfections. This surface was originally covered by timber cladding and the estimated designed lifetime was only about 20 years, but if we want to preserve these objects to future generations, we have to deal also with these problems.

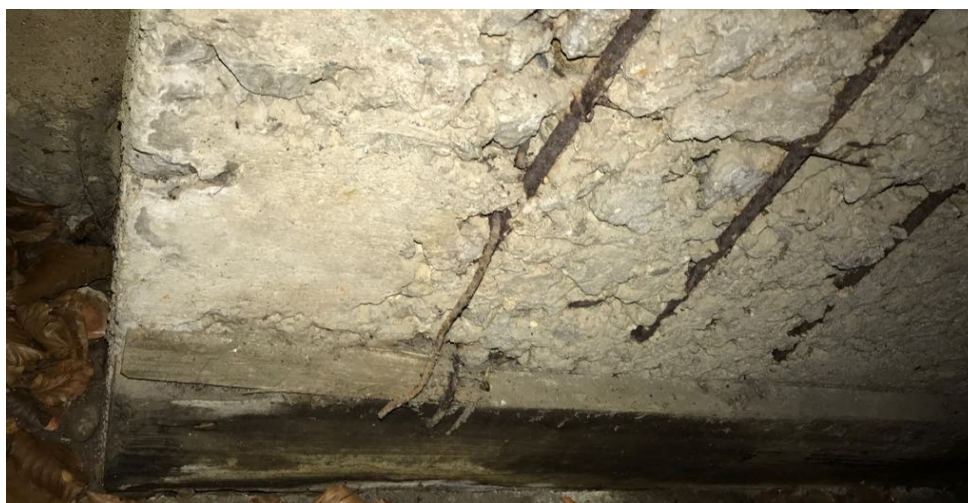
**Figure 3.** Insufficient compaction with uncovered steel reinforcement.

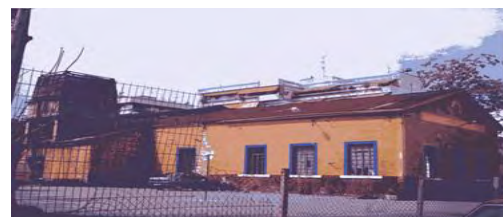
Figures 9, 10, 11. Power Plant building in Larisa, Greece (1913).

The Turbine House of the Larissa's Power Plant in Thessaly (1913, Fig 9,10,11.), was a building with an oblong rectangular ground plan and a double incline tiled roof elevated on its central part, completing natural lighting and ventilation of the building. On the other hand, the Power Plant in Karditsa city, also in Thessaly area (1909, Fig 4,5,6.) was an industrial complex of two buildings, one and two-storey, correspondingly. Additionally, noteworthy is the monumental Water Pumping Station building in Thessaloniki (Fig 7,8.), built by Belgian engineers in 1890–1892. The metal elements in combination with the bricks in the prominent masonry of the building formed a radical façade appearance (Cheirchanteri, 2014).

The entrance of this type of buildings was most often located in the center of the narrow or longitudinal side, in such a way, that the production line was not interrupted. In this construction building system, although the openings were large, symmetrical, repetitive and sometimes arched, interior lighting was not sufficient in the middle of the building. As a result, elevated skylights were installed along the roof in order to enhance lighting (Fig 7,10,11.), (Cheirchanteri, 2014).
