# **Current Topics and Trends on Durability of Building Materials and Components**

Proceedings of the XV edition of the International Conference on Durability of Building Materials and Components (DBMC 2020)

Barcelona, Spain

20 – 23 October 2020

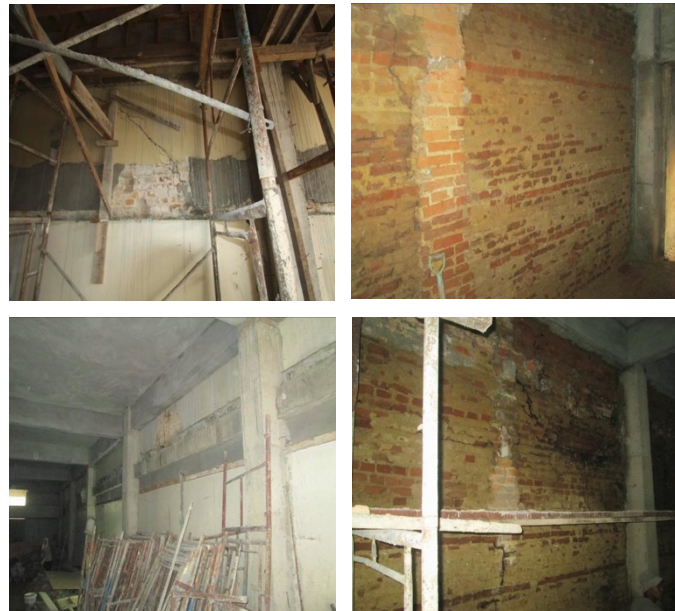
**Figure 4.** Additional Illustrations of the Remedial works.

The remedial work was carried out by a specialist contractor and the repair materials were supplied by Mapei. The works were carried out successfully and the shop house was reinstated to its original condition within 3 weeks (see Figure 4).

The arches and key structural components had been temporarily propped using specially designed timber props to guard against collapse and this was removed progressively. The stabilization of the foundation was undertaken within a week and as the injection works were completed in a particular area masonry strengthening works proceeded in the associated area. The crack repair works and stabilisation of the masonry walls proceeded over a 2 week period. The finishing works and painting was then undertaken by the main contractor.

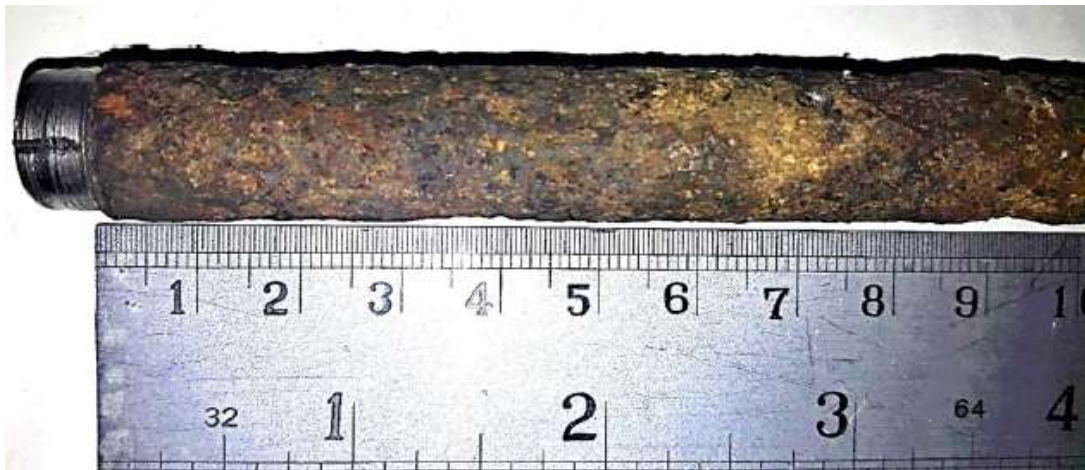
**Figure 1.** Specimen B2 before preparation and cutting.

Three bars composed the specimens, belonging to foundation block of ITA's building. The bars were smooth, originally had a nominal diameter of 15.88 mm (5/8"), and were named B1, B2 and B6.

These bars remained underground and unloaded for approximately a period 60 years, from their construction to 2008, when the samples were collected and stocked in the Materials Laboratory of the Civil Engineering Department. Currently, these bars have about 70 years of natural aging.

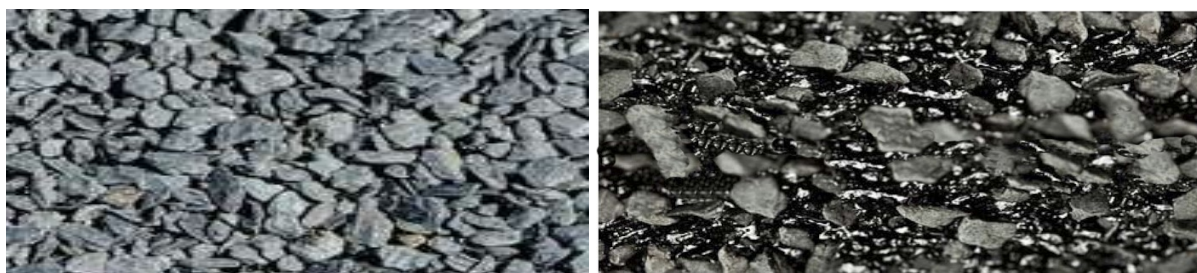
**Figure.1** This is a comparison of mineral topping on new roofing paper and topping on the same roofing paper after several years of use in adverse conditions (on the right photo a drastic example of a significant loss of granules and exposure of asphalt in a roof depression - a periodic puddle).

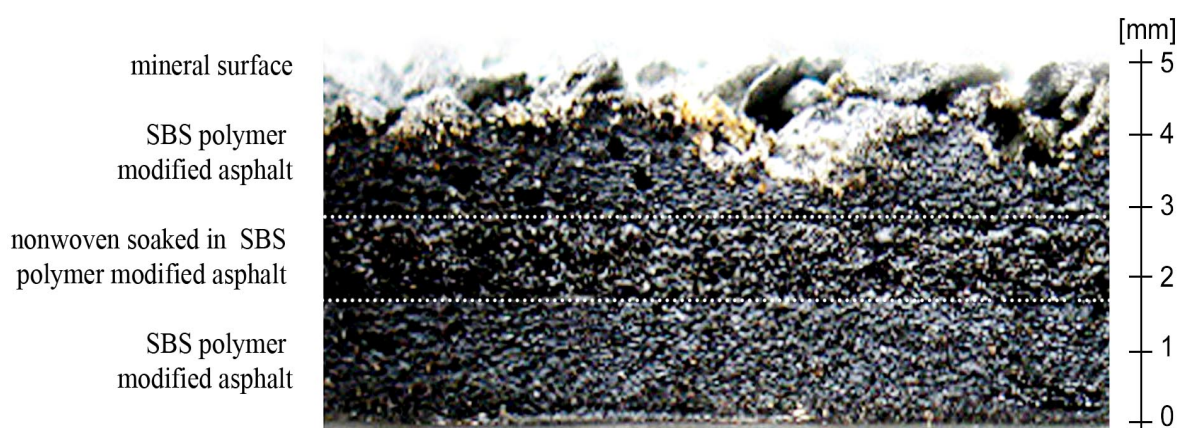
**Figure 2.** This is the cross-section of an ordinary polymer-asphalt covering roofing felt, on polyester nonwovens using typical roofing felt.

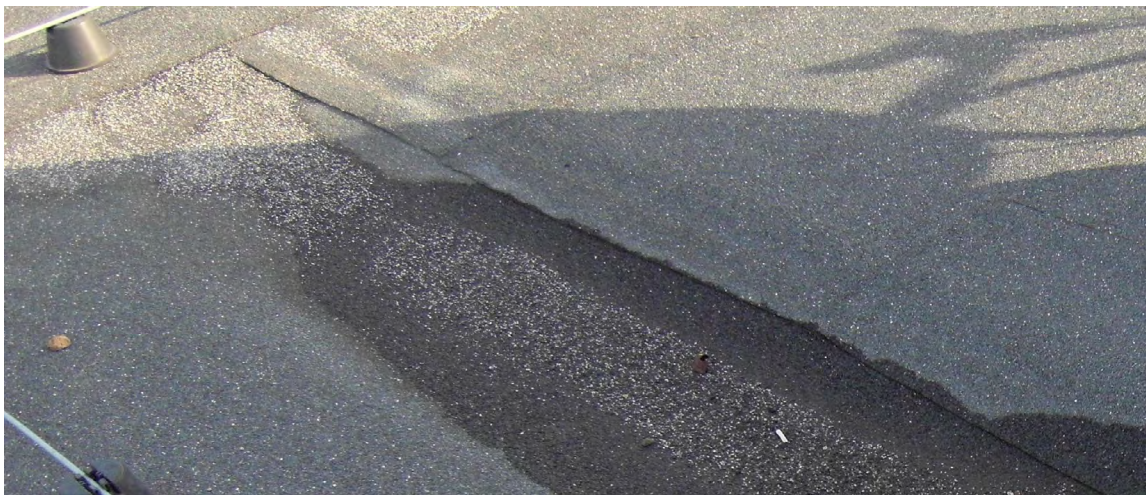
**Figure 5.** Accumulation of released granules (roof after one year of operation)

Analysis of released granules accumulation places and the impact on the destruction of these places; location of accumulation of unbound granules; phenomena occurring at places where pellets accumulate; the impact of these phenomena on the durability of roofing felt and roof.

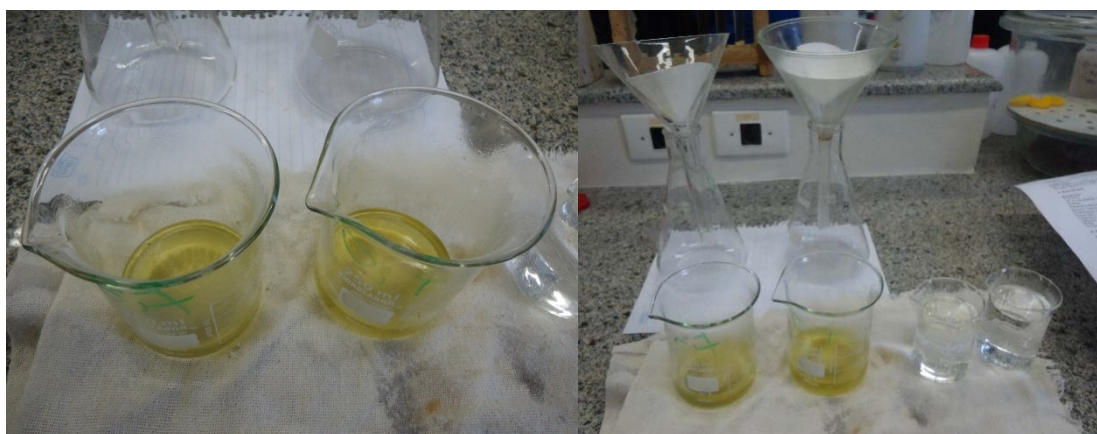
**Figure 1.** On the left the sample mixture with hydrochloric acid and on the right the filtered solution.

The samples were fully submerged in magnesium sulphate ( $\text{MgSO}_4$ ) solution of 10% for up to 70 days. The chemical test to determine the sulphate ions content in the samples was made according to an adaptation of the standard APHA Method 4500- $\text{SO}_4^{2-}$  (1997). The procedure consists to submit the ground sample, whose diameter is less than 600  $\mu\text{m}$ , to a solution of hydrochloric acid ( $\text{HCl}$ ), shown in Figure 1, with barium chloride ( $\text{BaCl}_2$ ), which will form a precipitate of barium sulphate ( $\text{BaSO}_4$ ), which after calcination at  $800^\circ\text{C}$  is heavy ( $M_{\text{calcined}}$ ).

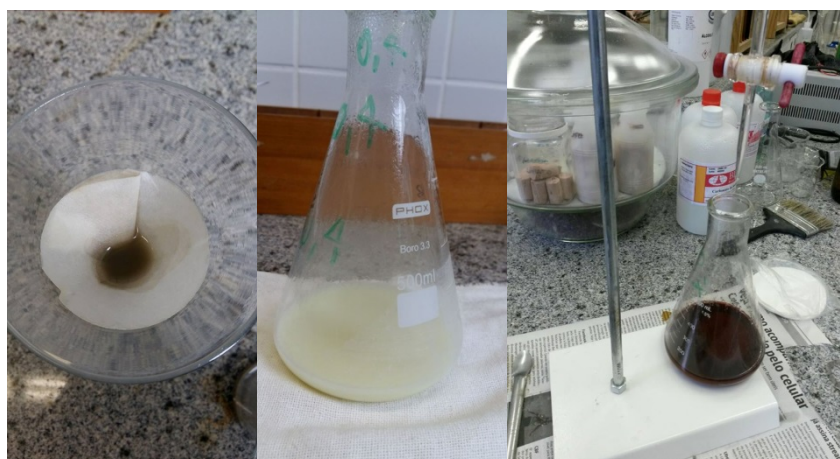
**Figure 2.** Silver chloride solution filtration and coagulation after boiling and then titanium ammonium titration.

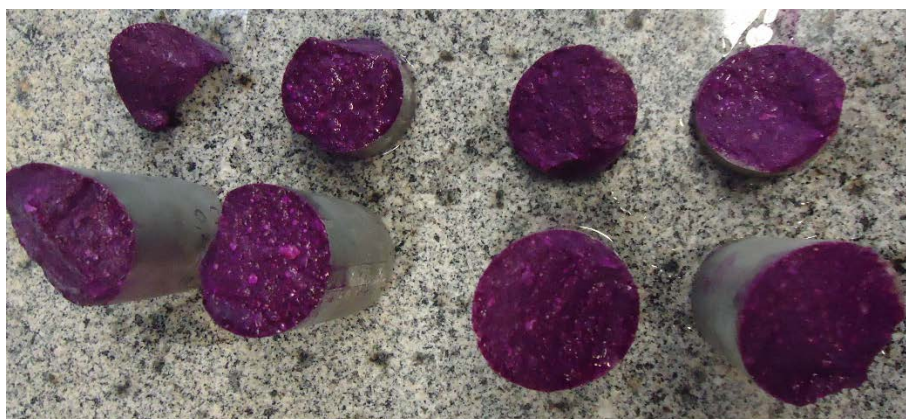
Figure 3 shows the color of the specimen when the phenolphthalein solution is sprayed.

**Figure 3.** Specimens submitted to the phenolphthalein spray test.

Carbonation tests were performed by cylindrical mortar samples. Phenolphthalein was used as test to carbonation penetration. It is in the initiation phase that it was intended to verify the occurrence of carbonation, because generally the typical appearance of carbonation is the occurrence of light spots produced by refraction of calcium carbonate, it is necessary to verify the carbonation using colorimetric indicators that point the pH. The lower the pH, the lighter its appearance, tending to colorless in the less alkaline regions. A non-carbonated concrete in the most alkaline region turns purple when using this same indicator. The most commonly used carbonation or pH indicator is the phenolphthalein solution or equivalent, being successfully used for pH between 8 and 11.

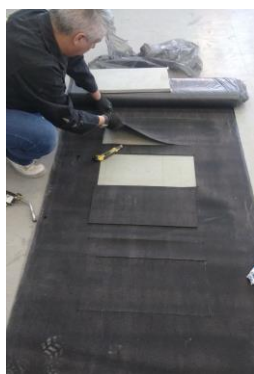
**Figure 1.** Preparation of Bituminous sheet.

The waterproofing systems were applied to the previously prepared substrate. The application process differs when the material is prefabricated or molded on-site. The membranes were applied using a brush and the material quantity is controlled by weighing it on a precision scale (0.01 g). For thickness control, a measurement was performed using a wet layer thickness gauge (25 to 3000 µm). Figures 1 to 4 demonstrate the procedure for specimens preparation.

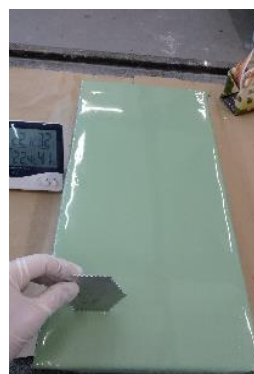
**Figure 3.** Application of Polyurethane membrane and inspection the thickness.

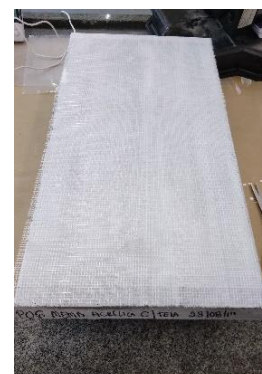
**Figure 4.** Application of the Acrylic membrane with polyester mesh.

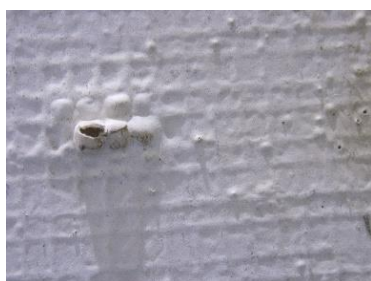
**Figure 5.** Air bubble disrupted and microporous in the Acrylic membrane with mesh.

Figures 5 to 10 illustrate the visual observations made in the test specimens throughout the 16 cycles. The visual inspection shows the occurrence of microbubbles, air bubbles, apparent pores, melting and debonding.

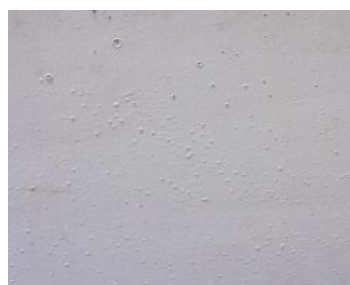
**Figure 6.** Microbubbles and microporous in the Acrylic membrane.

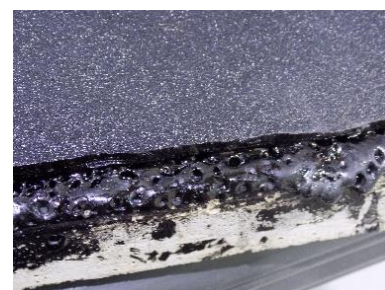
**Figure 7.** Increase in viscosity (melting) and microbubbles in the asphalt cement between the bituminous sheet and substrate.

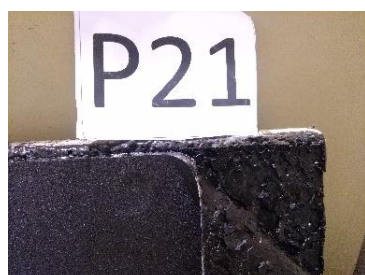
**Figure 8.** Debonding of the bituminous sheet of the substrate with increase the temperature.

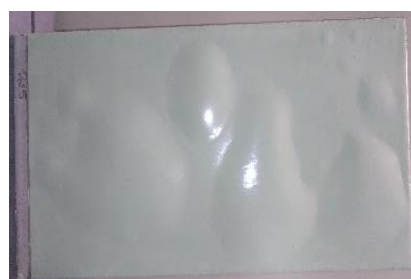
**Figure 9.** Air bubble in the Polyurethane system.

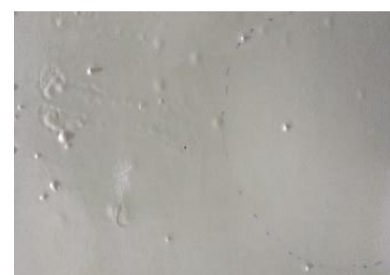
**Figure 10.** Microbubbles and apparent porous in the Polyurethane system.

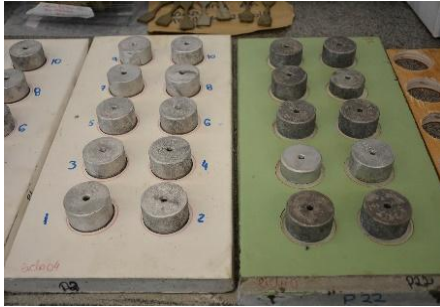
Figure 11. Preparation of the samples to the pull-off test.

The adhesion strength was measured using pull-off tests that were performed at the end of each wetting and drying cycle. Figures 11 to 12 demonstrate the preparation and performance of the test.

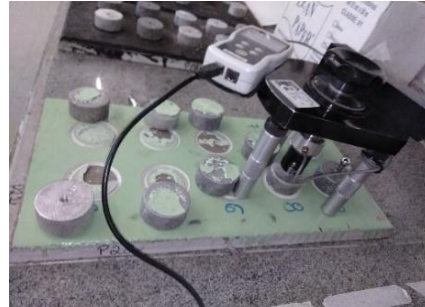
Figure 12. Pull-off test in the polyurethane membrane.

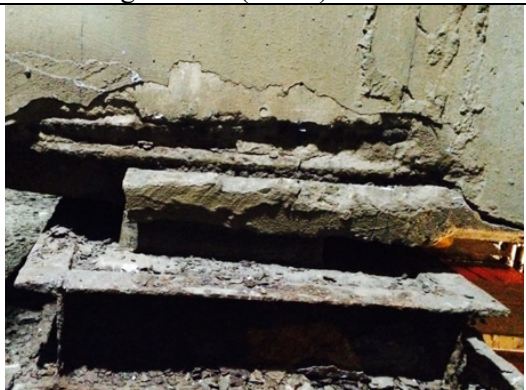
Pathological Manifestation - Cradle Degradation (Plinth)		
Pathology	Anomaly around the support apparatus, but caused by malfunction of the element.

Risk	Critical risk - severe pathological manifestation with compromised structural safety	
Cause	From a malfunction of the supporting bond between the superstructure and the mesostructure of the elevation.	
Treating	The treatment, in addition to the replacement of the support apparatus, should include reinforcement of the plinth with its repositioning at the bottom, called the cradle. As said, in neoprene support devices, it is not common to perform maintenance and treatment interventions on the element, but rather its immediate replacement.

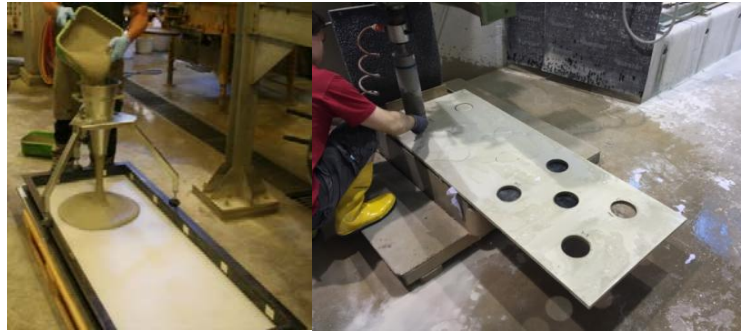
**Figure 9.** Concreting of test samples (left) and core extractions (right) to assess the self-cleaning properties.

In a further step the impact of the application of the hydrophobing agent and the flow behavior on the hydrophobicity of the concrete surface was assessed by concreting samples sized 160 x 60 cm. Within the test series the hydrophobing agent was applied in different

amounts 160 g/m<sup>2</sup> and 80 g/m<sup>2</sup> (active ingredient content 80 g/m<sup>2</sup> and 40 g/m<sup>2</sup>) and dilution with water (1:1, none) to the silicon mat at the bottom of the formwork in two different ways (spray and roller application). Maximum 5 minutes after the application of the hydrophobing agent the concrete was cast using a conical discharge hopper positioned 40 cm from the rim of the formwork (Figure 9, left). The formwork was stripped after 24 hours and the elements were stored for 14 days at 23°C and 50 RH. Afterwards 11 cores with a diameter of 10 cm were drilled out of the element (Figure 9, right) and after cleaning with rinsing water stored for another week at 23 °C and 50 RH before the contact and slope angles were measured.

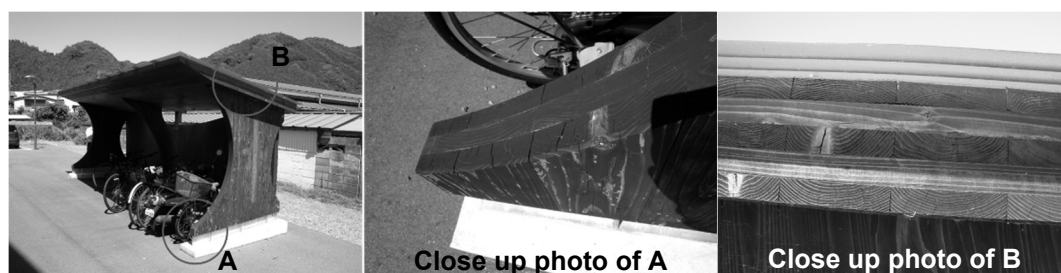
Figure 1 shows a bicycle parking space constructed with CLT panels for their walls and roofs. To protect the CLT panels from the sunshine and rain the panels were painted by some impregnated paint designed to protect wood from the outdoor climate. A certain number of check and shake was observed at the bottom of the wall panels and at the roof panels. And warp and delamination were also observed at the edge of the roof panels. The moisture, rain drop and sunshine (i.e. ultra-violet wave) may have caused these distortions.

**Figure 1.** Deformation of CLT exposed to outdoor climate (Bicycle parking space).

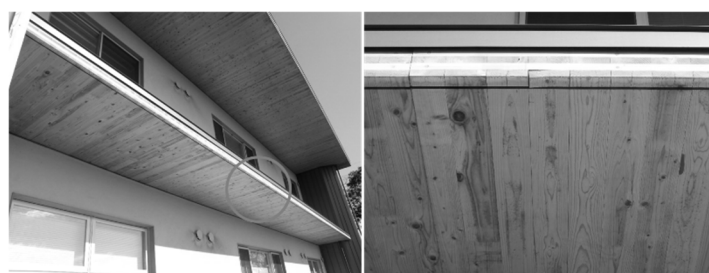
**Figure 2.** Deformation of CLT exposed to outdoor climate (Eaves of CLT flat roof).

Figure 2 shows the eaves of the CLT flat roof. As the edge of the panels was not covered with weather protecting materials such as steel sheet materials or ceramic boards the edge of the panels was fully exposed to the weathering force. And the panels had damages such as check and shake, warp and delamination.

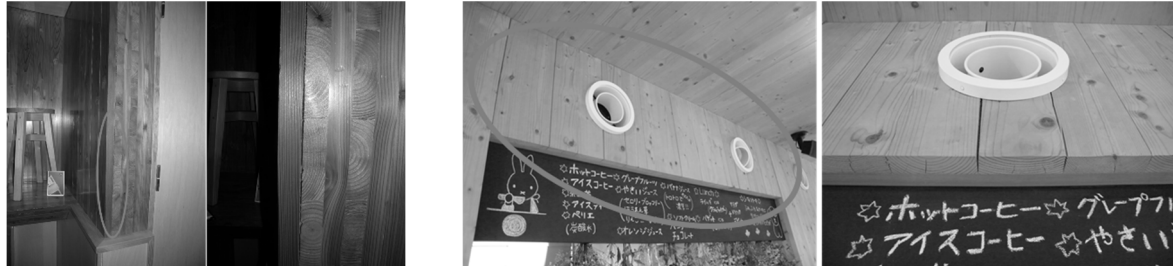
Figure 3(a) shows the delamination of the lamination of CLT panels used for the indoor partition wall. Figure 3(b) shows the check and shake and warp of the surface lamination of the CLT panels located close to the outlet of the air conditioner. The shrinkage of the surface of the CLT panels may have caused these types of distortion.

(a) Delamination of the surface lamination.

(b) Check and shake of the surface lamination.

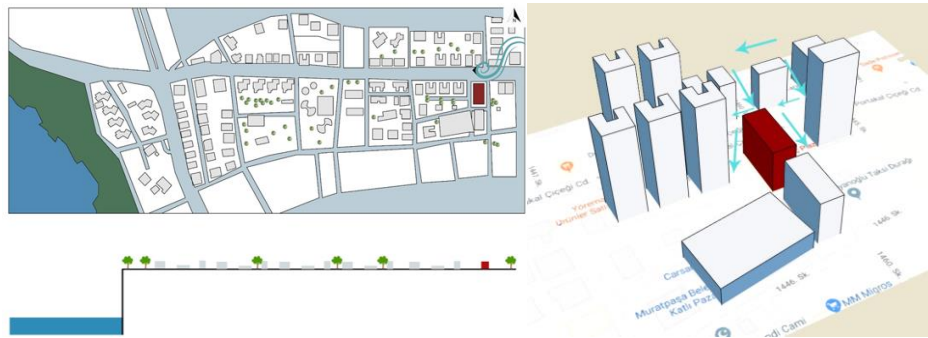
**Figure 3.** The site plan, the section of the site (on the left) and dominant wind direction and the movement around the building (on the right).

Antalya has a hot humid climate with rainy winters. The dominant wind direction is from northeast to southwest (Figure 3). The temperature changes 10°C to 35°C through the year. October, November and December are the months that take most of the rainfall (Holiday-weather, 2018).

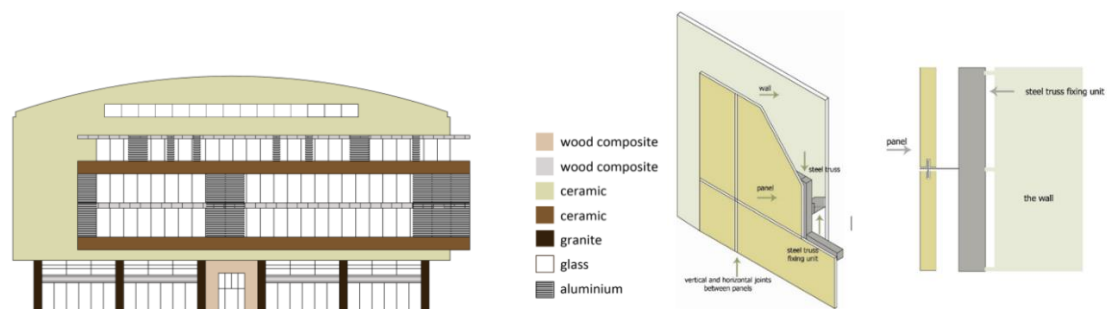
The six-storey office building is three years old. It has a rectangular form with the dimensions of 42.50 meters to 18.95 meters. The height of the building is 18.60 meters. The facade materials of the modern designed building are ceramic, aluminum, glass, granite and wood composite (Figure 4). The properties of the materials can be seen on Table 1.

**Figure 4.** Facade materials of the building and the structure system of the materials.

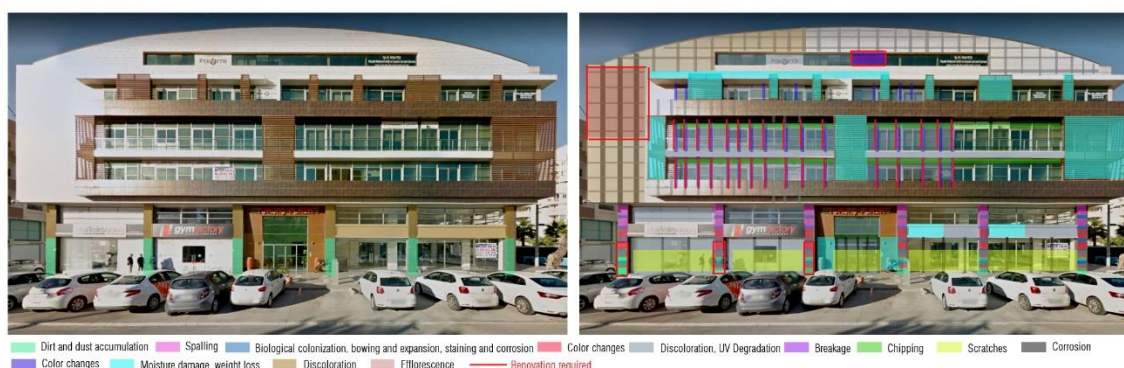
**Figure 5.** Facade of the building (on the left), facade of the building in 30 years (on the right).

The panels would be affected by the temperature. It is clearly seen that no expansion joint was used, either vertical or horizontal. This may cause cracks and/or breakage even falling of the panels. Corrosion may occur on the metal structural supports and anchors of ceramic tiles (Campante and Paschoal, 2002). The panel joints may easily take water and air inside of the structure. Color changes create visually improper aesthetic that can be seen on the ceramic tiles (Song and Lim, 2016). The reason of this can be dirt deposition which comes with the wind. Biological agents may use wood as a food source or for living with the help of water intake from the cracks or joints. This may cause weight loss of the panel (Morrell *et al.*, 2010). The WPC's on the east facade can easily take water from the rain. It is clearly seen that air pollution

The method presented in this paper was developed as a tool for the prediction of the service life of building components. Deteriorations have been analyzed by a systematic approach using environmental analysis, visual observations and literature review. It is clearly seen that, deteriorations on the facade of the building will occur in the future (Figure 5).

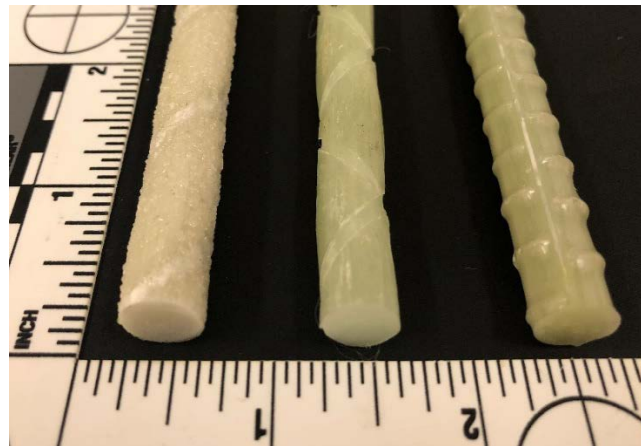
Three types of GFRP bars, denoted as A, B and C, were tested for comparison purposes due to diversity of the products in the GFRP rebar market (Ruiz Emparanza, Kampmann and De Caso Y Basalo, 2017). All tested bars in this study had a nominal diameter of 10-mm and were made of continuous EC-R glass fiber and impregnated with a vinyl ester resin. However, the manufacturing process and surface enhancements varied among them: Type-A bars were sand-coated, Type-B were helically wrapped, while Type-C were ribbed (see Figure 1).

**Figure 1.** GFRP rebars Type A, B and C (from left to right).

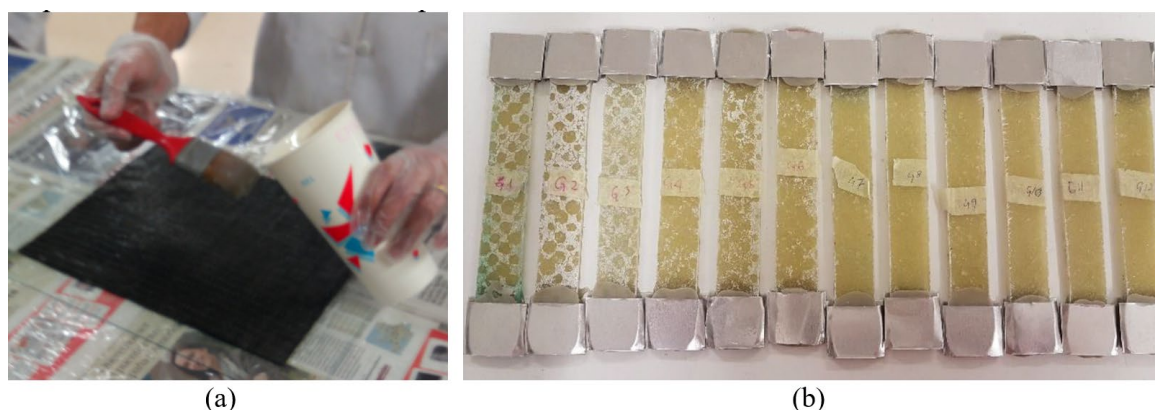
All immersed samples were subjected to an imposed electrical current according with (International Standardisation Organisation, 2017) which corresponded to 2.4mA for CFRP samples and 20mA for GFRP samples. Immersion lasted two weeks. Surface of GFRP specimens showed different coloring depending on the treatment as presented in Figure 1(b).

**Figure 1.** (a) CFRP production and (b) GFRP specimens state before tensile tests; from left to right supply water, wastewater, chlorinated water and untreated.

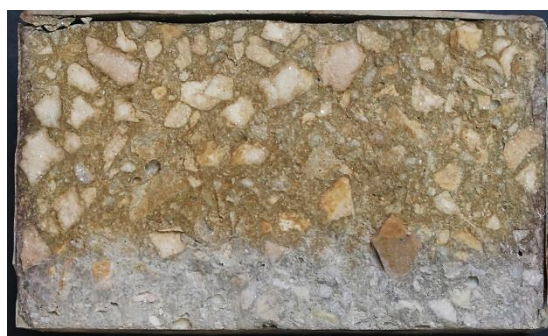
(a)

A colorimetric technique was used to evaluate the chloride penetration profiles on the split surfaces of different cracked and uncracked concretes. Figure 3a and 3c show, as an example, the chloride penetration profile in PLC uncracked and cracked specimens respectively, after 32 days of exposure. The penetration depths in different points after 32 days of exposure for the three cement types are reported in Figure 3b for sound and 3d for cracked configuration.

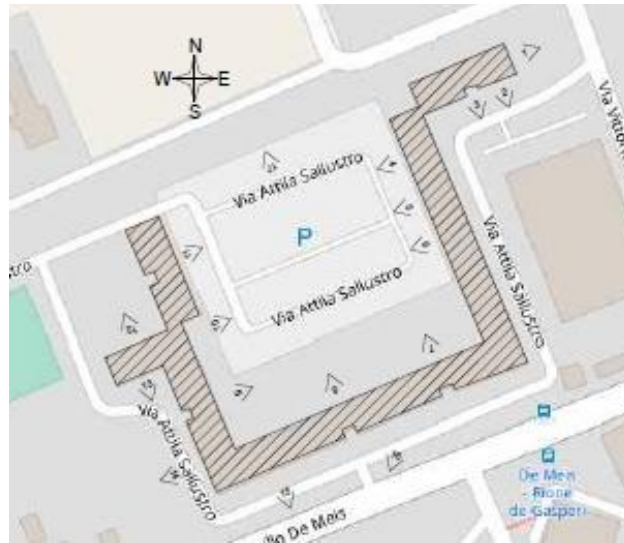
Figure 1 shows the distribution of the optical cones of the thermographic and photographic frames, numbered from 1 to 17; for each of them, 3-5 shots have been taken.

**Figure 1.** Distribution of the optical cones of the thermographic and photographic frames.

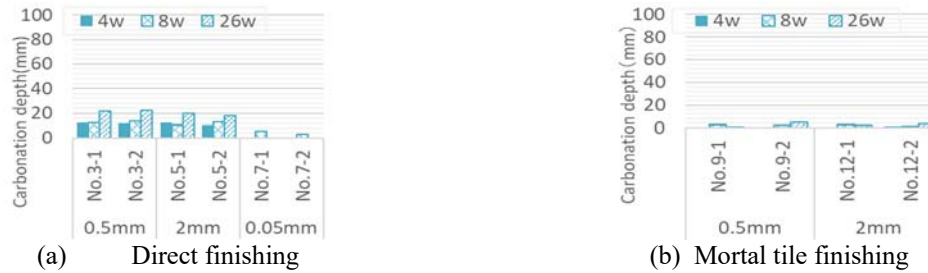
(a) Direct finishing (b) Mortal tile finishing  
**Figure 4.** The carbonation depth on y-y' and z-z' cut side of the repair case.

of the direct finishing, the carbonation depth at 4, 8 and 26 weeks were 7~13mm, about 12mm, and 16~24mm respectively. Also, it were under 3mm, 4mm and 6mm respectively in case of the mortal tile finishing.

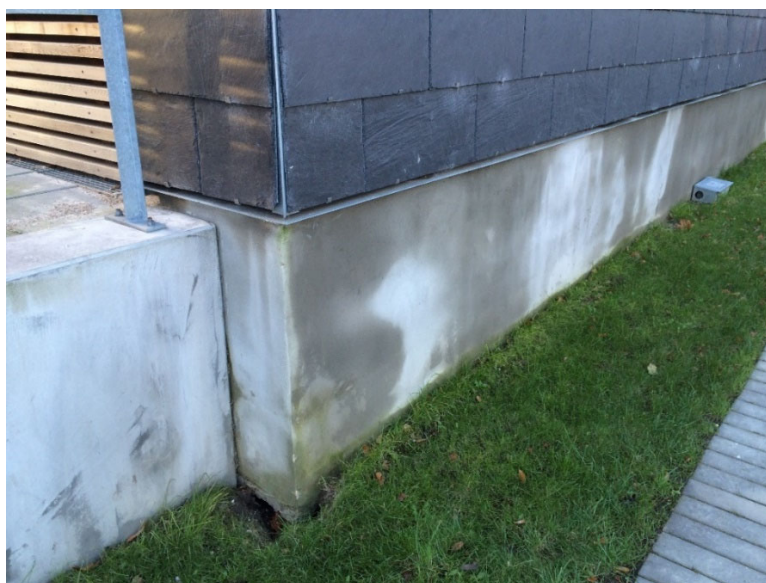
The boards contain MgO, which is a salt with a relatively low equilibrium moisture content, taking up moisture from the surrounding air when the relative humidity is high. Once saturated, the boards release salty liquid (Figure 1) that make screws, fittings and staples corrode and eventually initiate wood rot in surrounding wooden elements. In the longer run, the boards may disintegrate and lose their fire resisting, wind protecting and stabilizing properties. The Danish Building Defects Fund (2015a) declared promptly that they would not cover new claims related to building projects using MgO containing boards. They had by then been used in almost 20.000 social housing homes in Denmark and in an unknown number of single-family homes, private housing, schools, day care centers, hospitals, and industrial and commercial buildings. The cost of replacing boards alone in social housing dwellings has been estimated to around 1 billion DKK (Danish Building Defects Fund, 2015b).

**Figure 1.** Wetting of a concrete foundation revealing that salty liquid has been released from MgO boards in the above lightweight external wall. Photo: Tommy Bunch-Nielsen.

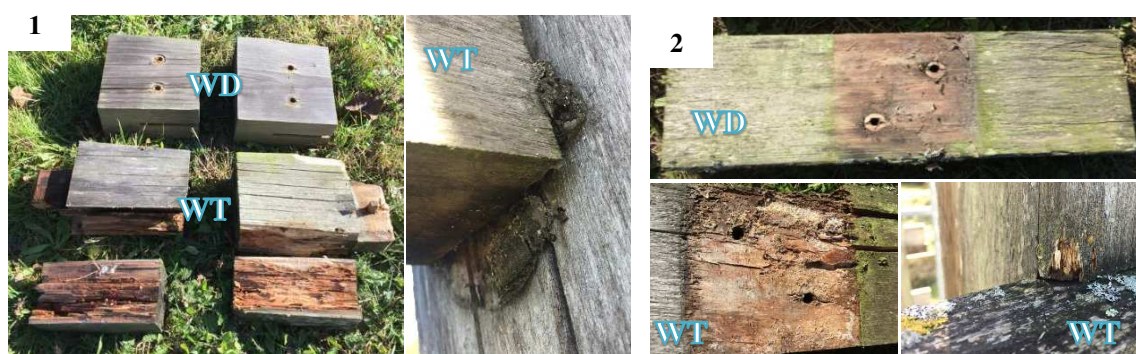
Several wooden elements connected to the posts were affected by superficial decay (larch, maritime pine, poplar and spruce), located mostly on their upper part and/or in sapwood parts.

**Figure 3.** Poplar posts connected to beams in Charrey-sur-Saône, France.

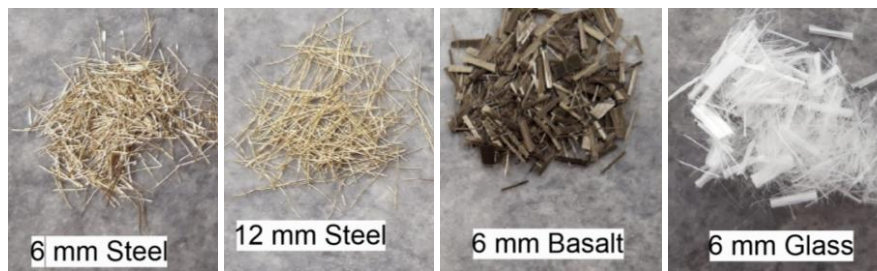
Alkali activated slag mortar (G1) was made with ground granulated blast furnace slag (GGBFS) which was obtained from Finnsementti, Finland. Granules of anhydrous sodium metasilicate (SS, 1 mm size) with  $\text{SiO}_2/\text{Na}_2\text{O}$  ratio of 0.9 was procured from Alfa Aesar. SS was mixed with GGBFS in the ratio of 1:9 and co-grinded in a ball mill for 30 mins. Four different fibers were used in this study (Fig. 1). Table 1 lists the properties of these fibers. Fiber reinforced mortar can be identified by a nomenclature that G1S6 represents G1 mix with steel fiber of 6 mm length. Similarly, G and B were used for glass and basalt fibers, respectively. Additionally, a mix with combination of 6 mm and 12 mm steel fibers in the ratio of 1:1 (G1SM) was made. Deionized water was used for mortar production.

Figure 1. Different type of fibers.

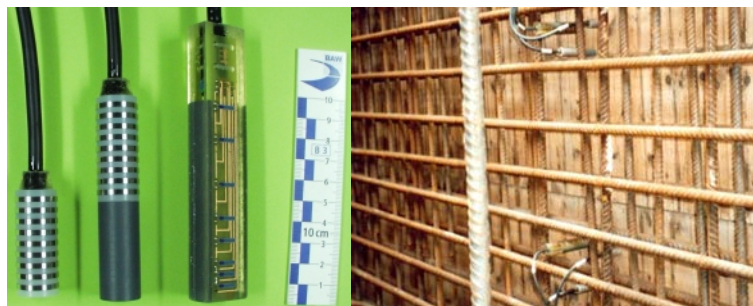
The resistivity measurement was conducted using a multiring electrode (MRE). The MRE is a sensor consisting of several rings of stainless steel, each with a thickness of 2.5 mm, with an insulating plastic ring between two steel rings. It enables AC resistance measurements of the concrete between two adjacent steel rings in eight steps at a frequency of 10.8 Hz and at a distance of 7 to 87 mm to the concrete surface (Raupach, 1992). A multitemperature probe (MTP) is installed near the MRE. The MTP is equipped with eight PT 1000 sensors to enable temperature measurements at eight different distances to the concrete surface. A typical arrangement of a measuring point is shown in Figure 1.

**Figure 1.** MRE and MTP (left), Sensor installation in a structure (right) (Spörel, 2019).

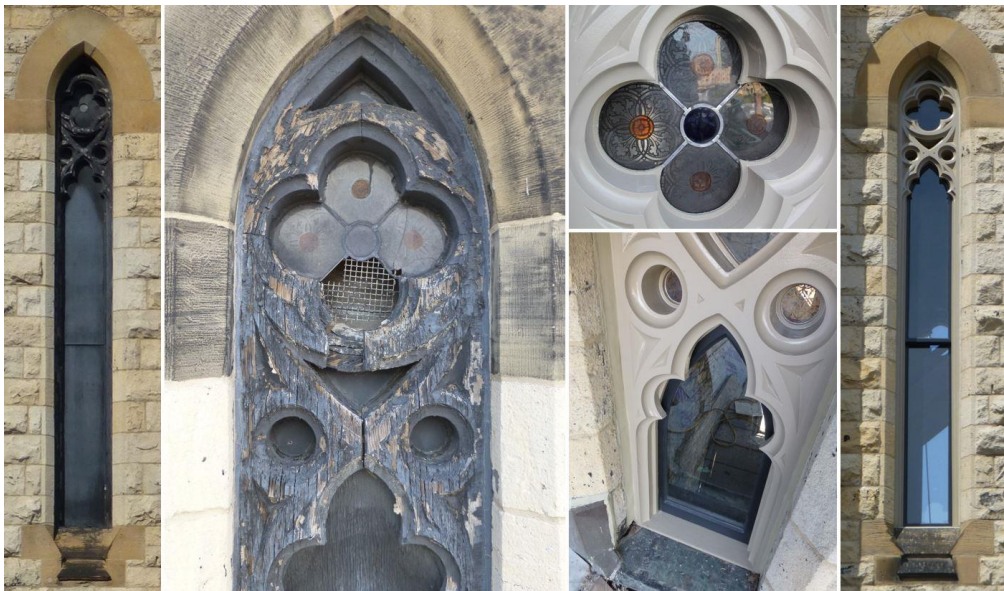
**Figure 1.** Typical window conditions before (left) and after restoration (right).

The exterior evaluation of the windows was performed from an aerial lift, which allowed access to all of the tower windows. The surfaces were probed with an awl, but no investigative openings were created. On the interior, access was limited based on the proximity of an interior stair. Conditions included wood decay at various exterior locations including sills, the base of jambs, and at decorative tracery. Several of the sash were missing, and the frames had been boarded up. Portions of the leaded art glass were broken or missing. Since the windows were likely built on site during construction, no original drawings or specifications existed.

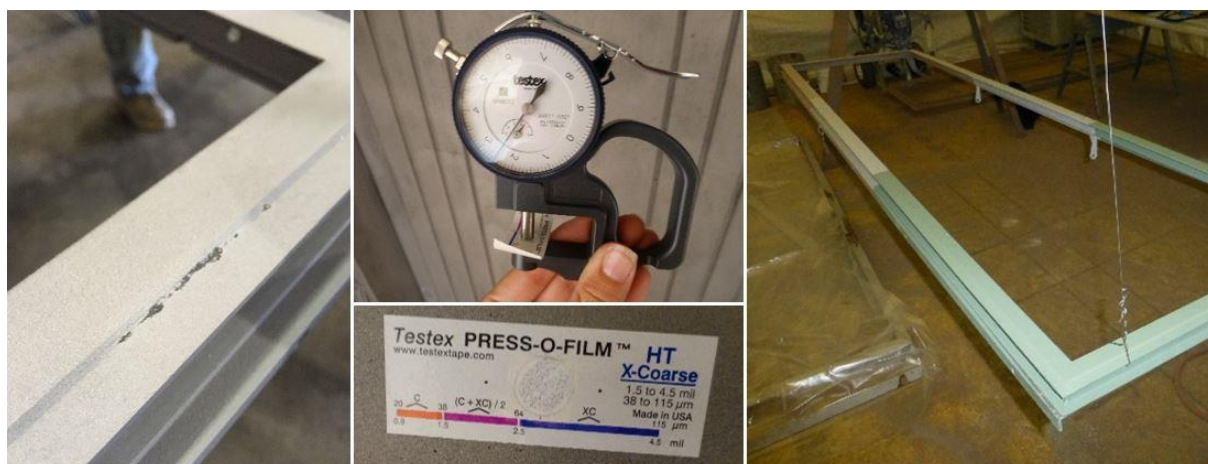
**Figure 4.** Steel frame blasting and surface profile measurement (left and center); coating mockup (right).

Several challenges were encountered at the beginning of the project that had to be resolved. Hazardous materials were found in concealed portions of the window assembly that required remediation. In addition, the weather-stripping had to be custom fabricated, as an off-the-shelf product replicating the profile could not be located by the contractor. A comprehensive quality control and quality assurance program was also established that included inspection and surface profile measurements of the window frames following blasting, and coating thickness measurements following each layer of coating application.

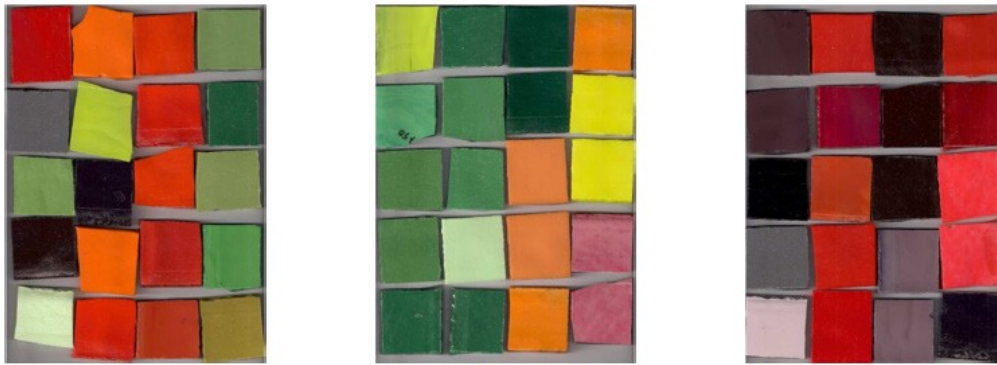
The JPG files corresponding to the scans of the groups of 20 glass samples and the subsequent edition of the images of the individual samples have been treated with the software "Adobe Photoshop CS6 version: 13.0.1 service pack: 1". The result of this work was the images of individual pieces, making a distinction between the two faces of each piece and calling them "sight" for the face generated by having a work view (face A), and "hidden" for the face generated to be arranged in contact with the mortar (face B). Generating jpg files of 1146 x 1146 pixels and a horizontal and vertical resolution of 600 dpi.

**Figure 4.** Overall images of the various image scanning processes with flatbed scanner (source: authors).

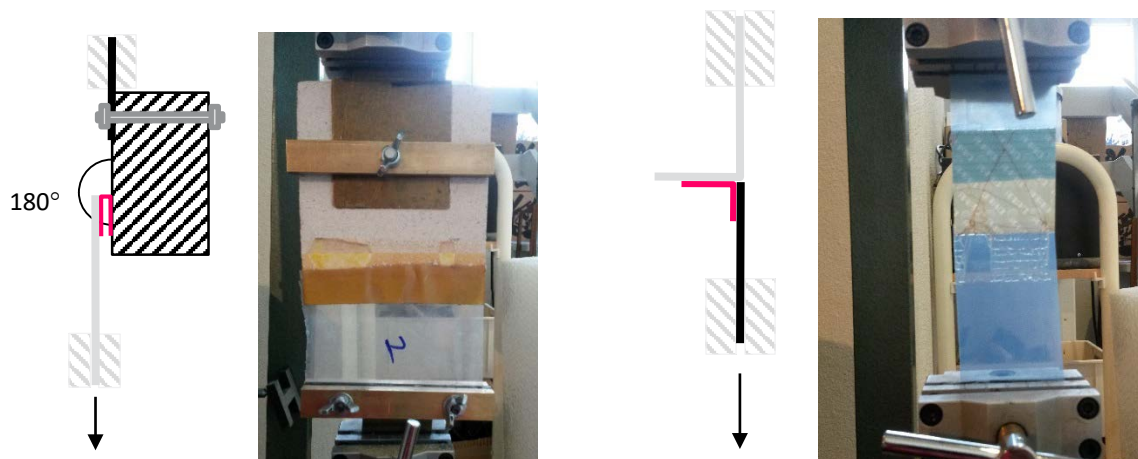
Peel resistance was tested on joints of two membranes and joints of membrane and aerated concrete (AAC). The tests were performed according to EN 12316-2:2013 that specifies how to test peel resistance of a joint between two pieces of a membrane. A sample was placed in a testing machine with the grips 200 mm apart. During testing the grips moved apart at a constant speed. The force used for peeling was recorded. The method was adjusted for the test with AAC because of the thickness of the AAC.

In addition, the speed of the tests was reduced from a separating speed for the grips from  $100 \pm 10$  mm/min to  $10 \pm 1$  mm/min. Samples used for membrane/AAC tests were approx. 14 cm wide instead of the standardised 50 mm, that were used for the membrane/membrane joints. The measured force was converted to the equivalent force for 50 mm samples. Figure 1 shows the principle of the tests as well as pictures from the testing. Five samples were tested for each material combination.

**Figure 1.** Test of peel resistance, sketch from the side and photo from the front. Left: Membrane taped to AAC. Right: Two pieces of membrane taped together.

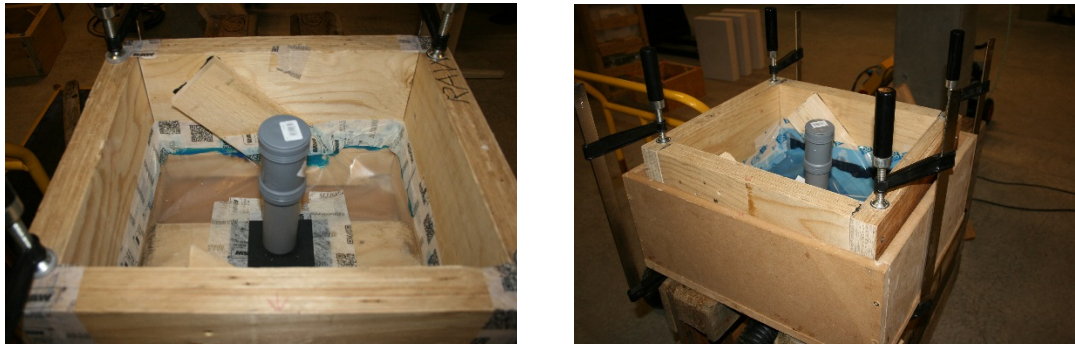
The test of airtightness was not a standard test but a test especially invented to simulate conditions in an older attic where it would be difficult to establish an airtight barrier. The aim was to test airtightness before and after artificial aging. The method is described in (Møller and Hansen, 2017). In short, it consisted of a wooden frame supplied with angled boards and a pipe in the middle. The inside of the frame was lined with the membrane to be tested and fixed to the frame with the system's tape. To secure airtightness around the pipe the system's collars were used and the pipe sealed. The frame was placed in a box leaving a small space between membrane and box, see Figure 3. It was ensured that the frame was airtight and so was the

connection between box and frame. Through a hole in the box a ventilator created a pressure difference between box and frame. The flow necessary to obtain pressurisation of 10, 22, 34, 46, 58, 70 and 82 Pa was recorded. The test was repeated three times and again three times with the same negative pressure differences. By linear regression, the results from the different pressure differences were combined to a single value for a pressurisation of 50 Pa. The test was inspired by the blower door test (EN/ISO 9972: 2015). After 164 days of artificial aging, the tests were repeated. One frame of each system was tested.

**Figure 3.** Test equipment for test of airtightness. Left: wooden frame with lining of membrane taped to the frame, pipe with collar in the middle. Right: wooden frame placed in box, a ventilator created a pressure difference between frame and box through a hole in the box (not visible on photo).

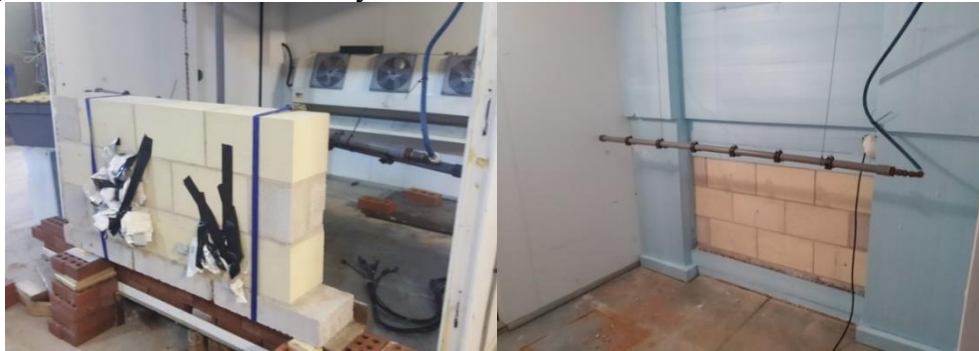
**Figure 1.** Test wall installed into climate chamber for frost testing.  
1a. Exterior, prior to installation. 1b. Interior, after sealing.

surrounding chamber using polystyrene sheeting and were sealed to prevent water ingress from above or around the sides of the panels (Figure 1). Chamber conditions were verified by test run with the wall in situ to confirm thermal performance. Testing commenced as soon as chamber conditions were confirmed. A study of data from the Meteorological Office suggested that a moderate frost cycle should be utilised. Chamber temperatures were initially set at  $-4$  but the frost front did not penetrate deeply enough into the stone to initiate damage (Laycock, 1997). It was therefore incrementally lowered when the panel was in situ in order to ensure that the frost front passed through the block to a depth of 30mm and released during the thaw cycle. This regime was found in previous work on the Magnesian Limestone to cause damage. This resulted in a final cycle between  $+8$  to  $-10^{\circ}\text{C}$ , cooling and warming at  $0.45^{\circ}\text{C}/\text{min}$ , 2 minutes of simulated rain and 10 cycles per day. The chamber was maintained at  $-10^{\circ}\text{C}$  for 14 minutes. A total of 300 freeze/thaw cycles were carried out. Phase 2 repeated this regime with 9 blocks of Cadeby stone cut to the same sizes as before.

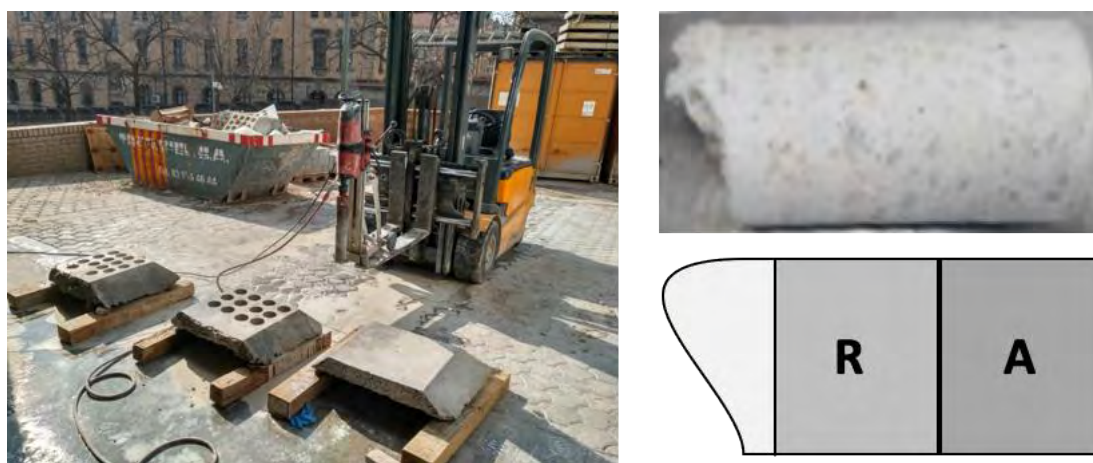
**Figure 1.** Extraction of sprayed concrete specimens (a) and division of samples into part A and part B.

Part A is the first layer, which under real conditions would have been in contact with the terrain. Part R is the second layer, which is adhered to the first layer and has a surface that was used to simulate exposure to open air.

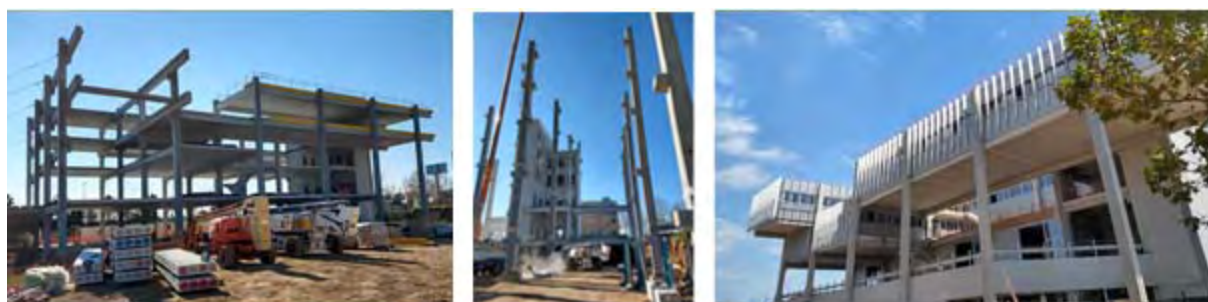
**Figure 2.** Prefabricated structure during the construction phase of the Socrates building.

The structure is constructed from a prefabricated concrete frame composed of 0,60m x 0,80 m pillars that span the full height of the building as a single element without vertical interruption in addition to horizontal beams with a section of 60 x 80 cm that connects to the vertical structure. Pillars are distributed across a 10 x 10-meter grid, with a 100m<sup>2</sup> free areas that guarantee the highest spatial flexibility for any tertiary and light industrial use. Prefabricated hollow-core slabs complete the horizontal enclosure and give structural stability to the frame.

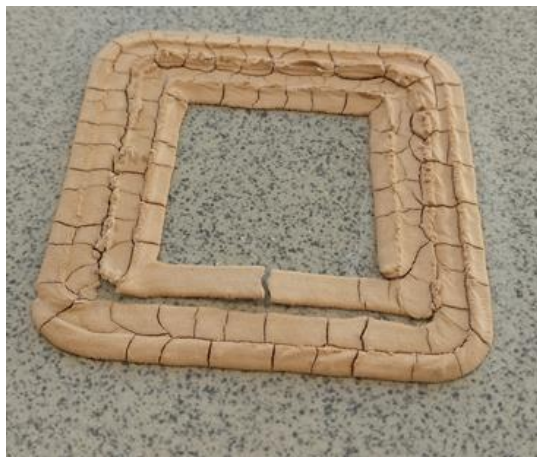
**Figure 3.** Samples after drying with visible cracks.

The other challenge was brittle material behavior after the curing time and cracking during the drying process (Figure 3).

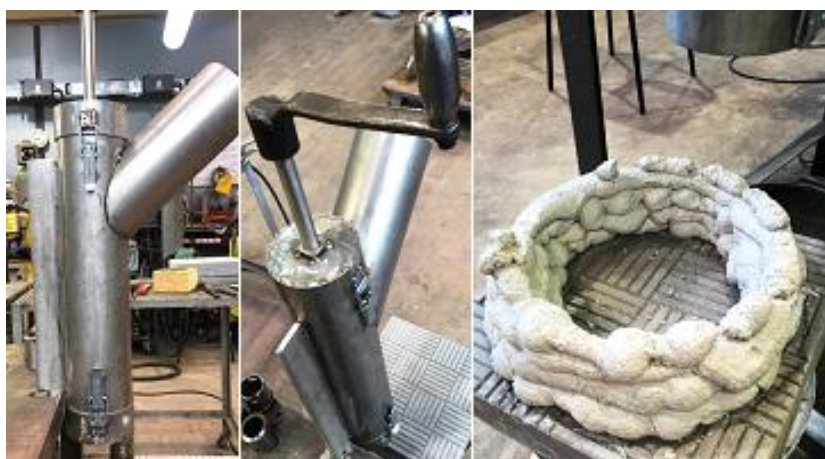
**Figure 4.** Self- produced manual 3D printing machine.

The other trials was performed on large scale samples made on the self-produced manual 3D printing machine (Figure 4). The construction given material using a rotating screw (own design for determining the optimal consistency and speed of material reproduction).

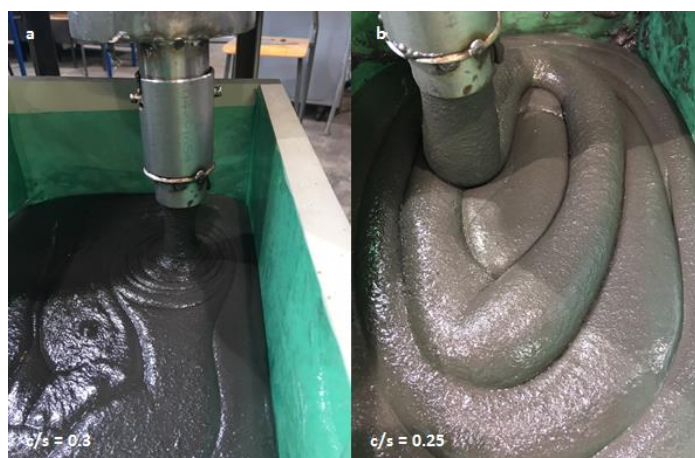
**Figure 5.** Samples after 3D printing with different liquid/solid ratio a) 0.3, b) 0.25.

The trials were conducted on the large form with using different ratio liquid and solid parts – Figure 5.

The achieved results did not fulfil the requirements. The samples produced with different kind of ratio were too liquid to application for building elements. The material need further modification.

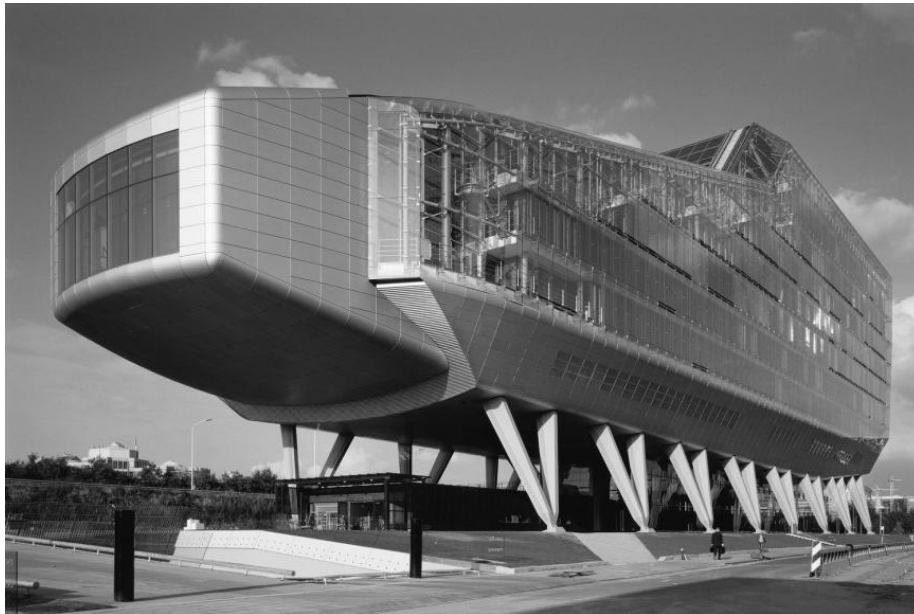
**Figure 1.** Headquarters ING Group, Amsterdam. MVSA Architects.

The external glass is hooked through 6 fixing points that guarantee the support of the façade by means of glass elements (thickness 20mm), bound to the floor by stainless steel components. The sheets of 1800 x 3300mm size, are made of tempered or tempered - laminated glass 12 or 19mm thick.

The sheets are separated vertically by silicon joints of 12mm; horizontally by a glass opening element with a height of 410mm for the ventilation of the facade. The internal facade is made up of inward opening wooden frames 950mm wide and 2900mm high. The cleanability and periodic control of the facade cladding is also guaranteed thanks to the accessible roof on the tenth floor. A system of tracks that runs through the entire building is designed to ensure a high level of inspection and maintenance: thanks to the installation of mobile trolleys on the roof, the easy cleaning of all the windows has been ensured.
