# **Current Topics and Trends on Durability of Building Materials and Components**

Proceedings of the XV edition of the International Conference on Durability of Building Materials and Components (DBMC 2020)

Barcelona, Spain

20 – 23 October 2020

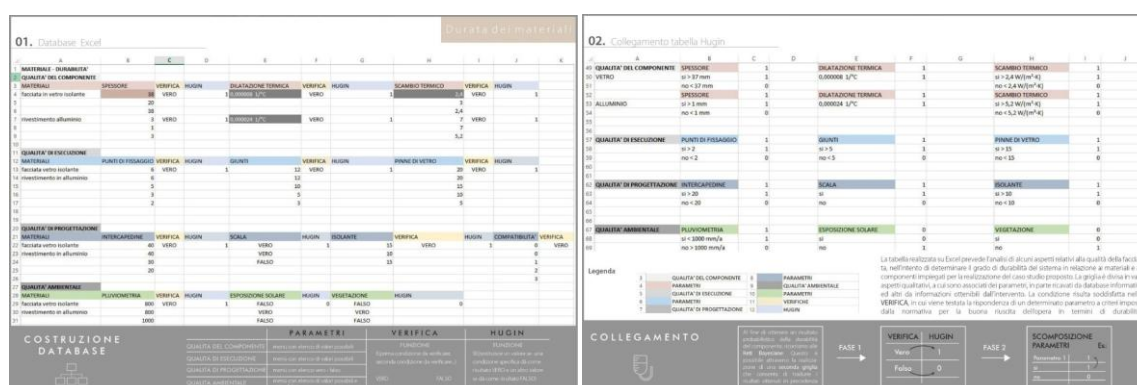
Figure 2. Database construction and data link.

The second step provides, in order to obtain the evaluation of the maintainability index, the use of Bayesian Networks. This consists in the realization of a second grid (Fig. 2) that allows to translate the parameters on Hugin (software for the use of Bayesian Networks).

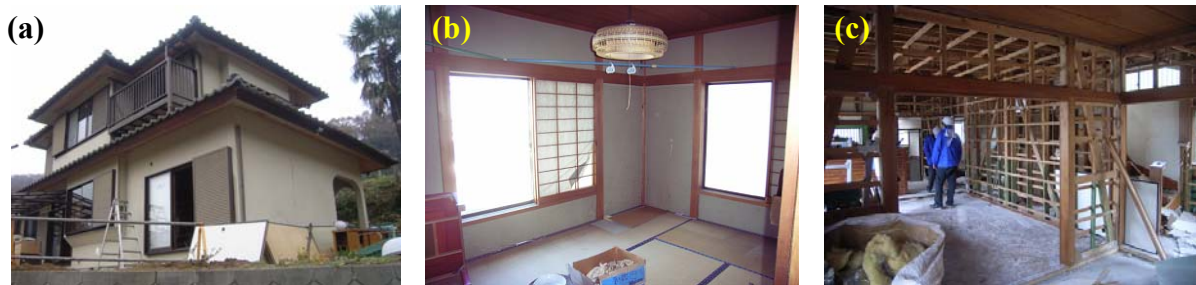
Photo 1. Overview of (a) inspected house, (b) appearance inspection and (c) bio-deterioration survey.

The bio-deterioration survey were conducted to all structural members after the removal of all sheathings and finishing materials (Photo 1(c)). The visual and tactile inspection were conducted to survey all structural members for bio-deterioration. The bio-deterioration includes the decay and the termite damage. The position and degree of the deterioration were grasped and recorded with reference to the above-mentioned manual issued by HOWTEC.

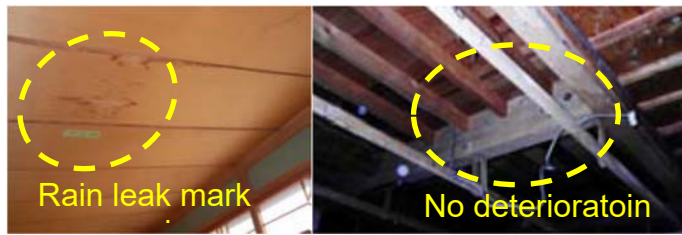
**Figure 8.** Not decayed structural member of floor system in 2F (right) in spite of the rain leak mark on the ceiling (left).

On the most of the dealing with the used houses, only the appearance inspection is conducted. So, the result of the appearance inspection needs to match the position of the bio-deterioration. However, the occurrence of the appearance degradation and the bio-deterioration of structural members were not the same, as mentioned above. For example, there was no decayed member in the 2<sup>nd</sup> floor system near the position of the rain leak mark on the ceiling of the 1<sup>st</sup> story found by the appearance inspection, as shown in Figure 8. And, the bottom of the column decayed even though no degradation were found by the appearance inspection, as shown in Figure 9.

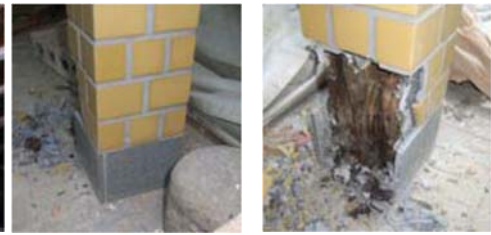
**Figure 9.** Decayed bottom of column (right) in spite of no degradation found by the appearance inspection.

Then, we analyzed the differences between the appearance degradation and the bio-deterioration of the structural members. The number of the segments with/without appearance degradation and those with/without the bio-deterioration of the structural member were subjected to the cross tabulation, as shown Table 3. It was clarified that there was no bio-deterioration in more than 90 % of segments out of all with the appearance degradation (e.g. Figure 8), and that there was the bio-deterioration in only 1.6 % of segments of all without the appearance degradation (e.g. Figure 9).

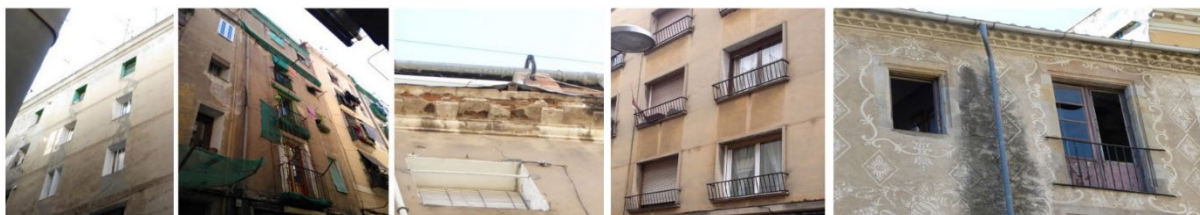
**Figure 2.** Fieldwork images of observed damages.

Firstly, this paper provides an analysis of a series of observed damages according to their relevance on the studied areas. The available data was obtained during a fieldwork campaign (Cornadó *et al.*, 2017) (Figure 2). The described damages are: cracks in bearing walls, façade buckling, risk of material detachment in facades and roofs, dampness (rising damp, moisture and rainwater leaks), degraded windows and woodwork, rusty metal elements, cracks in the facing, stains and dirt.

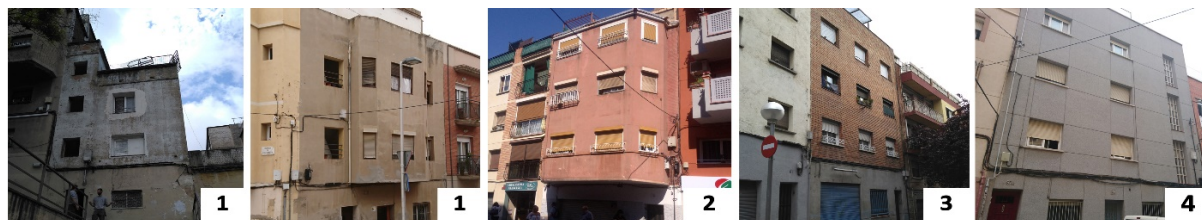
**Figure 3.** Fieldwork images of buildings with different results the need of rehabilitation indicator.

Secondly, this paper presents qualitative and quantitative indicators to statistically analyse the state of maintenance and conservation of the building stock: a qualitative indicator that describes the need of rehabilitation of the building stock obtained in a campaign of fieldwork (Cornadó *et al.*, 2017) (Figure 3), a quantitative indicator of the superposition of the previously described damages within one single building (Cornadó *et al.*, 2017), and finally a quantitative indicator of the existence of administrative requirements and orders of conservation provided by the Council of Barcelona (Garcia-Almirall *et al.*, 2017).

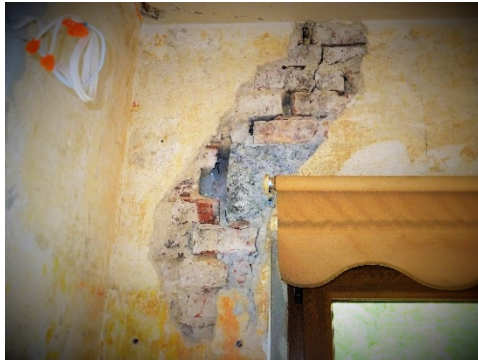
**Figure 2.** Cracks formed in a residential building in post-mining areas, around Bytom in Poland, 22/05/2011.

a dynamic phenomenon in the rock mass (rapid rock relaxation) is the emission of vibrations, *i.e.* the seismic shock effect. Shock (seismic) waves propagate to the surface, which induce vibrations of buildings (Fig. 2 &3).

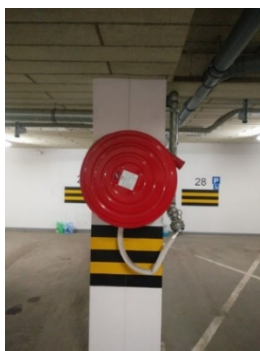
**Figure 4.** Fire extinguisher placed in the underground garage of a multi-family building 02/02/2016.

The next criterion for the assessed subcategory is  $K_{623}$  *Explosions*. In order to improve fire resistance, fire resistance of materials of higher classes than recommended can be used, which will improve the load-bearing capacity, integrity and / or insulation performance of building elements, improve access for fire brigades, make evacuation routes taking into account the needs of people with disabilities, install warning systems, smoke detectors, fire extinguishing systems in public areas, separate fire-cutting zones for the spread of fire, use fire-resistant products in places most exposed to fire (Fig. 4) (Phan, McAllister i Gross, 2010).

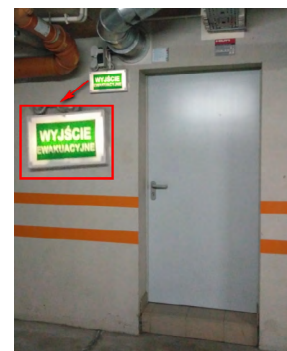
**Figure 6.** Emergency exit from the underground garage in a residential building 11/10/2016.

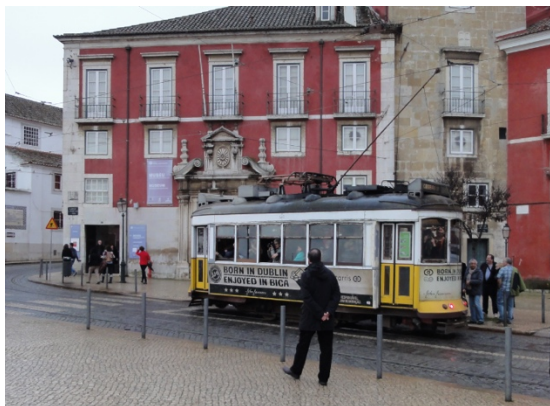
**Figure 7.** Tram line running right next to multi-family buildings, Lisbon 31/12/2015.

The last criterion in this subcategory is  $K_{624}$  *Resistance to dynamic external actions*, which can be implemented by applying measures for increased resistance to traffic influences, among which solutions such as: constructing barriers or strengthening the construction of building facilities located in areas at risk (Fig. 7&8).

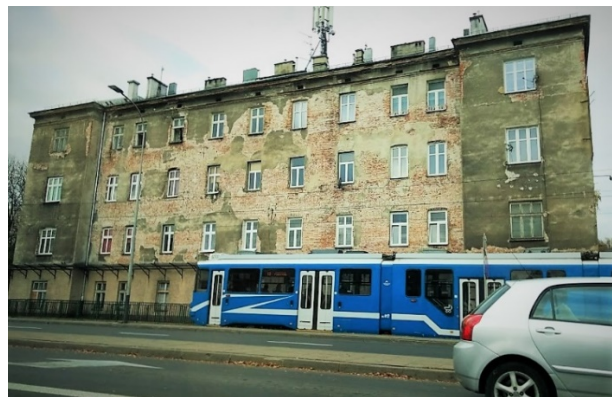
**Figure 8.** Tram line and busy two-lane road in the Borek Fałęcki district in Krakow, 25/10/2016.

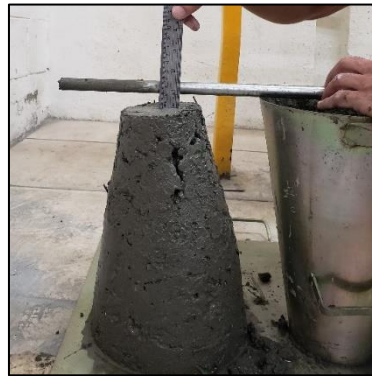
The fresh concrete test has showed the slump of the concrete cone specimen come was 90 mm for concrete without the addition of PET fibers, characterizing a rich concrete, while for the trait with 2% PET fiber, the slump was 20 mm indicating a poor concrete of very low workability, as shown in Figure 1.

**Figure 1.** Slump test of a concrete cone.

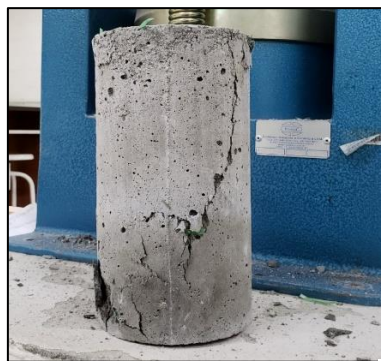
**Figure 2.** Specimen with PET fibers after cracking under axial compression.

According to Mheta and Monteiro (1994), in concrete with fibers, compressive strength is not the most important contribution of reinforcement. Figures 2 and 3 present the results of axial compressive strength according to NBR 5739 (ABNT, 2007). It can be observed that there was not much difference in the deformation presented by concrete with addition of PET fiber to concrete without fiber. Both presented type of D - conical and sheared rupture, as specified in Annex A of NBR 5739.

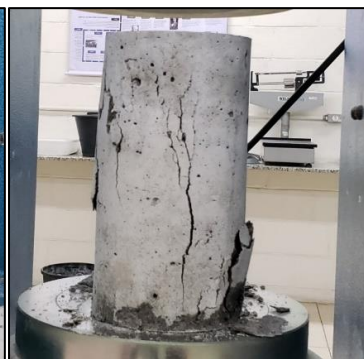
**Figure 3.** Specimen with no PET fibers after cracking under axial compression.

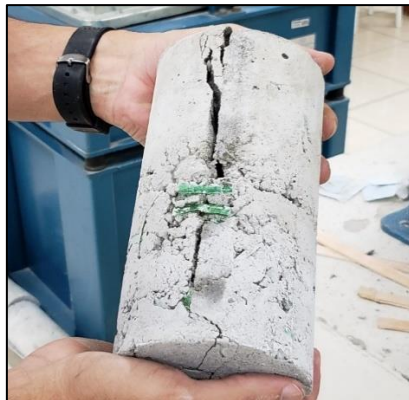
The Figure 5 illustrates the specimen with PET fibers after the diametric compression test. According to NBR 7222 (ABNT, 1994), it can be observed that the crack propagated easily at the top and with some resistance at the bottom, holding the parts together. Thus, an excess load is required to break it completely. However, this is not the case with concrete without the addition of PET fiber, where the crack propagated throughout the body and abruptly breaking it, as shown in Figure 6.

**Figure 5.** Specimen with PET fibers after cracking under diametral compression.

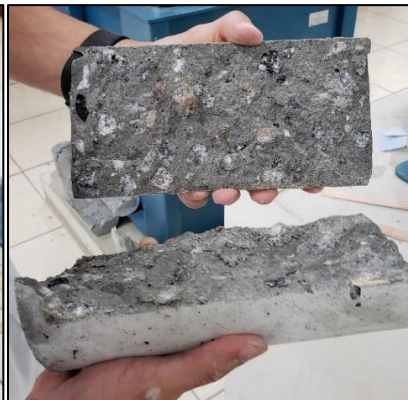
**Figure 6.** Specimen with no PET fibers after cracking under diametral compression.

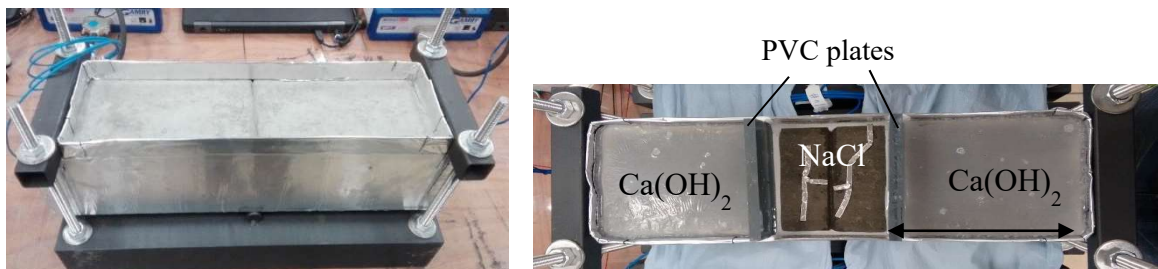
The prisms were placed with the crack facing upwards and the lateral surfaces were covered with aluminum butyl tape, extending beyond the upper surface of the samples, to create a basin with three compartments (Figure 2). The top (cracked) surface of the samples was exposed weekly to 1 d wetting and 6 d drying cycles for a total duration of 44 weeks. During the wet period, the central compartment was filled with a 33 g/l NaCl solution, while the outer compartments were filled with a 1.15 g/l  $\text{Ca}(\text{OH})_2$  solution.

**Figure 2.** Concrete prism mounted in a three-point bending test frame (left); Basins on the surface (right).

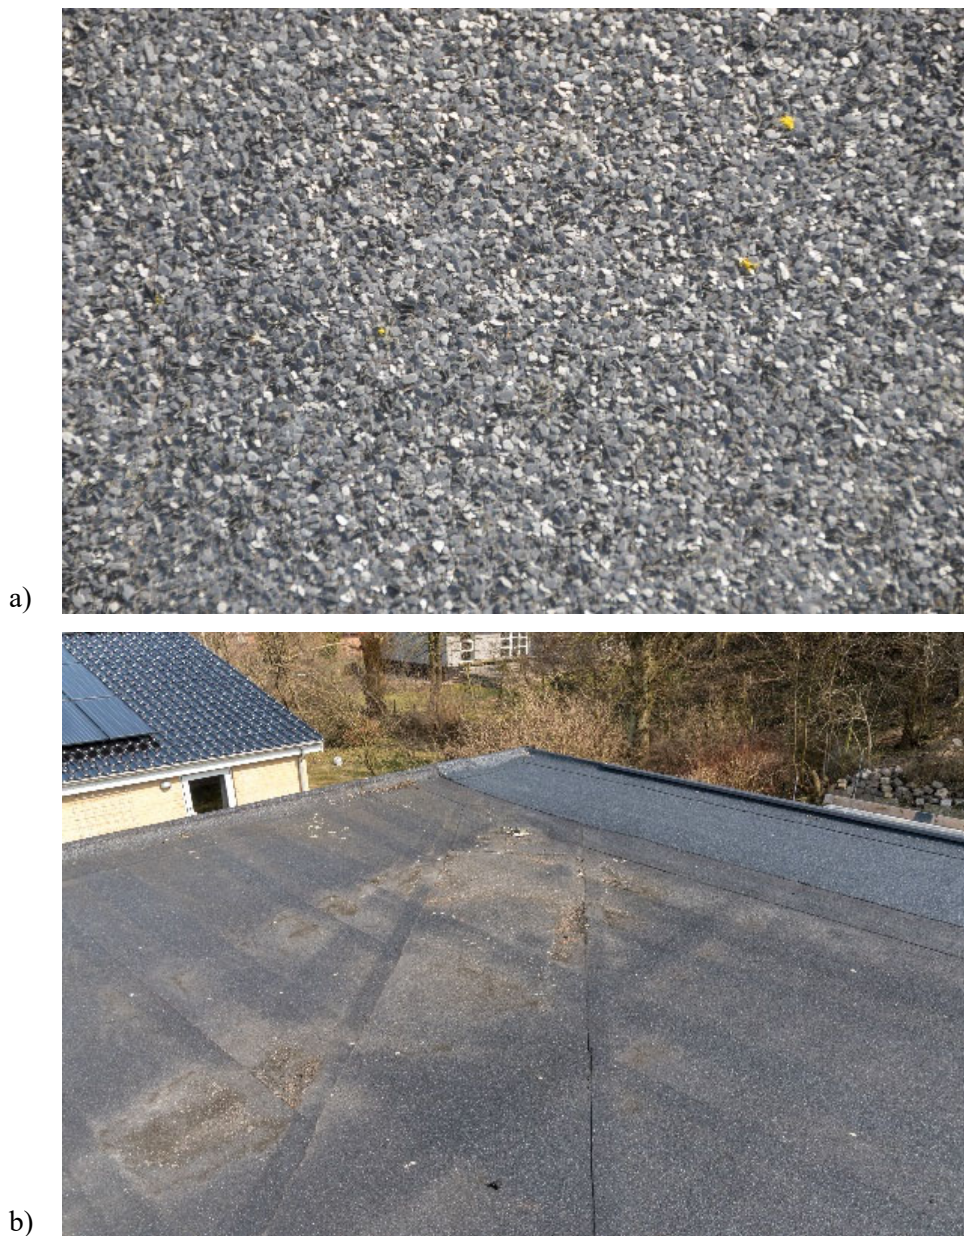
**Figure 2.** Roof condition at different points. a) Condition of slate is generally good as shown, b) roof valley in equal conditions as other parts of roof membrane.

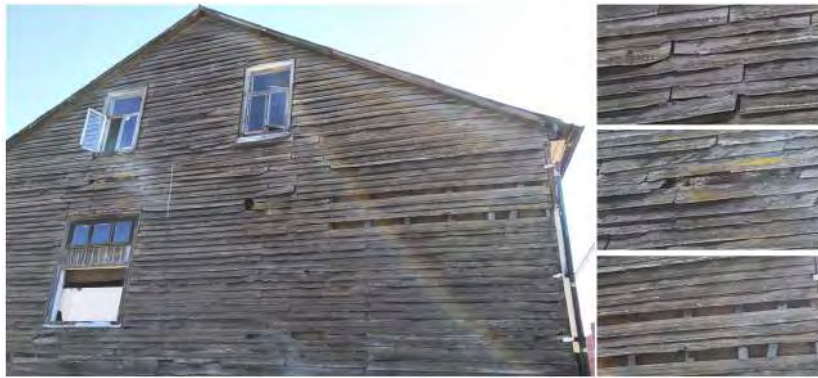
**Figure 1.** Case study that exemplifies the end of the service life of timber claddings.

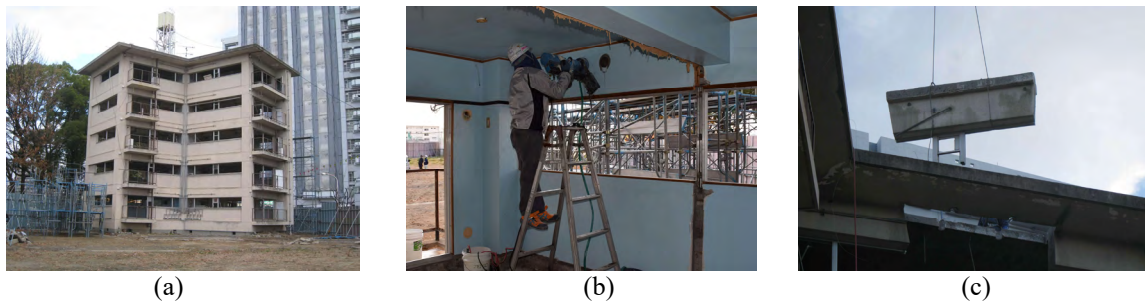
**Figure 1.** Existing building (a) comprehensive view of the test building; (b) concrete core boring; (c) cutting girder with a wire saw.
