## COMPUTER MODELLING AND SEISMIC PERFORMANCE ASSESSMENT OF A BYZANTINE BASILICA

**Keywords:** Unreinforced masonry building, Seismic assessment, Historic structure.

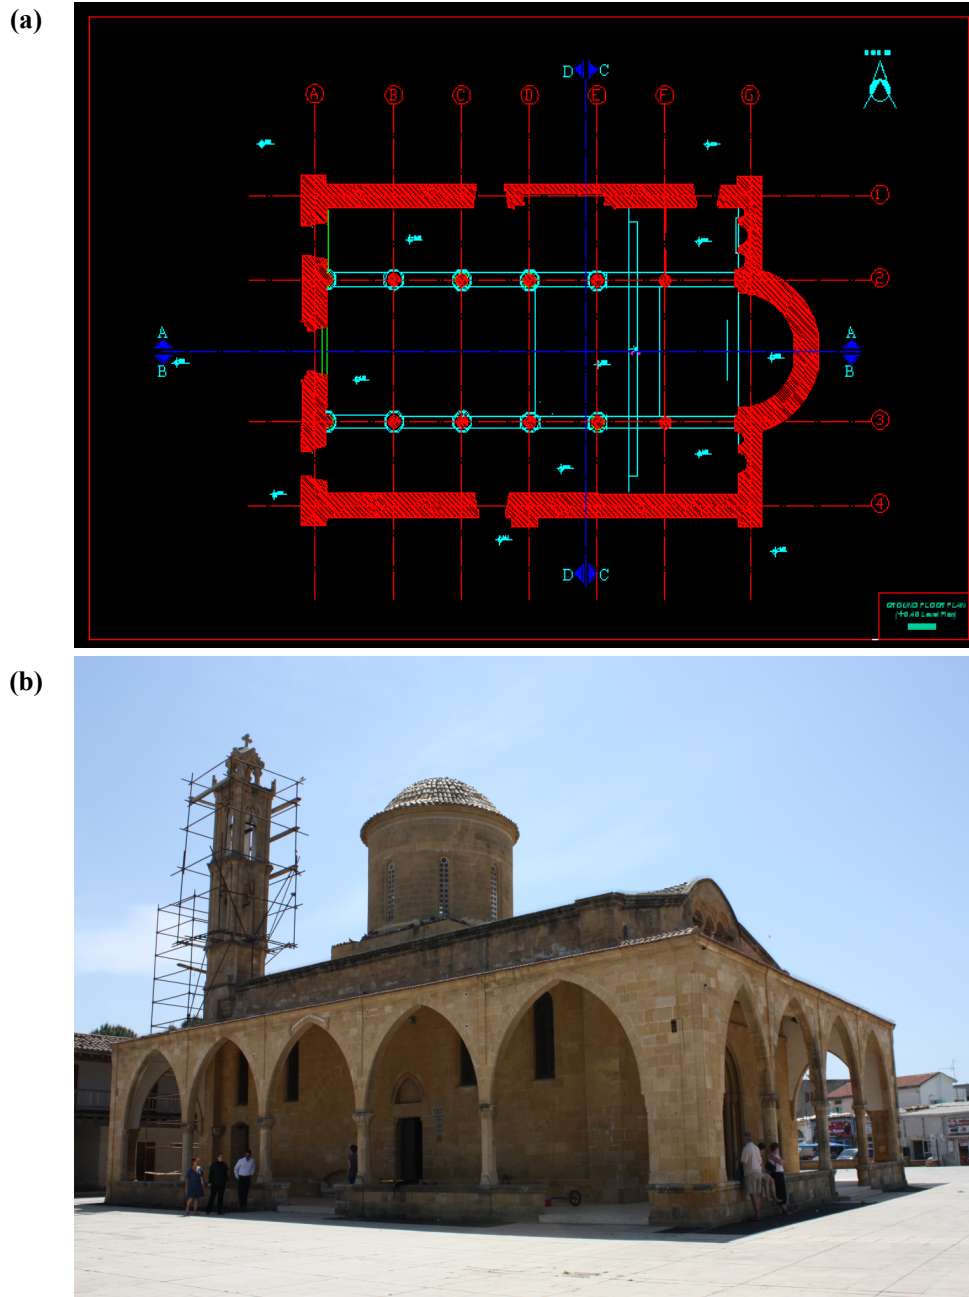
Figure 1: St. Mamas Church (a) plan view (Northern and Western porticoes are not included to the drawing), (b) picture of Northern and Western facades of the structure.

Results given in Table 1 indicate clearly the considerable variability observed. This was expected as the tested material is natural hence non-uniform. Also due to structure's age, time added additional heterogeneities caused by regional decay of the material under question. The middle columns of axis 3 (F3, E3, D3, C3) have relatively higher mean strength values in comparison to the rest. This can be one reason for observed cracking on columns D2, E2, F2 (supporting the dome above) whereas their mirror image counterparts on axis 3 being crack free. The rock hammer test results obtained for peripheral walls (both interior and exterior readings) have an average value of 11 with a coefficient of variance of 20%, in this respect similar to the results obtained from the interior columns. Regarding peripheral walls, local weaknesses were observed at the sanctuary apse, where axes G and 2 meet as well as G and 3.

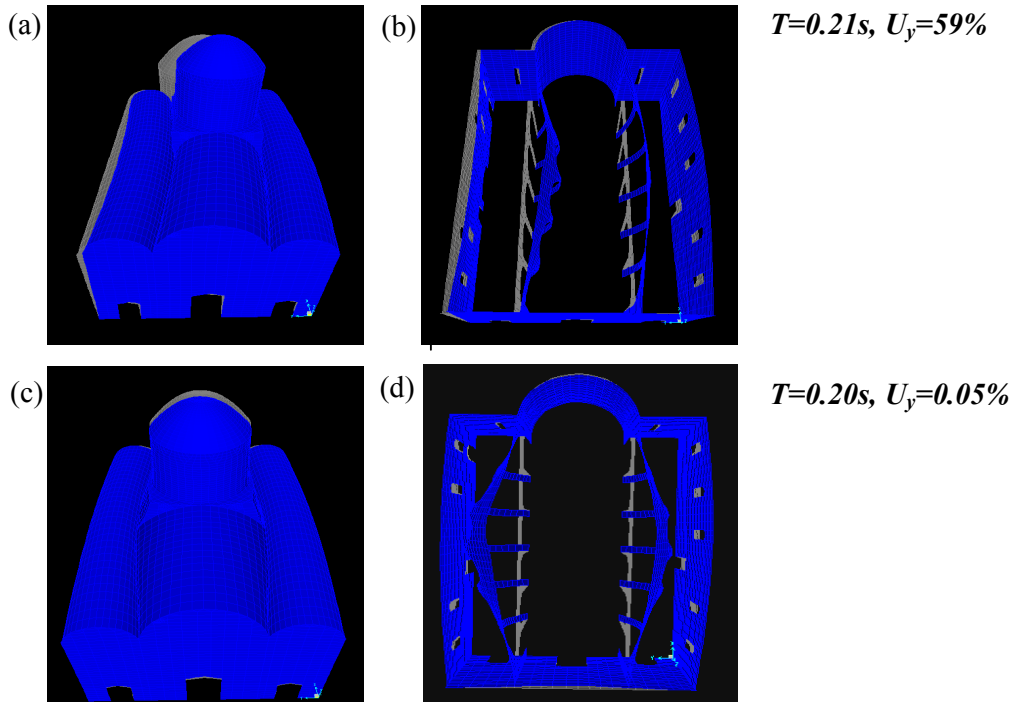
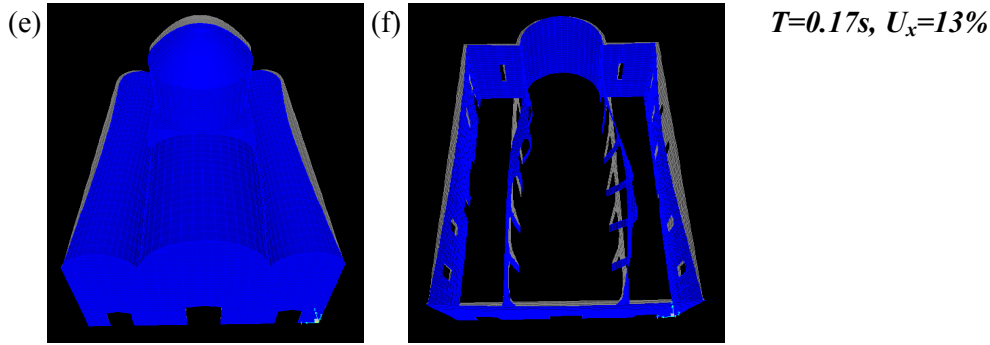
Figure 4: First three eigen-modes of the structure. First column of figures illustrate the structure as a whole, second column of figures do not include the roof system (hidden from view to illustrate directly the interior elements)

Figures 4a-4f depict the first three eigen-modes of the structure obtained by the linear elastic modal analysis carried out. The translational eigen-mode in the transverse North-South direction ( $y$  direction) is the one with the longest eigen-period (Figures 4a-4b,  $T=0.21s$ ). The structural response in this mode displaces the longitudinal walls mainly in an out-of-plane sense, which is achieved by the in-plane deformation of transverse peripheral walls. This first mode mobilizes approximately 59% of the total mass of the structure. This is later followed by a higher translational eigen-mode in the transverse direction that mobilizes only very small portion of the total mass and mainly causes out-of-plane deformation at internal longitudinal walls (Figures 4c-4d,  $T=0.20s$ ). The translational eigen-mode in the longitudinal East-West direction ( $x$  direction) is finally reached at the third longest eigen-period (Figures 4e-4f,  $T=0.17s$ ). The structural response in this mode displaces the longitudinal peripheral walls mainly in in-plane manner, with the cylindrical drum at the roof displacing in the East-West direction and the transverse peripheral walls mainly resisting with out-of-plane action. This third mode mobilizes approximately 13% of the total mass of the structure.

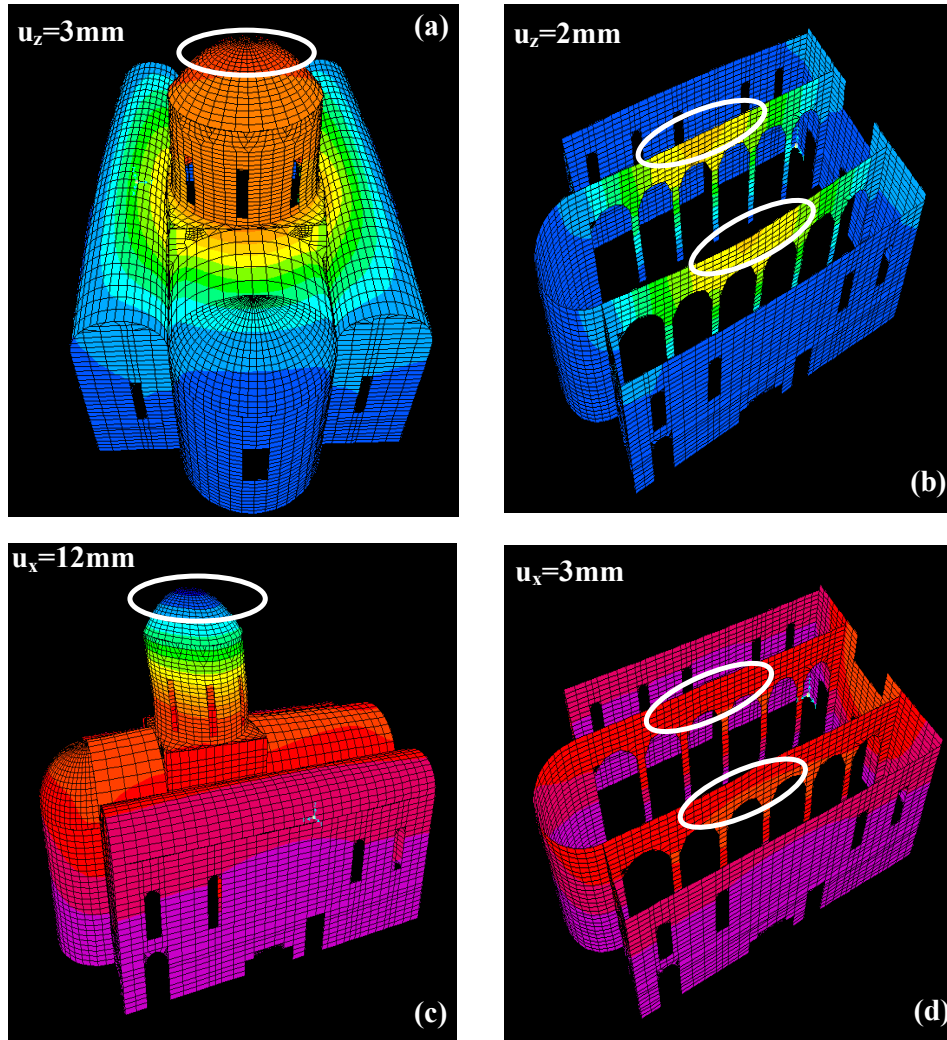
Results are shown in Figures 5a-5f below. Under the effect of dead load only, maximum vertical deformation of 3mm was observed at the spherical dome above the drum; whereas level of vertical deformation at the columns below supporting the drum was 2mm (Figure 5a-5b). The structure is considerably more flexible in the transverse direction than the longitudinal direction. Results also indicate that the internal colonnades are so flexible in both longitudinal and transverse directions that they contribute very little to the resistance in both of these directions. Under  $E_x$ , maximum deformation along the longitudinal axis of the structure at the dome level was determined to be 12mm whereas under  $E_y$  maximum deformation along the transverse axis of the structure at the dome level was almost twice as much approximately

22mm. Under both  $E_x$  and  $E_y$ , the deformations at the roof level below the drum were considerably lower than the aforementioned maximums, in the range of 3-4mm for  $E_x$  and 8-10mm for  $E_y$ . Under  $E_x$ , it is mainly the longitudinal peripheral walls resisting with in-plane action. Whereas under  $E_y$ , transverse peripheral walls resist with in-plane action and the longitudinal peripheral walls resist with out-of-plane action.

Figure 5: Deformations under (a)-(b) dead load  $G$  and (c)-(d) Earthquake load  $E_x$ . First column of figures illustrate the structure as a whole, second column of figures do not include the roof system (hidden from view to illustrate directly the deformation of interior elements)

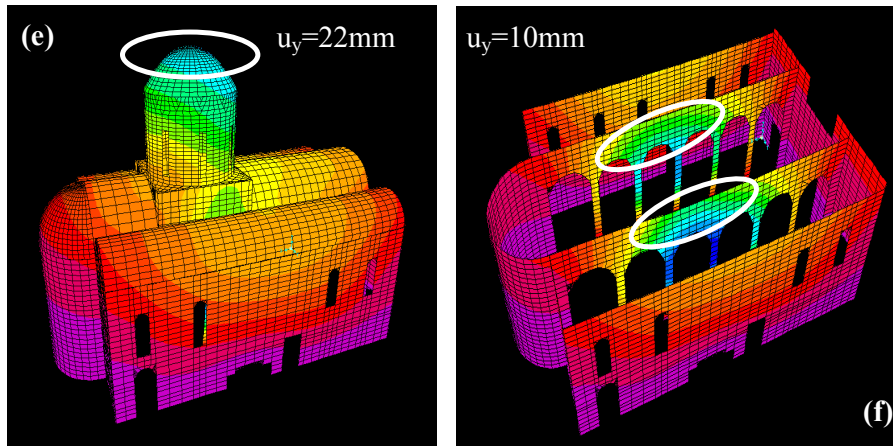
Figure 5 cont.: Deformations under (e)-(f) Earthquake load  $E_y$ . Figure on the left illustrate the structure as a whole, figure on the right do not include the roof system (hidden from view to illustrate directly the deformation of interior elements)
