The Structural Strengthening of a Masonry Heritage Shop House using Glass Fibre Based Materials

1 Introduction

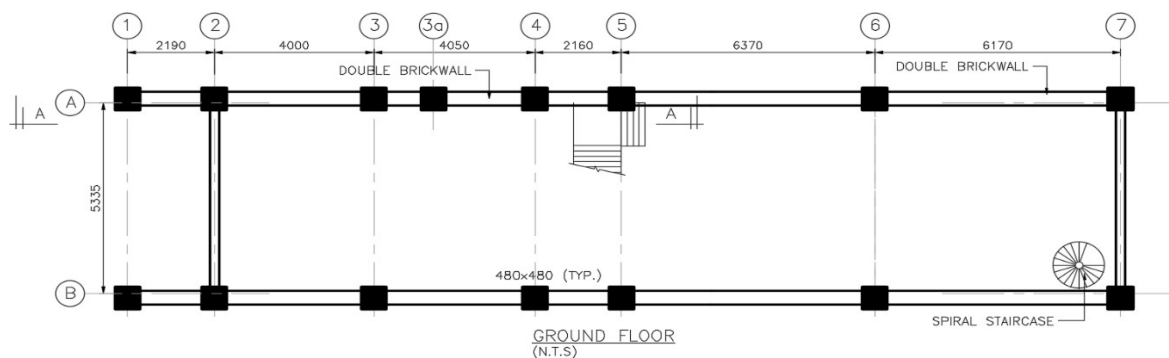
A masonry shop house in Malaysia was badly affected by construction being undertaken at an adjacent lot. The building was in a serious state of disrepair and on the verge of collapse at the time of the investigation and temporary propping and a stoppage of adjacent works had to be imposed. The uneven loads due to differential settlement on the masonry columns had caused the characteristic structural cracking of the Arches, where cracks of up to 50 mm in width were noted. The structural cracking extended to the party wall along Gridline A2- A5 where cracks of up to 30 mm were noted. The wall away from the new development was structurally intact. The cracking on the walls and the Corridor Arch were clearly to do with settlement and vibration loads associated with the adjacent construction, rendering the building unsafe. Compensation Grouting was undertaken for all footings at the common Boundary between the Shop House 150 and 152 from Gridline A/1 to 7 to guard against future movement and settlement.

Figure 1. Plan View of Shop House.
