The Structural Function of the Dutch Buttressing of the East Curtain Wall of Elmina Castle, Elmina, Ghana.

Renato Perucchio^{*}, Selman Tezcan¹ and Jiacheng Sun²

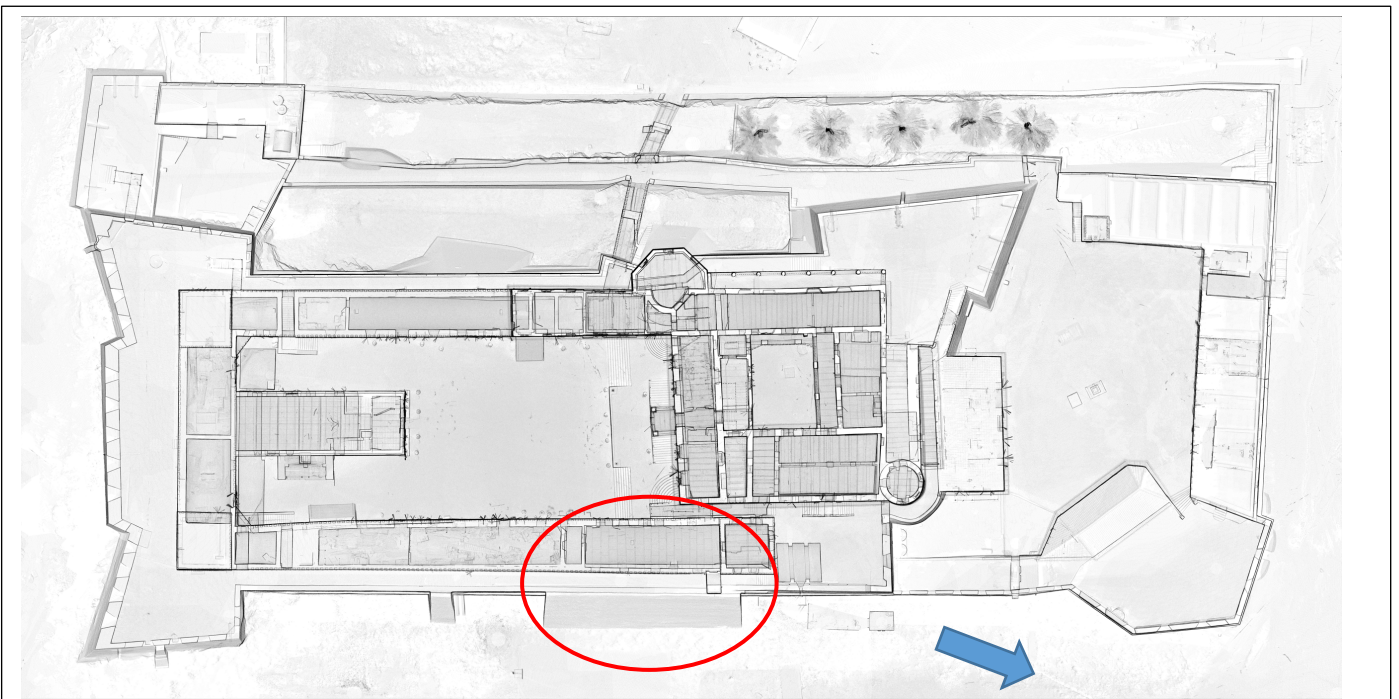
Elmina Castle floor plan with Dutch buttress highlighted, based on 2017-2018 FARO Scans taken by Michael Jarvis. - U. Rochester/ U. Ghana, Legon, Field School.

The present paper focusses on the structural static and dynamic analysis of the east curtain wall which features two massive masonry buttresses which reach up to the parapet but were built only along selected portions of the wall. Historical documents clearly show that these buttresses are a Dutch addition, since they do not appear in the only drawing showing the castle still in Portuguese hands in 1637 while they are present in detailed - and particularly accurate - Dutch maps of the second half of the 1700's. Like the western curtain wall, the original eastern curtain wall appears to be built with foundation resting on levelled limestone bedrock, as reported by the Portuguese chronicles describing the 1482 construction process. The laser-scan and photogrammetric survey conducted during the field school and information extracted from the historical record allow us to construct a reasonably accurate building sequence beginning from late Portuguese occupation (before 1637) to the mid 1700's. The late Portuguese west wall was extended in elevation and considerably thickened with mud-mortared masonry covered by lime plaster, and a two-story building was added along its entire length, with the inner side of the curtain wall becoming part of the new building. The first (ground) story of the building is vaulted with a 4m-span barrel vault approximately 15 cm thick (the length of an average Dutch brick.) This thin vault - excellently executed with bricks interlocking in two directions - carries a considerable
