FULL-SCALE SHAKE TABLE EXPERIMENTS AND VIBRATION TESTS FOR ASSESSING THE EFFECTIVENESS OF TEXTILE MATERIALS FOR RETROFITTING MASONRY BUILDINGS

Paul Michelis¹, Costas Papadimitriou², Grigoris K. Karaiskos², and Dimitra-Christina P. Papadioti²

Keywords: Masonry structures, FRP reinforcement, Shake table tests, Structural identification, Damage assessment.

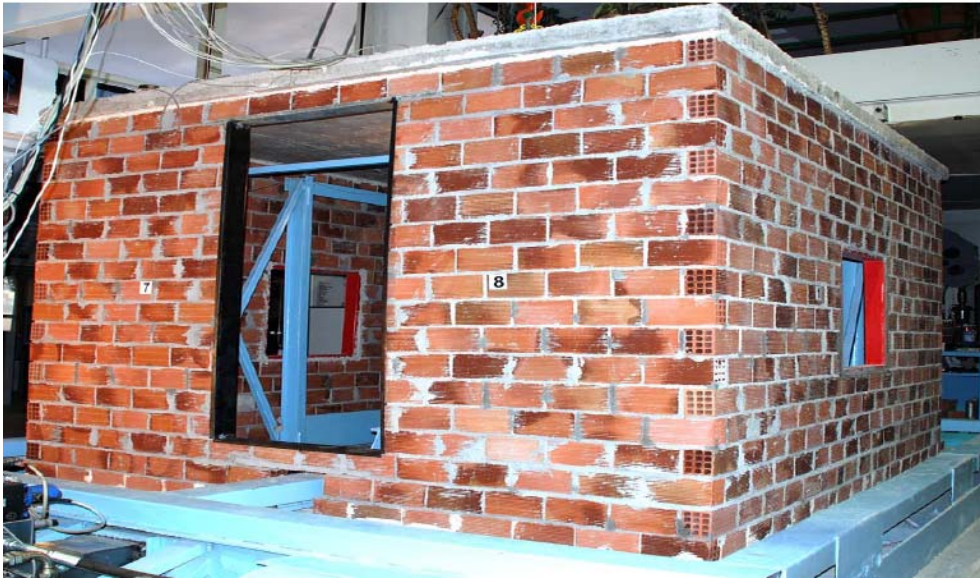
Figure 1: A picture of the intact masonry building.

A full-scale single-story (one-room) brick-masonry building is designed and constructed in the laboratory. The un-reinforced brick building is representative of existing masonry buildings in Greece, particularly in the countryside. A picture of the intact building resting on the shake table is shown in Figure 1. The geometry of the masonry structure is shown in Figure 2. The masonry structure consists of four single masonry brick walls with two opposite

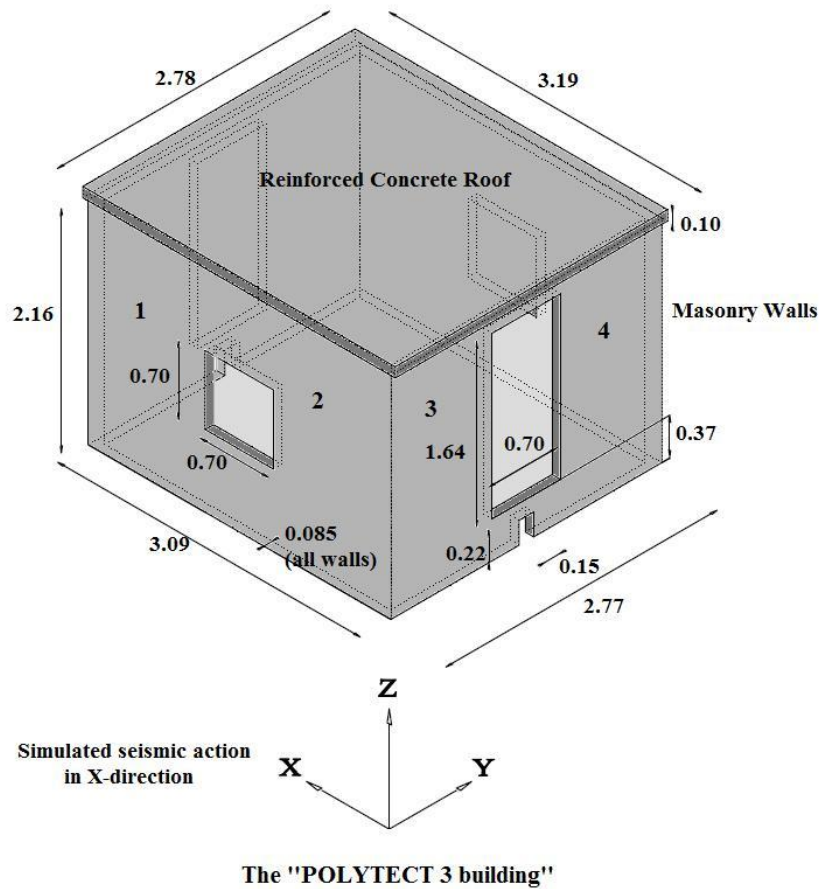
Figure 2: Geometric of masonry building.

doors and windows, and a reinforced concrete roof. The four walls of the masonry building are anchored on the shake table. The top view dimensions are 3.19m parallel to the X-axis and 2.78m parallel to the Y-axis. The structure height is 2.26m (including 10 cm concrete roof thickness). The door's width and height is 0.70m and 1.64m, respectively and it is placed on the center of the two opposite wall's width. The window's width and height is 0.70m and 0.70m, respectively and it is placed on the center of the two opposite wall's width. The layout of the door and window openings results in a symmetric building, avoiding eccentricities as much as possible. All the surrounding walls are 8.5 cm thick, determined by the width dimension of the bricks.

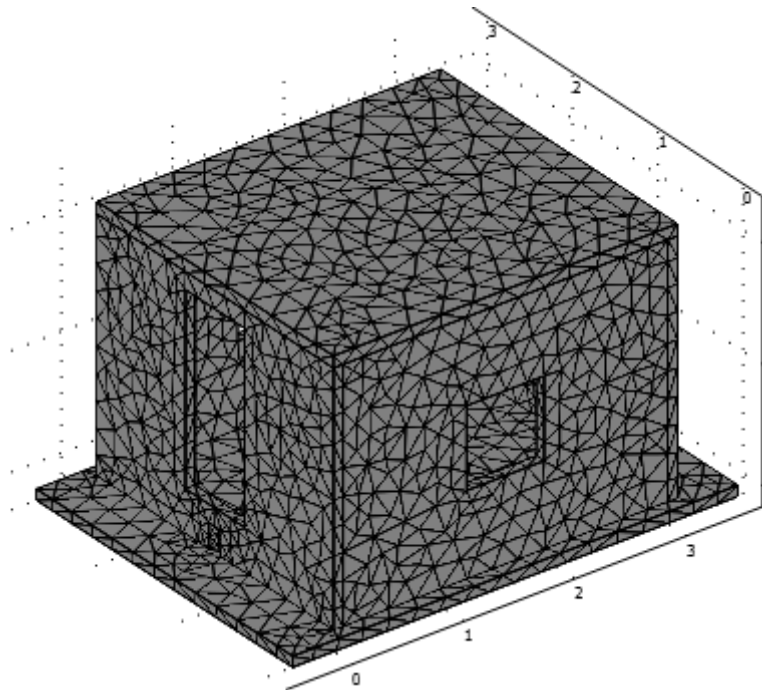
Figure 3: Finite element model of the masonry building using tetrahedral solid elements.

the following nominal values for the mechanical properties were assumed for the composite brick-mortar units: elasticity modulus parallel to the brick's holes $E_1 = 1.8$ GPa, elasticity modulus vertical to the brick's holes $E_2 = 2.3$ GPa, shear moduli $G_1 = 0.64$ GPa and $G_2 = 0.82$ GPa, Poisson ratio $n_1 = n_2 = 0.4$ and average density $r = 1000$ Kg/m³. The finite element model is shown in Figure 3. It consists of 8341 solid finite elements and has 50553 degrees of freedom.

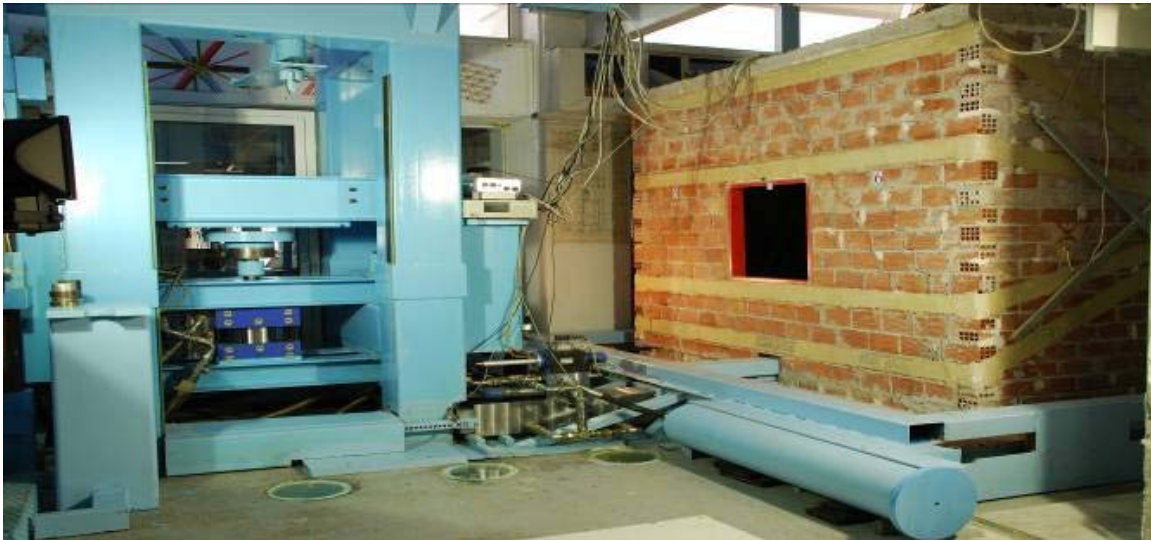
Figure 4: The reaction-actuating unit of the shake table facility (left) with a masonry structure (right).

The tests were performed at IMM. A unidirectional textile shake table was designed and constructed at IMM for carrying out the seismic test campaign. The dimensions of the shaking table are 4m by 3m. The table is accelerated using a displacement controlled servo-hydraulic system, developed and validated within the European Research Project "POLYTECT" [18]. The table has the following two original characteristics. It is not metallic but textile table, produced by a honeycomb panel (glass reinforced PEEK), manufactured by IMM based on the patented DIRIS architecture (Directionally Reinforced, Integrated, Stretched, Sing yarn) [20]. This panel is light, weighting only 210 Kg and extremely stiff, ex-

hibiting the highest shear strength in in-plane and out-of-plane loading [21]. The actuation-control mechanism of the servofvalve is piezoelectric, reacting much faster and more precisely than the ones available in the market. Exploiting the previous capabilities, the shaking table possesses the following characteristics. It is capable of sinusoidal, random, shock and arbitrary time history excitation, it has a maximum payload of 10 Ton, maximum displacement of ± 120 mm, maximum acceleration of 4 g (with 10 Tons payload), and frequency limit of 100 Hz. The reaction-actuating unit of the shake table facility is shown in Figure 4. The previous technical characteristics classify the facility as one of the few operating in Europe but with one distinction: its very low cost of construction (<10% of the equivalent European facilities) and operation.

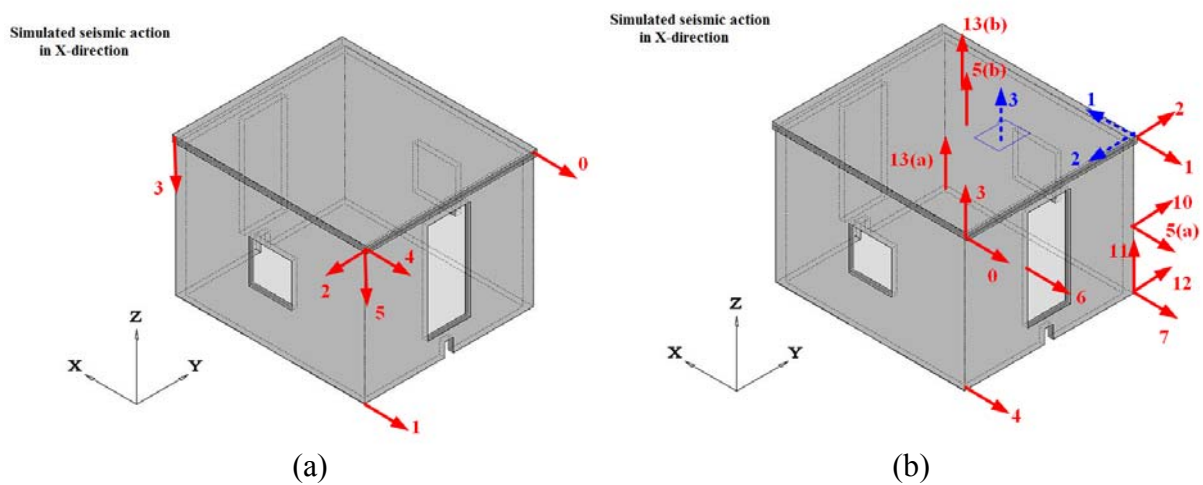
Figure 5: Sensor configurations (positions) and hammer impact points on the masonry structure, (a) un-reinforced building, (b) reinforced building.

After each earthquake event, a total of 6 impulse hammer tests were conducted. The impact force was inflicted along the two horizontal directions and one vertical direction in order to excite all lower important modes of the structure. The impact points and directions are shown in Figure 5(b) with blue (broken) arrows. Two independent tests per each excitation direction were performed. Each impulse hammer test lasted only a few seconds allowing to speed up considerably the whole procedure of acquiring data from the structure.

During the first four (4) seismic tests (1st, 2nd, 3rd, and 4th) the building was instrumented with 10 sensors (sensors 0, 1, 2, 3, 4, 5, 10, 11, 12 and 13 in Figure 5(b)). During the 5th, 6th and 7th seismic tests the building was instrumented with 12 sensors: sensors were added at positions 6 and 7 in Figure 5(b) and the sensors 5(a) and 13(a) in the set up shown in Figure 5(b) were re-positioned (at locations (5b) and 13(b) in Figure 5(b)) on the roof of the building as shown in Figure 5(c). This sensor relocation was necessary in order to monitor the z -direction and take more accurate measurements of the out-of-plane mode of the concrete roof

where strong motion was detected. During the final six (6) seismic events (8th to 13th events) the building was again instrumented with 12 sensors. The location of sensor 13(b) in sensor configuration shown in Figure 5(b) was changed to its original location 13(a).

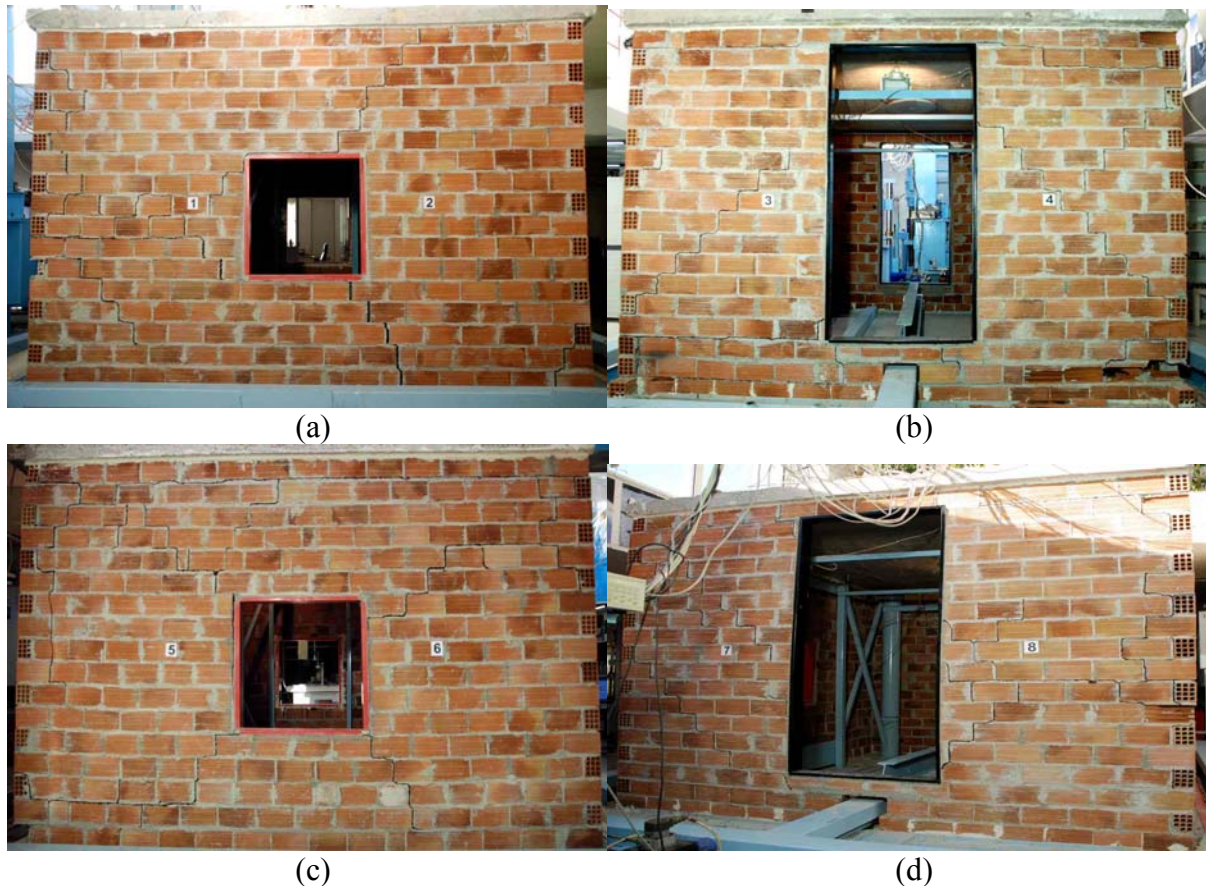
Figure 7: The masonry building damaged after the application of the sixth seismic event. (a) Walls 1 and 2, (b) Walls 3 and 4, (c) Walls 5 and 6, (d) Walls 7 and 8.

The un-reinforced masonry building sustained the first five seismic events without suffering any serious visible damage. The last seismic event, which was theoretically intensified almost 8 times the original seismic event, heavily damaged the building with large crack openings developed along the walls and propagated mainly through the mortar. The four sides of the masonry building after the application of the sixth seismic event are shown in Figure 7. Based on visual inspection, the sixth seismic event generated shear failure of many bricks and mortar, diagonal cracking on the walls, extensive flexural faults and measurable shear sliding in the walls 1, 2, 5 and 6. Larger crack opening were observed on the two sides of the wall with the window openings that extend along the direction of motion. The other two sides of the building walls, with the door openings that extend along the perpendicular direction of motion, also sustained serious damage. All the walls were damaged but it seems that the in-plane shearing (walls 1-2 and 5-6) produced more damage than the out of plane loading (walls 3-4 and 7-8). Overall, during the action of the sixth seismic event, the masonry building sustained serious visual damage, with the walls losing their structural integrity and posing increased threat to occupants due to high risk of collapse to future seismic excitations.

Specifically, from the results in Figures 11(a) and 11(c), one clearly observes that earthquake shaking damages internally the structure causing a stiffness degradation, manifested as a reduction in the values of the modal frequencies. As the intensity of the earthquake event increases the values of all four modal frequencies reduce. However, for the first five seismic events no visible cracking in the masonry walls was evident for the case of the un-reinforced masonry structure. The small reduction of the modal frequencies observed is an indication of internal damage caused by non-visible micro cracking in the mortar and the interface between the mortar and the bricks. A large reduction in the modal frequency is observed after the sixth earthquake event which is due to significant stiffness deterioration caused by the severe damage in the masonry walls. As mentioned before, under the action of the sixth seismic event all four masonry walls sustained large crack openings, shown in Figure 7.

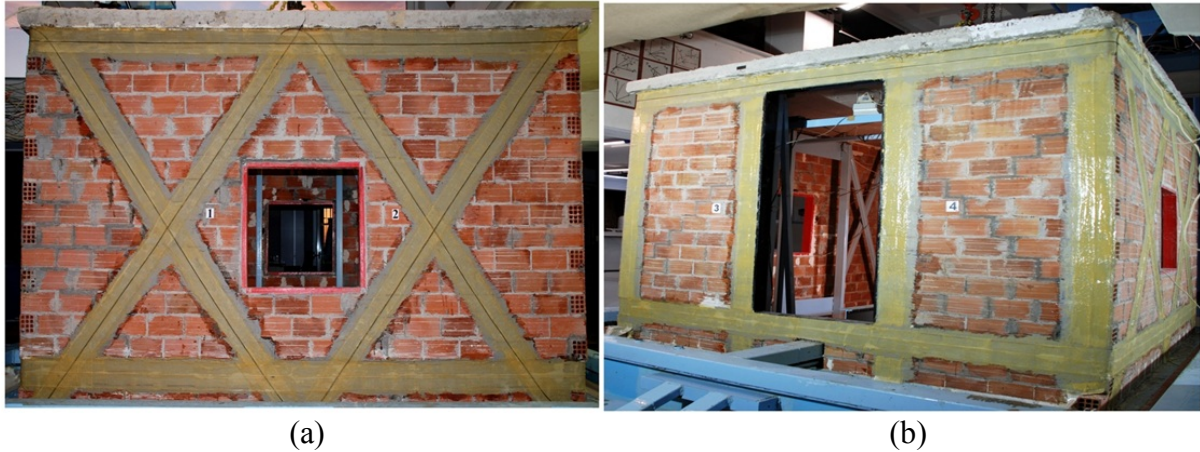
Figure 8: A picture of the repaired masonry building with reinforced GFRP strips; (a) sides 1-2, (b) sides 3-4.

The repairing design consists also of external reinforcement by bonding peripherically, tensioned glass fibre thermoplastic (GFRP) strips, with spacing in agreement with the CNR-DT/2004 guidelines [22]. Specifically, after the repair work was completed, the masonry walls were reinforced by GFRP strips against out-of-plane and in-plane loading, according to the CNR-DT/2004 guide. Figure 8 show the GFRP strip reinforcement along the masonry building walls 1-2 and 3-4. Exactly the same reinforcement patterns were applied along the masonry building walls 5-6 and 7-8. A schematic diagram of the reinforcement is also shown in Figure 9 and covers all four sides of the masonry walls along horizontal, vertical and diagonal directions. The GFRP strips are 150 mm wide, 3 mm thick and have 4 kN tensile strength.

The GFRP strips were bonded on the bricks, initially by polymer and then by polymer-cement plaster of B.G. Polymers. The patterns – positioning of the strips were designed to maximize the out-of-plane resistance for the walls with the doors (sides 3, 4, 7 and 8) and the in-plane resistance to shear for the walls with the windows (sides 1, 2, 5 and 6) along the direction of loading. To this end the strips are parallel in the walls with the doors and diagonal in the remaining walls with windows. The thin and flexible strips allow the masonry to move (to micro-slide) and therefore to mobilize more effectively reaction mechanisms to absorb energy. Also the symmetry of the strip layout prevents eccentric stiffness and strengthening that may cause twisting.

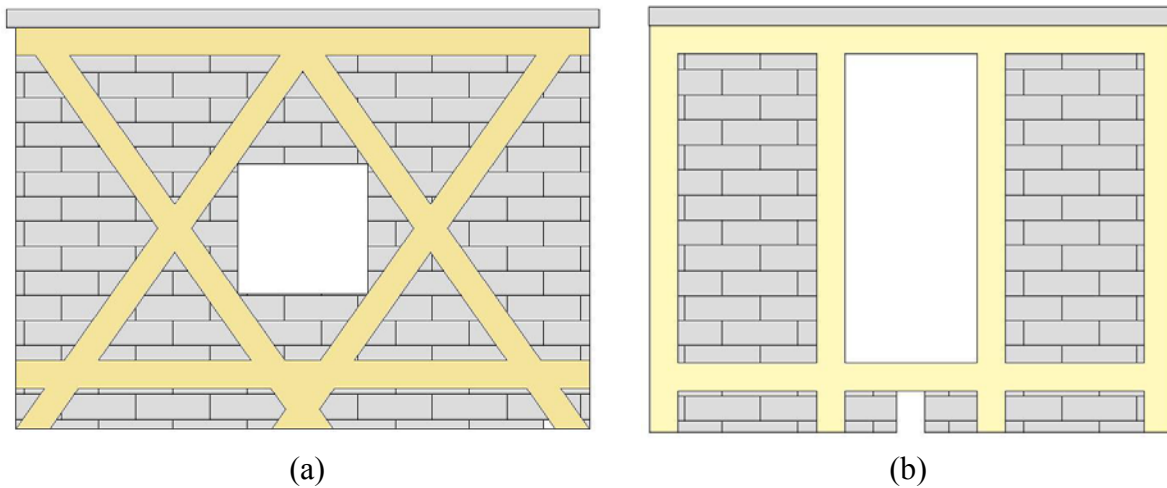
Figure 9: A schematic diagram of the reinforcement on the masonry building; (a) sides 1-2 and 5-6, (b) sides 3-4 and 7-8.

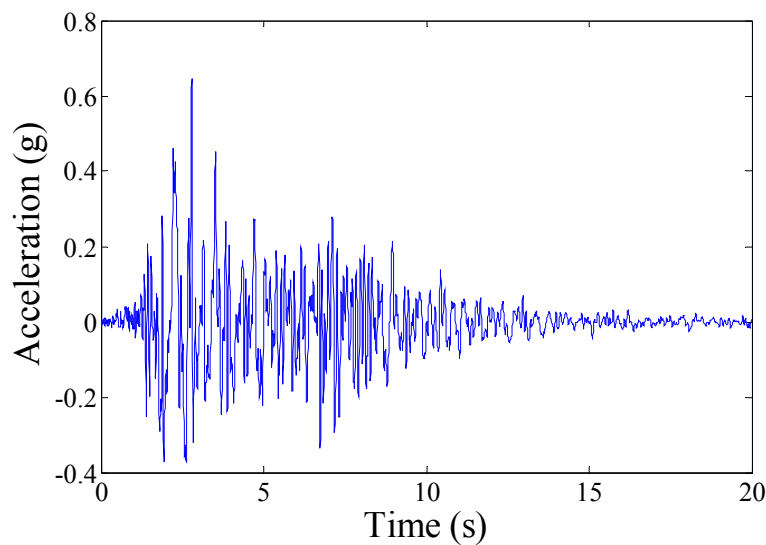
Figure 10: 2009 W-E component of L' Aquila earthquake shaking.

A new series of earthquake excitation tests were conducted on the retrofitted building by scaling the intensity and time of the 2009 L' Aquila W-E earthquake accelerogram, shown in Figure 10. Thirteen (13) seismic excitation events were included in the new series of tests. The thirteen excitations correspond to various intensity levels of the L' Aquila earthquake. As before, the different intensity levels were accomplished at the shake table by either changing the intensity of the command displacement in the table or scaling the time over which the earthquake was applied. Table 2 reports the information on the thirteen seismic excitation events, including the corresponding scale in intensity and time. It also gives the PGA values along the direction of motion.

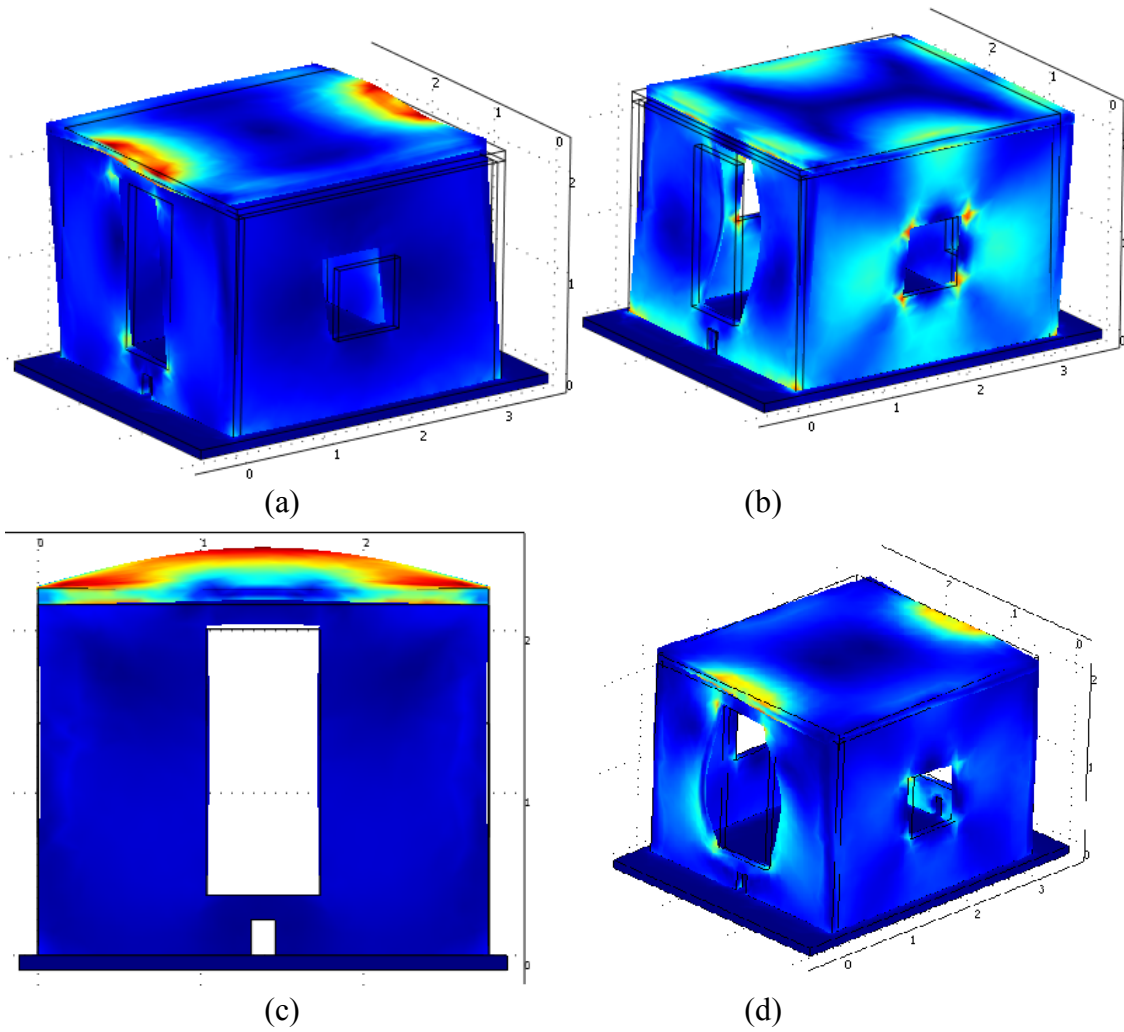
Figure 14: Model predicted mode shapes (a) first mode, (b) second mode, (c) third mode, (d) fourth mode.

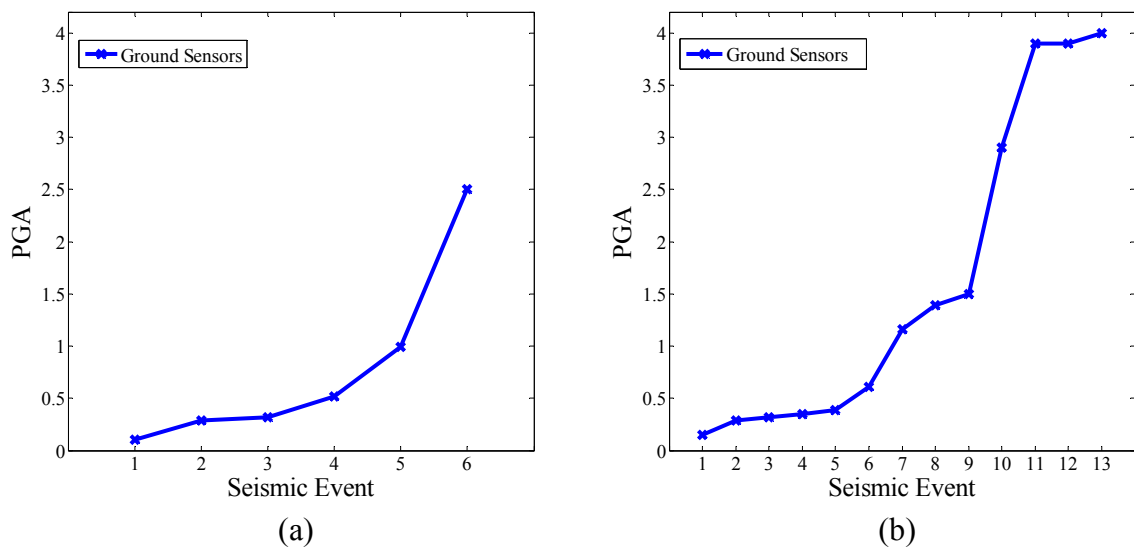
Figure 15: Evolution of PGA as a function of the seismic events (a) un-reinforced building, (b) reinforced building.

The change (reduction or increase) of the lowest four modal frequencies observed in Figure 11 is due to the change in stiffness of the masonry building caused by damage under the applications of the seismic events or by the retrofitting actions. The results in Figure 11 confirm that the identified values of the modal frequencies are highly dependent on the intensity levels of the seismic events and the corresponding health state of the building. The PGAs of the seismic events are shown as a functions of the seismic events in Figures 15(a) and 15(b) for the un-reinforced and the reinforced building, respectively.
