## SMART BEHAVIOUR OF CNT MODIFIED ADHESIVE FILMS FOR CARBON FIBER COMPOSITE REPAIR

A. UREÑA, C. GARCÍA-NIETO, X.F. SÁNCHEZ-ROMATE, J. RAMS, M. SÁNCHEZ

**Key words:** Adhesive, repair, composite, SHM, CNT

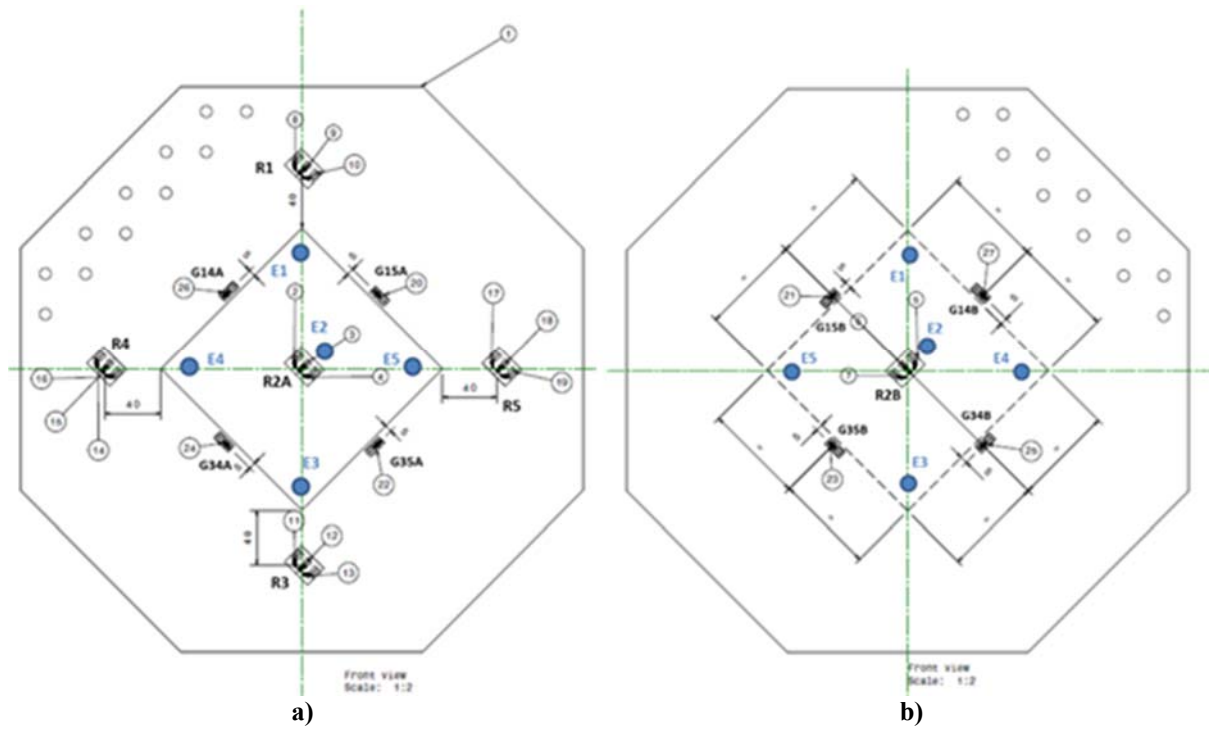
**Figure 3.** Schemes of the extensometry and electric sensorization of a repaired composite panel:  
a) front face; b) back face.

A shear test was carried out in the panel. Six rectangular rosettes RY81-6-350 with 350  $\Omega$  and eight strain gauges LY41-6-350 with linear geometry and 350  $\Omega$  were placed in the panel. The disposition is shown in Figure 4, where the outer and the inner (Side A and B, respectively) surface of the panel is represented. The outer corresponds to the composite patch repair side. In addition, the corners were cut according to the required tooling for the mechanical tests.

In combination with rosettes and strain gauges, an electrical sensing scheme was defined. This electrical network (blue circles) was composed by five channels (E1 to E5) and it is shown in Figure 3. E1 and E3 were placed in the load axis at 10 mm from the corner of the patch. E2 was placed at 20 mm from the center of the repair. E4 and E5 channels were placed near the right and left corners of the patch at 10 mm.

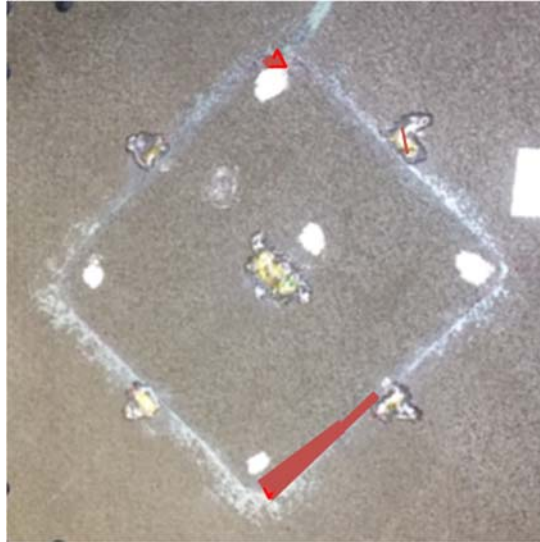
**Figure 7.** Ultrasonic inspection of repaired panel after shear testing.

Regarding to the repaired panel, the NDT inspection after the test showed the presence of two disbond areas (Figure 7):

- **Disbond area A:** it was detected in the upper region of the patch repair. It was not possible to determine if the bottom echo came from the interface between the substrate and the adhesive film (adhesive failure) or inside the adhesive (cohesive failure). Damage extent was similar to an equilateral triangle of 10 mm.

- **Disbond area B:** it was detected in the lower region of the patch repair with dimensions of  $61 \times 10 \text{ mm}^2$ , approximately. Similarly to disbond area A, it was not possible to determine if the failure was located in the interface between substrate and adhesive film or inside the adhesive

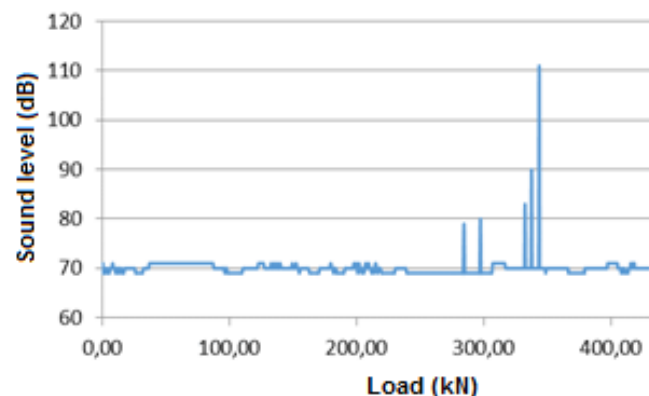
**Figure 8.** Detected sounds during mechanical testing of repaired panel

The results obtained by the sound level meter during the mechanical test are shown in Figure 8. The environmental sound was between 69 and 71 dB. By taking into account this reference, several sounds at different magnitude were detected. The first one of them was detected at 283 kN with a magnitude of 79 dB. Then, the second one was detected at 297 kN, reaching a value of 80 dB. After 330 kN, several sounds were recorded with higher intensities: at 332 kN, a sound with a magnitude of 87 dB was detected; at 337 kN, the acoustic emission reached a value of 90 dB; and at 344 kN, the highest acoustic emission was detected, with a value of 111 dB. From this point until the end of the test (430 kN), no more anomalous sounds were recorded.

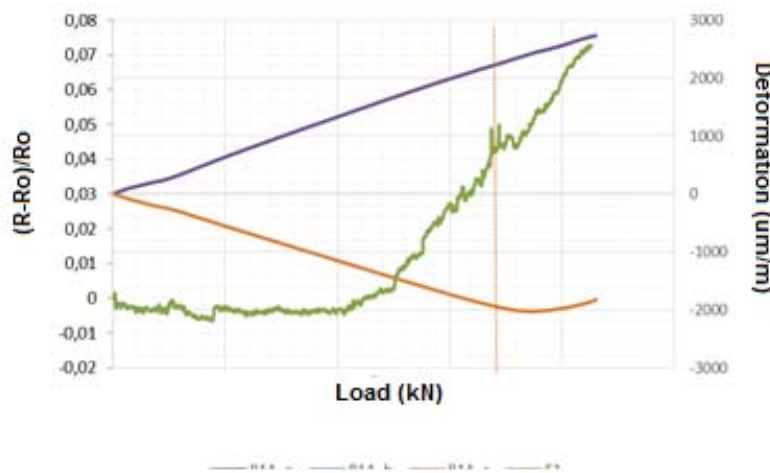
**Figure 9.** Correlation between extensometric measurements and electrical sensorization for emitted sound at 337 kN

The analysis at 337 kN showed that the most significant variation on the strain gauge and sensing curves took place at the E1 channel. Figure 9 shows the electrical response of the E1 channel and the strain gauge response of the nearest rosette, R1 from 0 to 430 kN. At 337 kN, a sudden change on the electrical curve, R1\_c was observed. In addition, a disbond were also observed in the area A. Therefore, it can be concluded that the disbond took place at 337 kN.

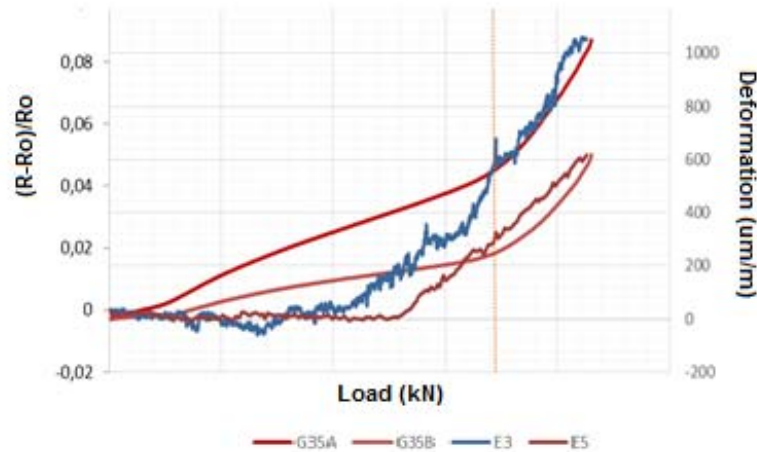
**Figure 10.** Correlation between extensometric measurements and electrical sensorization for emitted sound at 344 kN

On the other hand, the most significant changes on the sensing and strain gauge curve at 344 kN took place in the E3 and E5 channels. Figure 10 shows the strain gauge response of the nearest rosettes, G35A and G35B in combination with the electrical response. At 344 kN, a noticeable change on G35A and G35B curves was observed. As a disbond was detected during the inspection phase, it can be concluded that it took place at 344 kN.
