Long-term Performance of Repairs to Reinforced Concrete Exposed to Coastal Conditions

Keywords: *Exposure Test, Corrosion, Cracking, Patch Repair Methods, Surface Coating.*

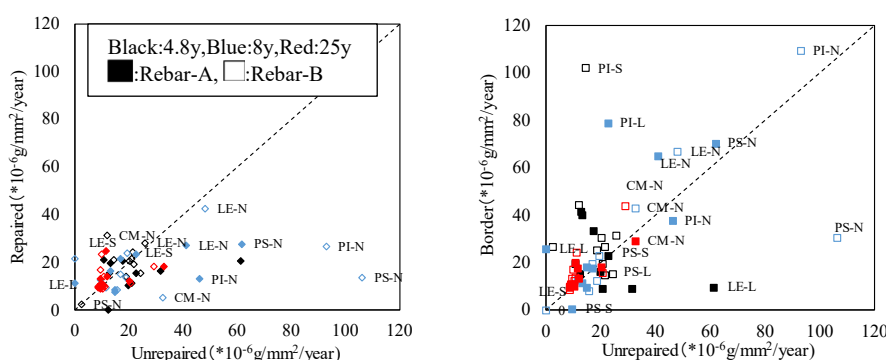
Figure 1 depicts correlations of rebar corrosion speed in the unrepaired versus border and repaired sections. Corrosion was effectively prevented by the repair techniques utilized, by and large proceeding at slower speeds in repaired than unrepaired rebar. Corrosion speed was quite high in the border region after eight years of exposure following repair with the rust-resistant SBR polymer cement (PI). This behavior could be attributable to a macrocell formed by a major differential in corrosion potential between the repaired and unrepaired parts due to the anti-rust additive in the mortar. However, the same tendency was not apparent in the 25-year-old specimens repaired using the same material, suggesting this variation likely originated in individual differences between specimens. In any case, the results showed that multi-layer textured coating is most effective to prevent corrosion.

Figure1. Rebar corrosion speed.

- Corrosion protection was greater when concrete chipping extended below the rebar than merely to the same depth.
- Rebar corrosion, as with carbonation, was most effectively prevented by the multi-layer textured coating material.
- Rebar was more resistant to corrosion following patch repair with SBR polymer cements than with lightweight epoxy.
