Drying Potential of Wood Frame Walls Subjected to Accidental Water Infiltration

Keywords: *Wood Frame Construction, Measurements, Drying, Water Infiltration.*

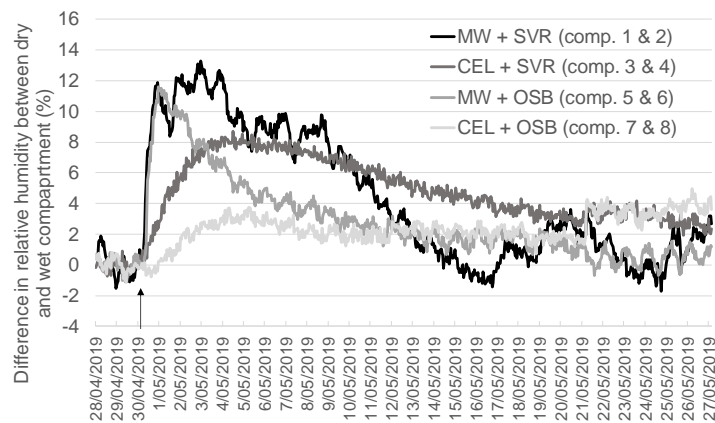
Figure 2. Difference in RH between wet compartment and the dry compartment.

The results showed that the RH in the insulation layer increased when water was injected. It was assumed that the injected water mainly runs down at the interior side of the insulation layer, especially for the compartments with mineral wool due to its very low moisture capacity. The drying rate was estimated by comparing the RH of the wet and dry compartment of each construction type (Figure 2). The RH difference increases faster in the compartments filled with mineral wool compared to the compartments filled with cellulose. Similarly, the drying rate of the compartments with cellulose is lower. For the compartment with mineral wool and SVR (comp. 2) and with mineral wool and OSB (comp. 6), the drying period is ± 14 and ± 21 days respectively. For the compartments with cellulose (comp. 4 & 8), the drying period is considered longer than the measurement period (> 27 days).
