# Performance of European Wood Species in Above Ground Situations After 10 Years of Weathering: Evidence of a Positive Impact of Proper Design

Magdalena Kutnik, Martine Gabillé and Mathilde Montibus

Technological Institute FCBA, Allée de Boutaut, BP 227, 33028 Bordeaux Cedex, France.  
magdalena.kutnik@fcba.fr, martine.gabille@fcba.fr, mathilde.montibus@fcba.fr

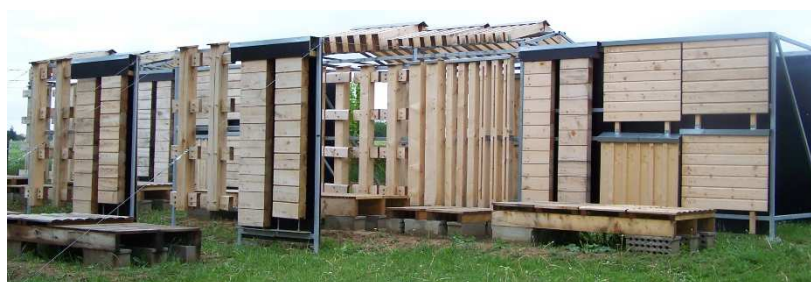
**Figure 1.** Test devices installed in Charrey-sur-Saône, France.

To evaluate the impact of proper design on wood's service life, large experimental structures (Figure 1) were constructed from six wood species selected for their economic importance and different natural durability against fungal decay according to EN 350 (2016): spruce, poplar (non-durable); maritime pine, Douglas fir, larch (moderately to poorly durable); oak (durable). The test devices mimicked different wooden constructions used outdoors: cladding, decking, vertical posts, assemblies, and log house outer walls. Each type of construction comprised both water-trapping and water-draining design details (up to six design schemes for the decking modules). The test devices were installed in 2009 in Bordeaux and Charrey-sur-Saône, two French cities with different climatic conditions (oceanic and continental).
