Reconstruction and design of a timber membrane stadium roof

Abstract

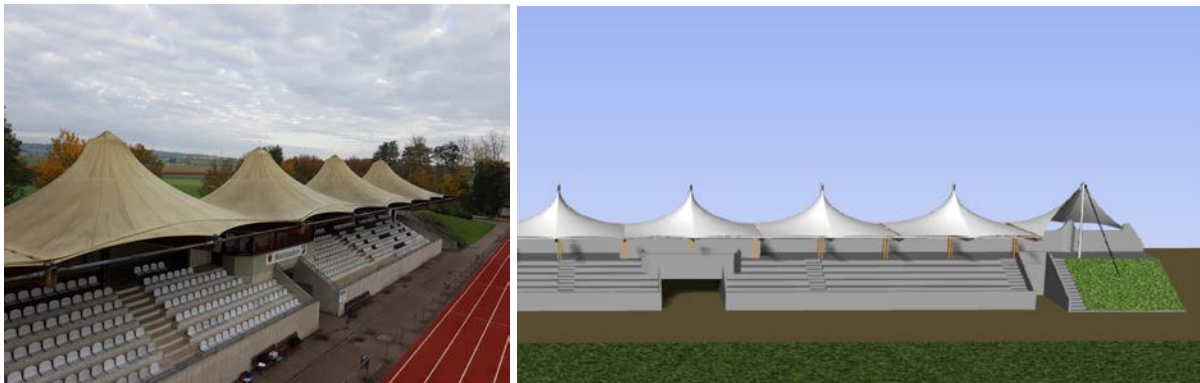
Fig 1: Original roof of the Dagersheim Stadium and its re-design
