Stabilization and consolidation of historical multi-layer masonry

J. Witzany[†], R. Zigler[†] and A. Libecajtová^{†*}

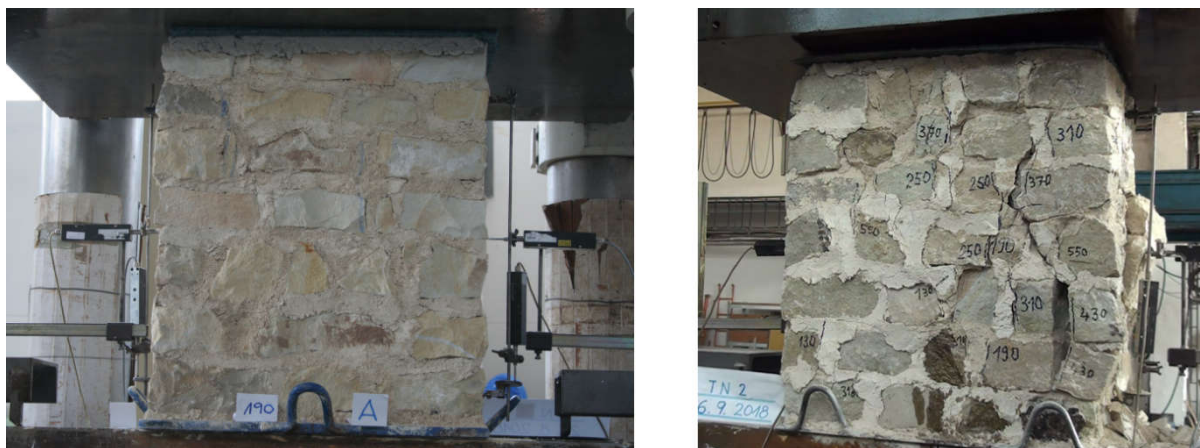
Fig. 1 Test specimens of multi-layer masonry segments before and after experimental loading.

One of the means of ensuring the cohesion of the individual layers is grouting of the joints with mixtures of suitable properties. As a part of the NAKI II research project, load tests of multi-layer masonry segments were performed. These tests pointed to the difficulty of solving this problem. The results of experimental tests of multi-layer masonry structures "reinforced" by grouting and corresponding numerical analysis will be presented in the article.
